SS 734-WST 2022 Thread Spring Pin Suspension Alignment & Installation

WST vehicles with threaded spring pin bushing front suspension installations.

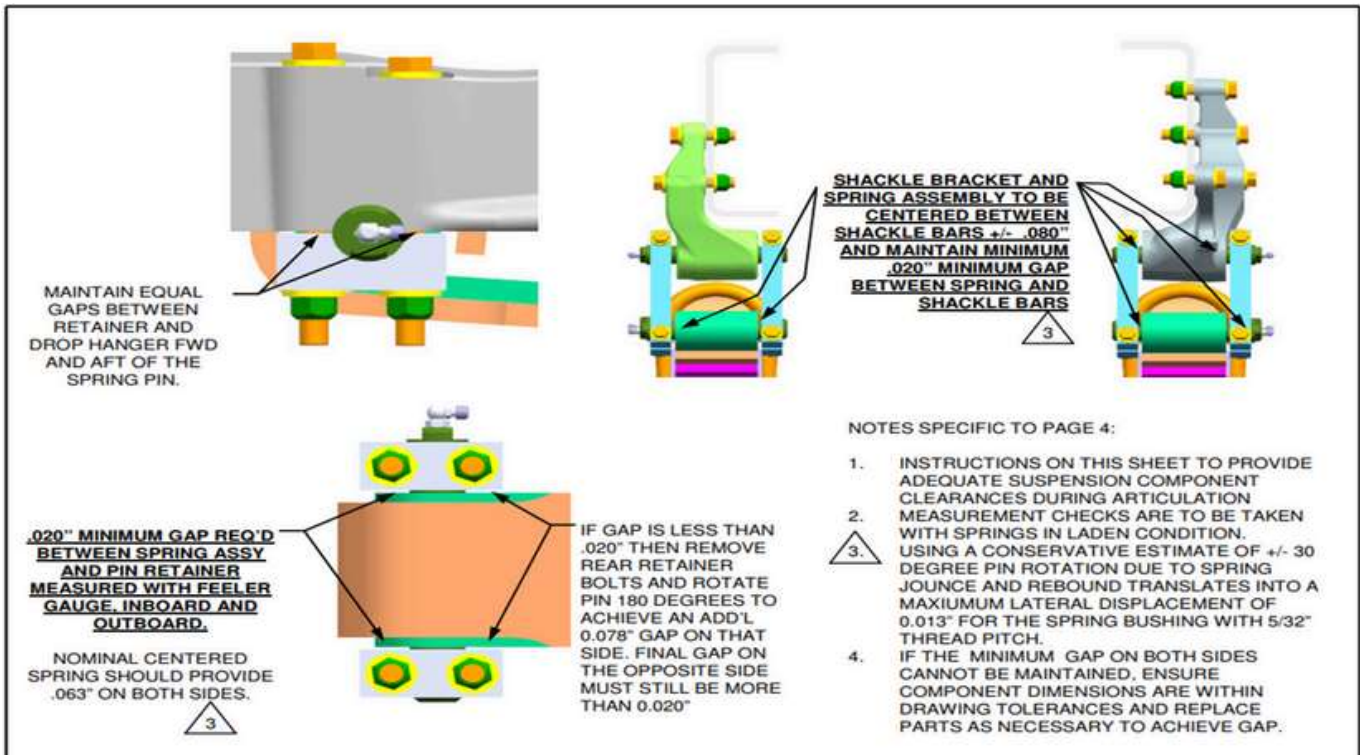
Front spring/shackle alignment on the vehicle.

When replacing front spring assemblies, threaded spring pin bushings, shackles on a vehicle, verification of correct alignment per attached drawing will reduce repeat failures in the field.
