## STAR ONLINE PUBLICATION

**Case Number:** S2423000029

**Symptom/Vehicle Issue:** Water Leaking Near Front Bulkhead Or Cowl Area On Driver's Side.

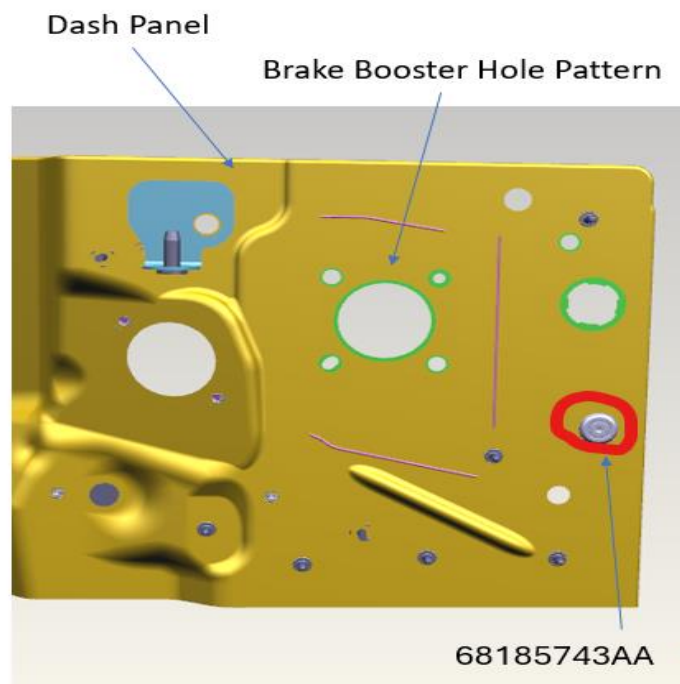
View from engine compartment side

**Discussion:** Inspect the front bulkhead for an opening that has no plug or tape covering it. Refer to the figure below. If this hole is uncovered, install plug 68185743AA. Then water test the vehicle to confirm the condition is resolved.

Plug should be inserted from the engine side
