Interior Symptom - Cup Holder on Passenger's Side Jams due to External Influences (SY 75/24)

Model Line: **911 (992)**

Model Year: **As of 2020**

Concerns: **Cup holder on passenger's side**

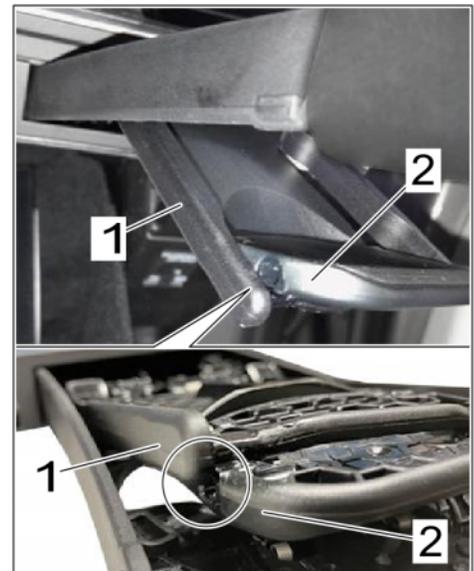
Bottom part unclipped (shown on one side)

Cause: The base part can unclip from the retaining bracket due to an increased force effect from below on the bottom section of the open cup holder, for example due to accidental snagging when getting in and out of the vehicle. As a result, the cup holder jams when inserted into the housing slot.

Replacing the cup holder is not advisable if the retaining bracket is ⇒ *Bottom part unclipped (shown on one side) -1-* only unclipped ⇒ *Bottom part unclipped (shown on one side) -Circle-* on one or both sides from the bearing point on the bottom section ⇒ *Bottom part unclipped (shown on one side) -2-* and both parts show no damage.

Inform the customer that if the retaining bracket is only unclipped from the bottom section, the full function of the cup holder can be restored by clipping the retaining bracket into the bottom section. This can also be carried out independently by the customer.

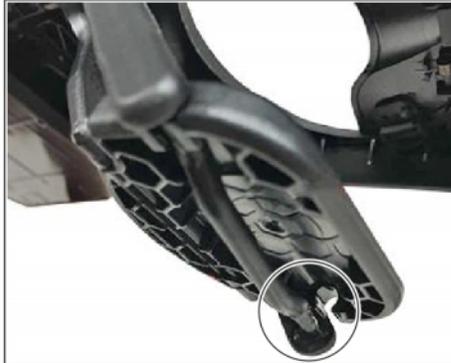
*Retaining bracket unclipped
from bottom section*

Assessment	Action
Bottom section of the cup holder unclipped from the retaining bracket on one or both sides.	Rework the cup holder.

Continue with Step ⇒ 2.
