REFERENCE:	TSB: 08-120-24 GROUP: 08 - Electrical	Date:	May 3, 2024	REVISION:	-
VEHICLES AFFECTED:	2025 (DT) RAM 1500 Pickup This bulletin applies to vehicles built on or after January 02, 2024 (MDH 0102XX) and on or before April 08, 2024 (MDH 0408XX) equipped with ParkSense FR/RR Park Assist w/Stop (Sales Code XH4) and without the following systems: <ul style="list-style-type: none"> • Trailer Reverse Steering Control (TRSC) (Sales Code XA1). • Surround View Camera (SVC) System (Sales Code XAK). • Parksense Automated Parking System (Sales Code XPM). 			MARKET APPLICABILITY: <input checked="" type="checkbox"/> NA <input type="checkbox"/> MEA <input type="checkbox"/> SA <input type="checkbox"/> IAP <input type="checkbox"/> EE <input type="checkbox"/> CH	
CUSTOMER SYMPTOM:	Customers may experience the following: <ul style="list-style-type: none"> • A pop-up on the Instrument Panel Cluster (IPC) telling customer to wipe off the Park Assist Sensors (PAS), even though nothing is actually on the sensors. When this IPC pop-up is present, the front Parksense feature is disabled Fig. 1.

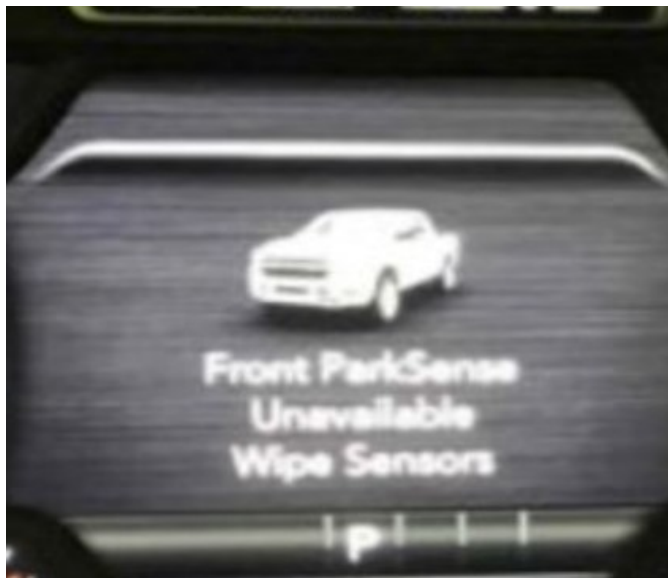
Fig. 1
IPC Message

CAUSE:	PAM software

This bulletin involves reprogramming the PAM with the latest software available.

1. Reprogram the PAM with the latest available software. If issues arise when flashing a module using the wiTECH Diagnostic Application, please submit a ticket to the Helpdesk. The helpdesk can be found within the Help menu.
2. Clear all DTCs that may have been set in any module due to reprogramming. The wiTECH application will automatically present all DTCs after the flash and allow them to be cleared.
