JLRTB02120NAS2

TECHNICAL BULLETIN

Excessive Wind Noise

MODEL:	MODEL YEAR:	VIN:	ASSEMBLY PLANT:
Range Rover (LK)	2022 Onwards	000293 Onwards	Solihull
Range Rover Sport (L1)	2023 Onwards	100000 Onwards	Solihull

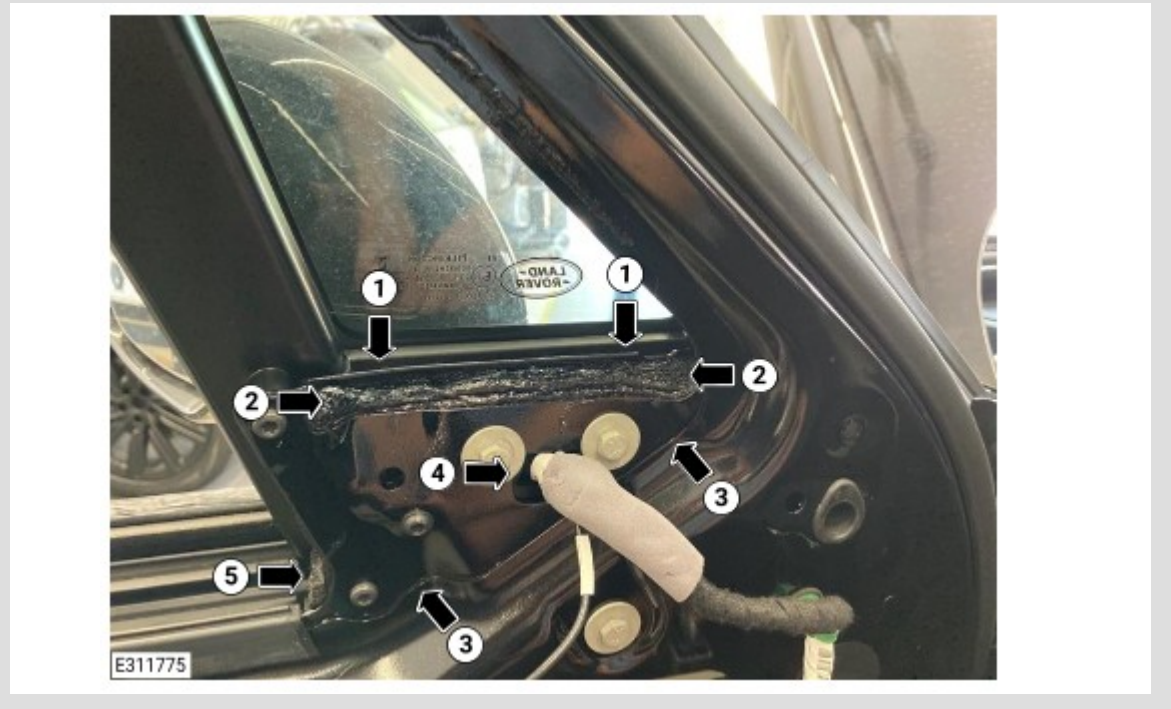
The illustration shows the 5 areas to be reworked during this SERVICE INSTRUCTION.

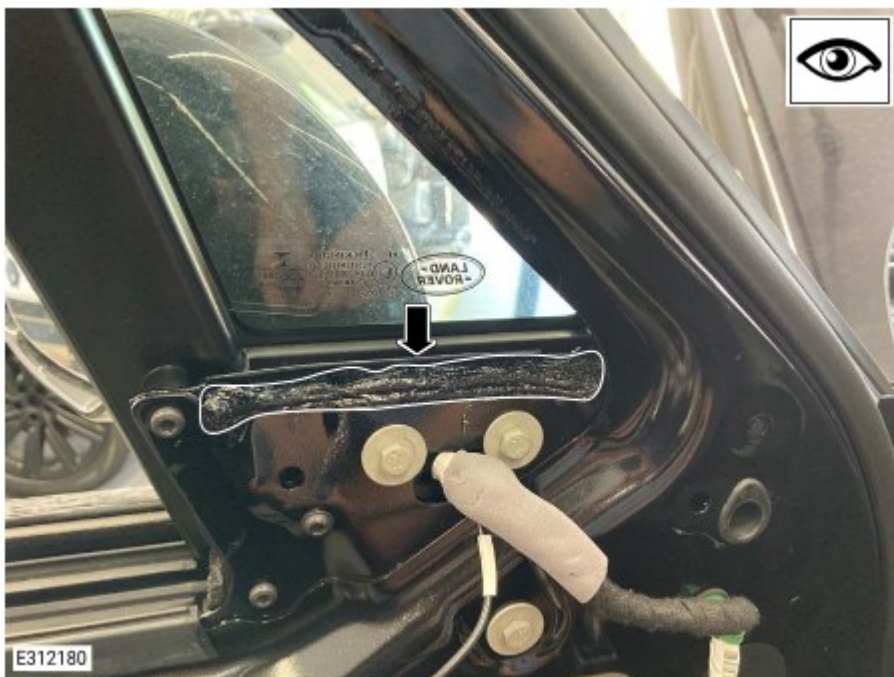
REWORK 2

Inspect the NVH material already applied in the area shown.

- Apply 3M™ Scotch-Weld 5313 (or an equivalent suitable black butyl strip) to fill any cavities which may be present in the area shown.
- Use a finger or thumb to firm down the butyl.
