TECHNICAL SERVICE BULLETIN

Classification: FA24-002	Reference: ITB24-005	Date: April 23, 2024
-----------------------------	-------------------------	-------------------------

POPPING NOISE FROM FRONT SUSPENSION WHEN TURNING

APPLIED VEHICLES: 2022-2024 QX60 (L51)

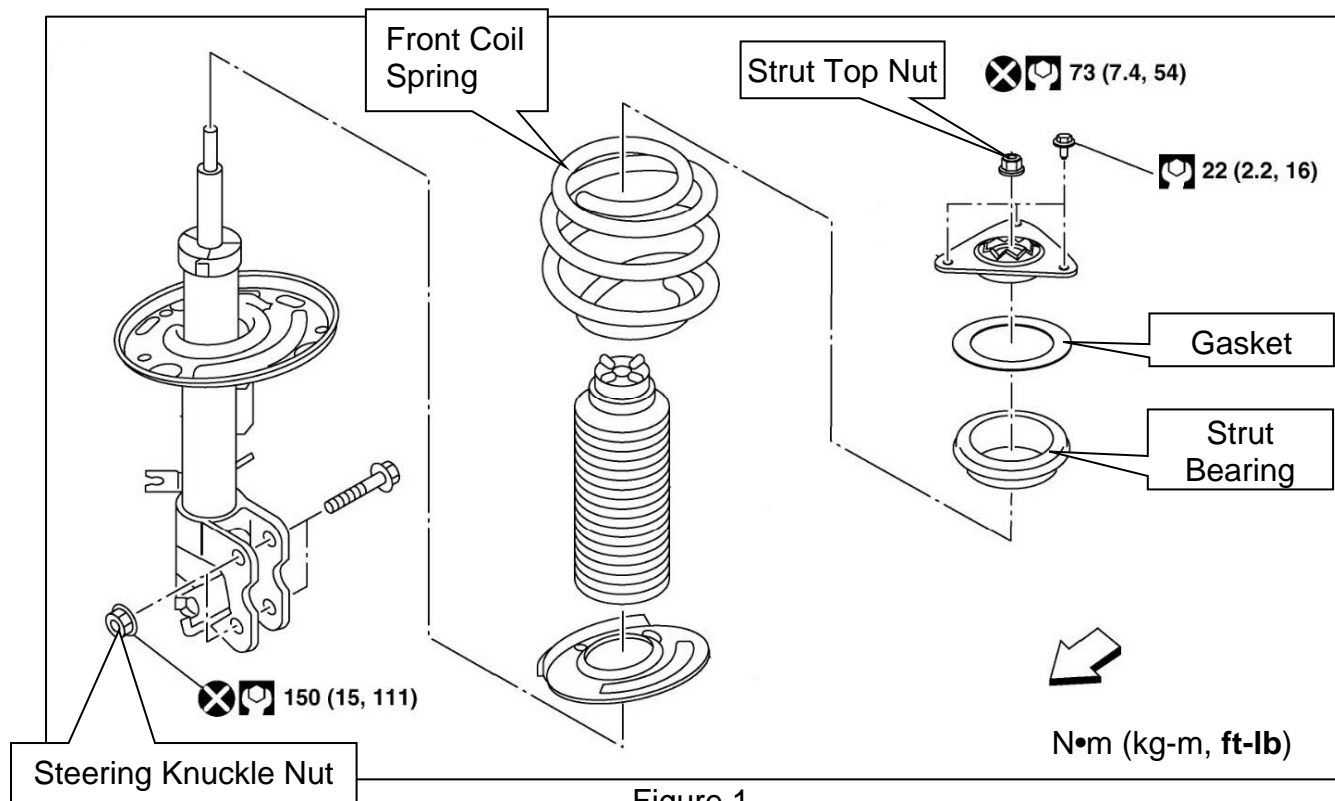
- For an effective repair, all parts called out in Figure 1 must be replaced. These parts are also listed in the **PARTS INFORMATION** on page 7.

HINT: The Stabilizer Connecting Rod Nut, not shown in Figure 1, will also need to be replaced.

- The incident noise may return if all listed parts are not replaced.
- The **Coil Spring Installation Guidelines** section in this bulletin **MUST** be followed in order for a correct repair to be performed.

If this bulletin applies, replace the front coil spring, strut mount bearing, and all other associated parts for the side(s) that is popping, with those listed under **PARTS INFORMATION** on page 7.
