TECHNICAL SERVICE BULLETIN

Classification: BT09-052K	Reference: NTB09-081K	Date: April 29, 2024
------------------------------	--------------------------	-------------------------

WINDSHIELD CRACKING

APPLIED VEHICLES: All Nissan vehicles

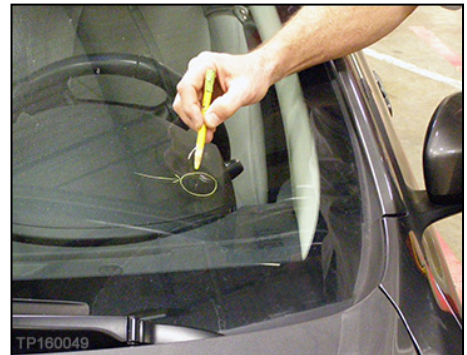
Prior to removal, dealers must take at least two (2) digital photographs of the damaged area. Dealers are required to mark glass and other components returned that have "visible issues" using masking tape or appropriate means (grease pen, etc.) to identify and highlight the area damaged.

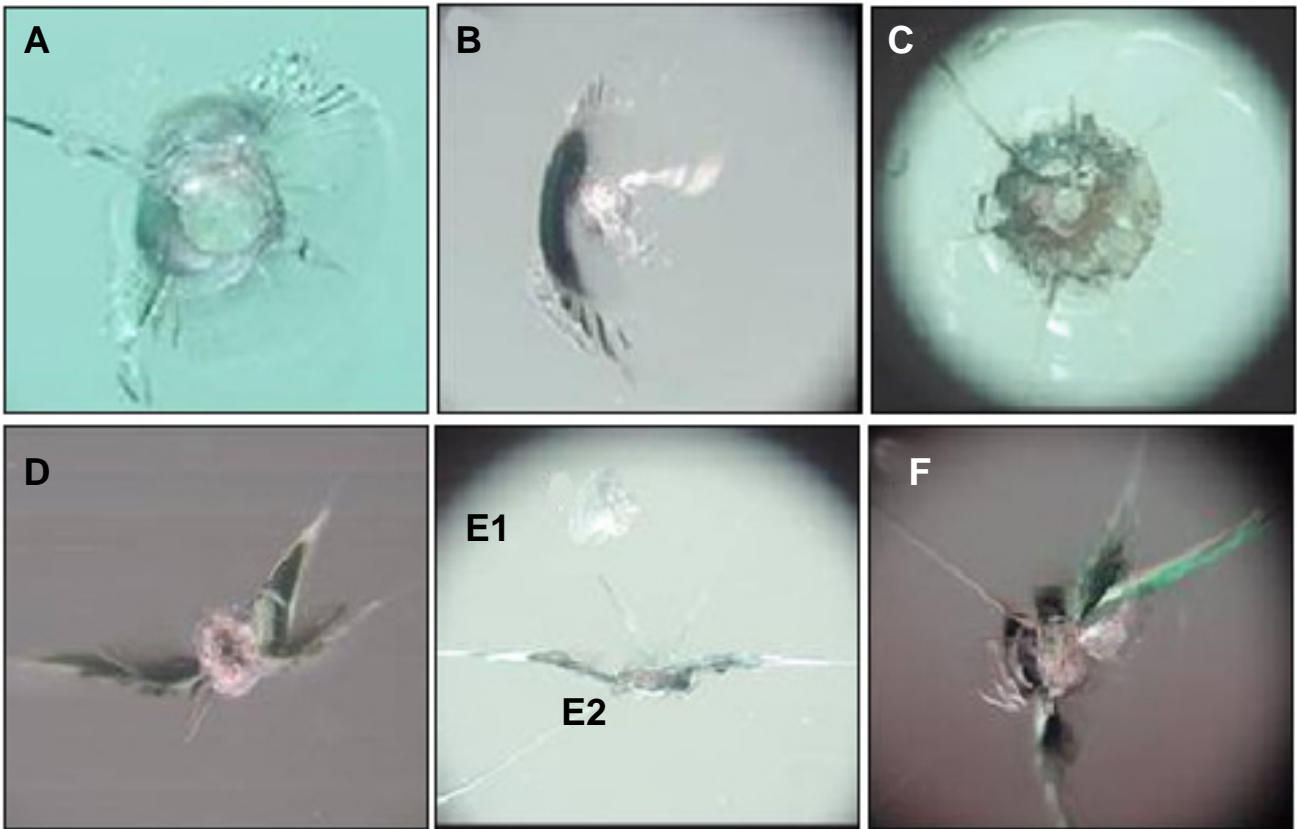
Most windshield damage that occurs due to impact is easily identified as shown below:

- Cone shaped break (A, B, C)
- Crush mark (D, E1, F)
- Star shape crack (C, D, E2, F).

Cracks can spread and become larger from the original strike point or crush mark due to:

- Thermal stresses caused by temperature fluctuation.
- External physical stresses, such as hand touch, wind force, or vehicle vibration during driving (pot holes).

A lead, or crack from one of the star cracked impact points can run to the edge of the glass and **appear** to be a low stress crack starting from the glass outside edge.

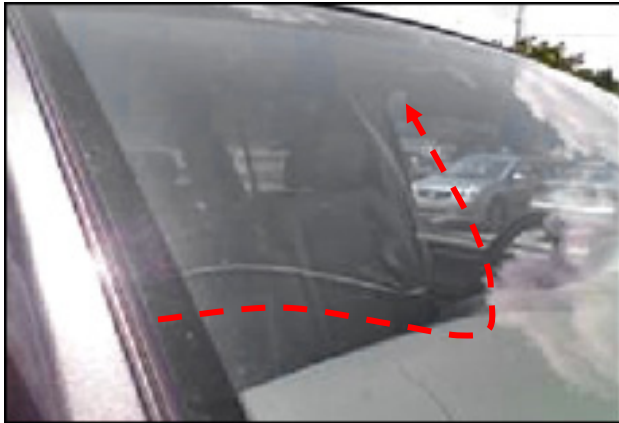
Single cracks must be inspected along the entire crack for impact marks.

Single crack with **no** impact mark:
Warranty

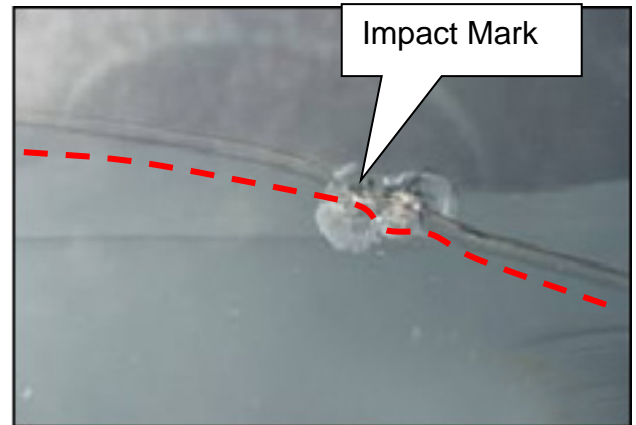
- If any impact mark is found anywhere along the crack, it indicates the damage occurred from an object striking the windshield. This is not covered under warranty.
- A magnifying glass (10X magnification) may be necessary to identify impact marks that may be less than 1 mm in diameter.
- The tip of a ball point pen can be run along the crack in the windshield to find the impact point.

Single crack with impact mark:
Not Warranty

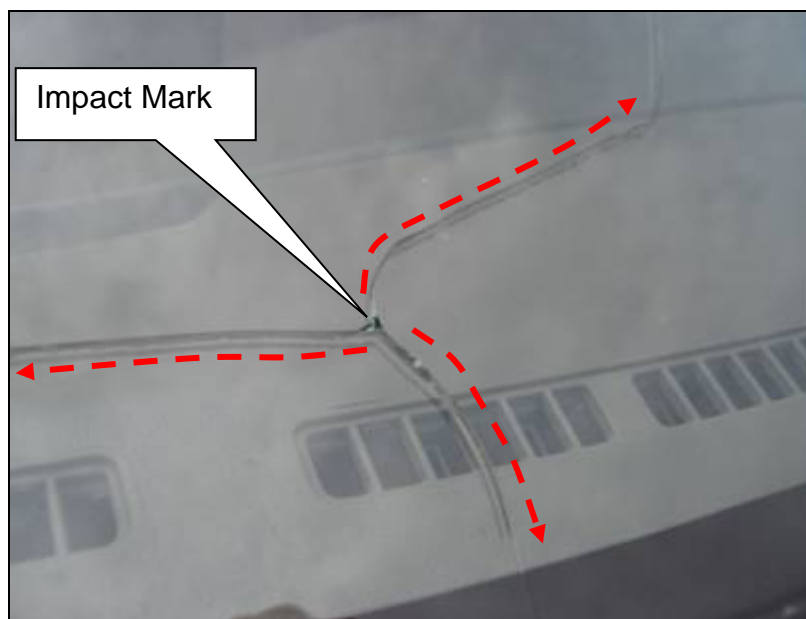
This type of crack is always caused by impact to the glass. The point of impact is located where the crack “branches out”.

Compound crack: **Not Warranty**

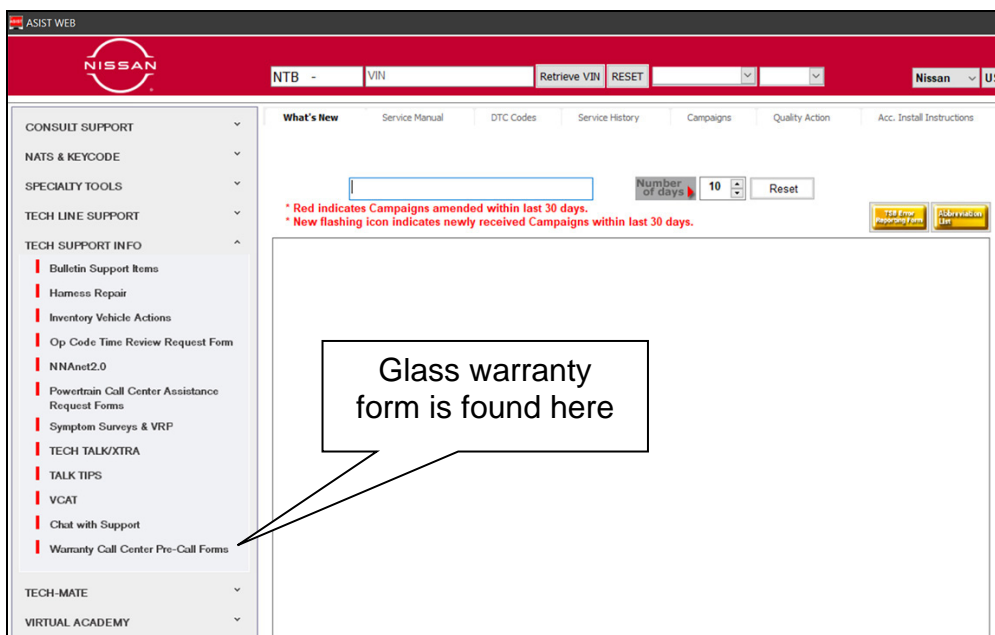
- Dealers are required to take at least two (2) digital photographs that clearly identify the alleged glass defect prior to removing the glass from the vehicle.
- Digital photographs must be kept in dealer records.
- Dealers are required to mark glass and other components returned that have “visible issues” using masking tape or appropriate means (grease pen, etc.) to identify and highlight the area damaged.
- The new glass warranty form must be completed and digital photograph files attached through ASIST for:
 1. Over DCAL Warranty Call Center pre-authorization
 2. Glass Part Return requests
- **The claim will be subject to a claim debit if the part is not marked properly and/or missing the required digital photographs (via ASIST) to support identification of a warrantable defect.**
