TECHNICAL SERVICE BULLETIN

Classification:	Reference:	Date:
DA19-011E	NTB19-042E	April 12, 2024

AUTOMATIC EMERGENCY BRAKING WARNING LIGHT BLINKING

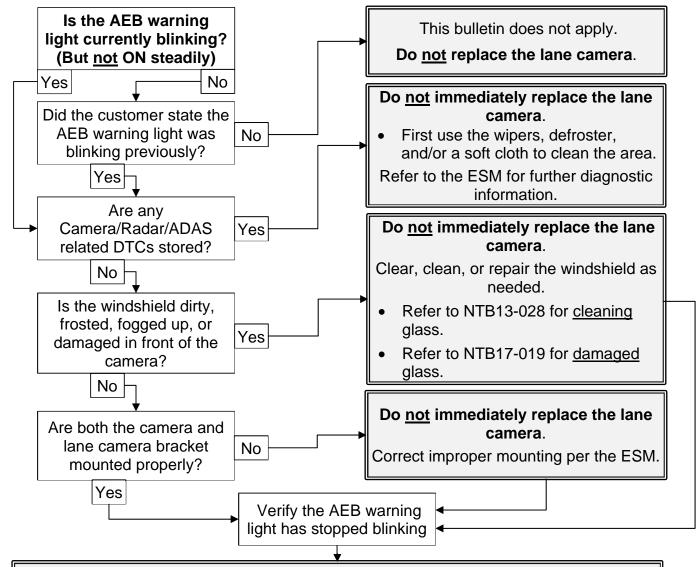
FLOW CHART

If the Automatic Emergency Braking (AEB) warning light or or or lilluminated steadily) or the customer states it is blinking, and there are no related DTCs, inspect the windshield.

A blinking AEB warning light may occur under the following conditions:

- When contamination or foreign material adhere to the lane camera viewing window on the windshield.
- When driving while it is snowing or when frost forms on the lane camera viewing window on the windshield.
- When the lane camera viewing window on the windshield is temporarily fogged up.

Inform the customer the following conditions may cause the AEB warning light to blink:

- Heavy rain or thick fog may cause the light to blink. Good use of wipers and keeping the windshield clean will mitigate some of the issue.
- When contamination or foreign material adhere to the lane camera viewing window on the windshield.
- When driving while it is snowing or when frost forms on the lane camera viewing window on the windshield.
- When the lane camera viewing window on the windshield is temporarily fogged up.

Explain to the customer the difference between contamination detection and a malfunction.

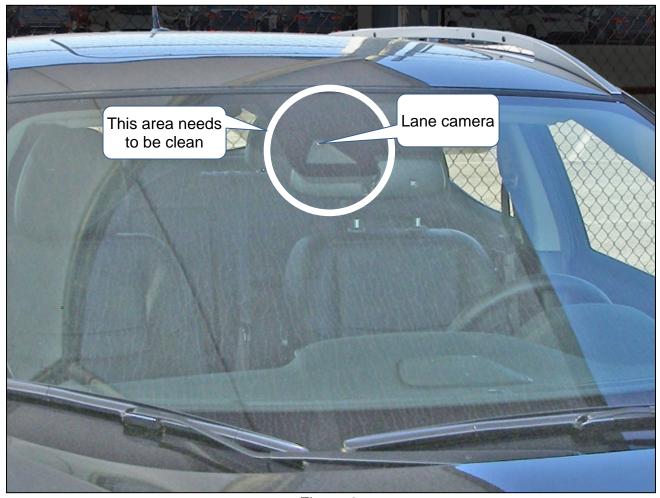
Figure 2

During the following conditions, the AEB warning light may blink/flash. However when these conditions no longer exist, the AEB will resume automatically:

- Strong light is shining from over the front of the vehicle.
- The cabin temperature is over approximately 104°F (40°C) in direct sunlight.
- The radar sensor picks up interference from another radar source.
- When driving on roads without any road structures or buildings (for example: long bridges, deserts, snow fields, driving next to long walls).
