<b>REFERENCE:</b>	<b>TSB:</b> 08-123-24 <b>GROUP:</b> 08 - Electrical	<b>Date:</b>	May 7, 2024	<b>REVISION:</b>	—
<b>VEHICLES AFFECTED:</b>	<b>2025 (DT) RAM 1500 Pickup</b> This bulletin applies to vehicles built on or after January 02, 2024 (MDH 0102XX) and on or before April 08, 2024 (MDH 0408XX) equipped with ParkSense FR/RR Park Assist w/Stop (Sales Code XH4) and without the following systems: <ul style="list-style-type: none"> <li>• Trailer Reverse Steering Control (TRSC) (Sales Code XA1).</li> <li>• Surround View Camera (SVC) System (Sales Code XAK).</li> <li>• Parksense Automated Parking System (Sales Code XPM).</li> </ul>			<b>MARKET APPLICABILITY:</b> <input checked="" type="checkbox"/> NA <input type="checkbox"/> MEA <input type="checkbox"/> SA <input type="checkbox"/> IAP <input type="checkbox"/> EE <input type="checkbox"/> CH	
<b>CUSTOMER SYMPTOM:</b>	<b>Customers may experience the following:</b> <ul style="list-style-type: none"> <li>• A pop-up on the Instrument Panel Cluster (IPC) telling customer to wipe off the Park Assist Sensors (PAS), even though nothing is actually on the sensors. When this IPC pop-up is present, the front Parksense feature is disabled <a href=

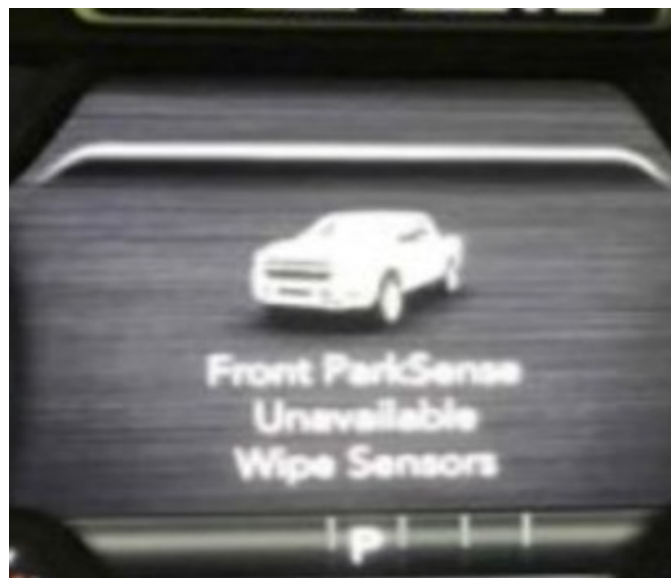
<b>CAUSE:</b>	PAM software

**Fig. 1**  
IPC Message

This bulletin involves reprogramming the PAM with the latest software available.

1. Reprogram the PAM with the latest available software. If issues arise when flashing a module using the wiTECH Diagnostic Application, please submit a ticket to the Helpdesk. The helpdesk can be found within the Help menu.
2. Clear all DTCs that may have been set in any module due to reprogramming. The wiTECH application will automatically present all DTCs after the flash and allow them to be cleared.
