REFERENCE:	TSB: 23-028-24 GROUP: 23 - Body	Date:	May 7, 2024	REVISION:	23-094-23
VEHICLES AFFECTED:	2023 (JT) Jeep Gladiator This bulletin applies to vehicles built on and after March 07, 2023 (MDH 0307XX) on and before March 07, 2023 (MDH 0307XX).	MARKET APPLICABILITY:			
		<input type="checkbox"/> **NA** <input type="checkbox"/> MEA <input type="checkbox"/> SA <input checked="" type="checkbox"/> IAP <input checked="" type="checkbox"/> EE <input type="checkbox"/> CH			
CUSTOMER SYMPTOM:	Interior water leak at back glass (backlite) and hardtop, allowing water to leak into the vehicle at the lower passenger side corner Fig. 1.				
CAUSE:	Manufacturing issue

This bulletin supersedes Technical Service Bulletin (TSB) 23-094-23, date of issue September 12, 2023, which should be removed from your files. All revisions are highlighted with ****asterisks**** and includes removing a market, an updated RSU statement, and adding a NA RSU cancellation note.

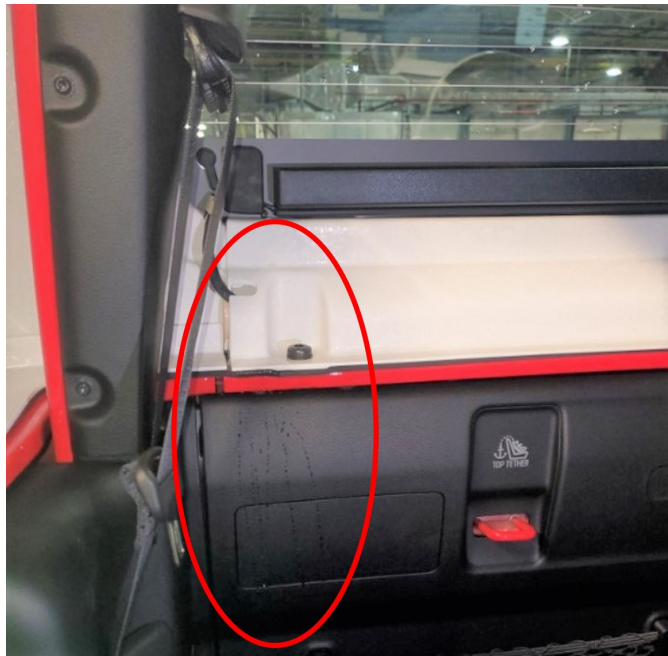
Fig. 1
Water Leak At Backlite

- Using a hose, pour water over the outside right upper corner of the backlite continuously for five minutes.
- Was a water leak detected on the inside backlite lower corner [Fig. 1?](#)
 - YES>>> Proceed to [Step 1](#) of the Repair Procedure.
 - NO>>> Normal diagnosis should be performed. Use the Inspection LOP (23-30-32-98) to close the active RSU.

- Replace the backlite. Refer to the detailed service procedures listed in DealerConnect>Service Library under: 23 - Body / Stationary Glass / Backlite / Removal and Installation.
