Technical Service Bulletin (TSB)
Noise From Front End While Driving Over Bumps

REFERENCE:	TSB: 02-007-24 GROUP: 02 - Front Suspension	Date:	May 10, 2024	REVISION:	-
VEHICLES AFFECTED:	2024 (RU) Chrysler Pacifica This bulletin applies to vehicles built on after May 01, 2023 (MDH 0501XX) and on or before January 08, 2024 (MDH 0108XX).			MARKET APPLICABILITY:	
				<input checked="" type="checkbox"/> NA	<input type="checkbox"/> MEA
				<input type="checkbox"/> SA	<input type="checkbox"/> IAP
				<input type="checkbox"/> EE	<input type="checkbox"/> CH
CUSTOMER SYMPTOM:	Customers may experience the following:				
	<ul style="list-style-type: none"> Noise (rattle/thump/clunk noise) coming from the front end of the vehicle when driving over bumps. 				
CAUSE:	Distorted isolator spring.

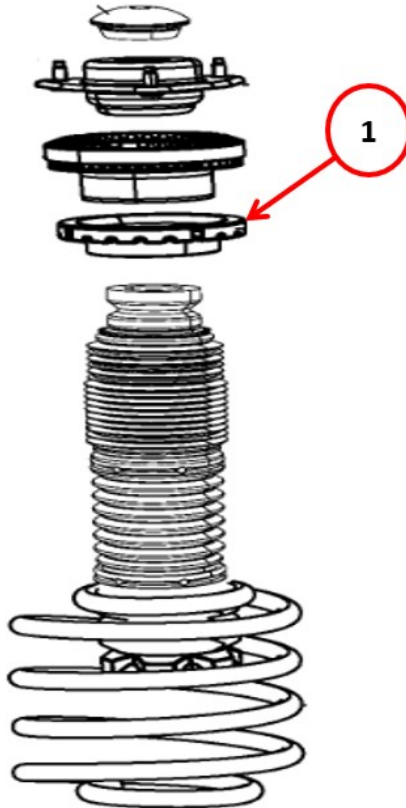
**Fig. 1**

Front Upper Isolator Spring Location On Strut

1 - Front Upper Isolator Spring

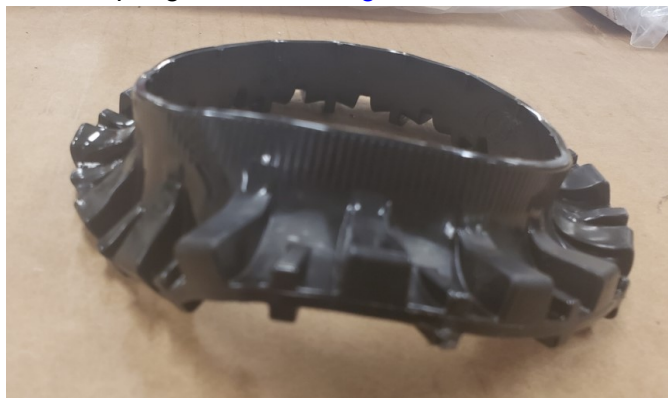
**Fig. 2**

3. Are either front strut upper isolator springs deformed [Fig. 2](#)?

Distorted Upper Isolator Spring

- YES>>> Proceed to [Step 4](#).
 - NO>>> This bulletin does not apply. Normal diagnosis should be performed.
4. Disassemble the front strut(s) assembly. Refer to the detailed service procedures available in DealerCONNECT/Service Library under: Service Info>02 - Front Suspension / Front / Strut, Suspension, Assembly / Disassembly.
 5. Replace the deformed upper isolator spring.

NOTE: The vehicle comes equipped with a one piece upper spring isolator. The new replacement upper spring isolator is a two piece design.
