Technical Service Bulletin (TSB) Front Control Arm Bushings Under Cured

REFERENCE:	TSB: 02-008-24 GROUP: 02 - Front Suspension	Date:	May 14, 2024	REVISION:	02-005-23
VEHICLES AFFECTED:	2023 (LA) Dodge Challenger 2023 (LD) Dodge Charger 2023 (LX) Chrysler 300 This bulletin applies to vehicles built on and after February 08, 2023 (MDH 0208XX) and on and before February 09, 2023 (MDH 0209XX).	MARKET APPLICABILITY:			
CUSTOMER SYMPTOM:	The technician or customer may notice the following: <ul style="list-style-type: none"> Knock or rattle noise when going over bumps. 				
CAUSE:	Front lower control arm bushings under cured

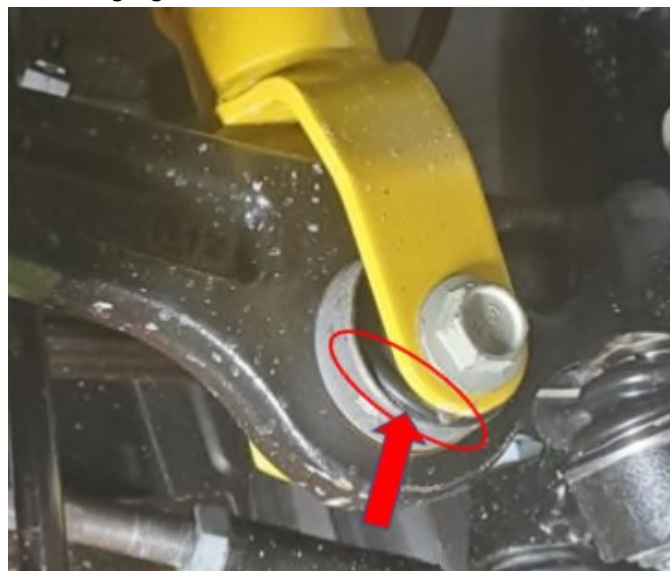
1. Pull vehicle onto flat, dry surface (suspension should remain loaded).
2. Bushing is bad if there is rubber bulging out from the bottom area of the bushing [Fig. 1](#).

Fig. 1
Bad Bushing

NOTE: Only replace the one (or both) side control arm that the bushings are bulged out / bad on.

1. Replace lower control arm(s). Refer to the detailed service procedures listed in DealerCONNECT Service Library under: 02 - Front Suspension / Front / Arm, Lower Control / Removal and installation.
2. Perform Alignment. Refer to the detailed service procedures listed in DealerCONNECT Service Library under: 02 - Front Suspension / Wheel Alignment / Standard Procedure.
3. Test drive vehicle. Is the noise driving over bumps gone?
 - YES>>> This bulletin is complete.
 - NO>>> Further diagnosis is needed.
