Technical Service Bulletin (TSB)
Engine Misfire From Intake Manifold Crack

REFERENCE:	TSB: 09-013-24 GROUP: 09 - Engine	Date:	May 14, 2024	REVISION:	09-025-23
VEHICLES AFFECTED:	2022 - 2023 (LD) Dodge Charger This bulletin applies to vehicles built on or after December 09, 2022 (MDH 1209XX) and on or before January 20, 2023 (MDH 0120XX) equipped with a 5.7L V8 Hemi MDS VVT Engine (Sales Code EZH).	MARKET APPLICABILITY:			
		<input checked="" type="checkbox"/> NA <input type="checkbox"/> MEA <input type="checkbox"/> SA <input type="checkbox"/> IAP <input type="checkbox"/> EE <input type="checkbox"/> CH			
CUSTOMER SYMPTOM:	**Customers must experience a Malfunction Indicator Lamp (MIL) illumination and the vehicle must exhibit/set the following Diagnostic Trouble Code (DTC): <ul style="list-style-type: none"> • P0301 - Cylinder 1 Misfire. Customers may also experience the following:** <ul style="list-style-type: none"> • Rough idle and shakes while driving. 				
CAUSE:	Fracture crack at left front of intake manifold Fig. 1 .

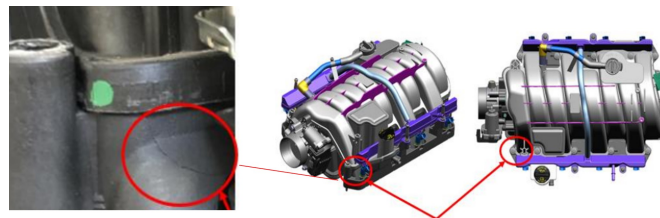
Fig. 1
Area Where Crack Occurs
