<b>REFERENCE:</b>	<b>TSB:</b> 23-034-24 <b>GROUP:</b> 23 - Body	<b>Date:</b>	May 14, 2024	<b>REVISION:</b>	23-081-23 REV. A
<b>VEHICLES AFFECTED:</b>	<b>2023 (WS) Grand Wagoneer/Wagoneer</b> This bulletin applies to vehicles built on or after January 09, 2023 (MDH 0109XX) and on or before April 04, 2023 (MDH 0404XX) equipped with Sea Salt/Black (Sales Code D7) or Global Black (Sales Code X7).	<b>MARKET APPLICABILITY:</b>			
		<input type="checkbox"/> **NA** <input type="checkbox"/> CH <input type="checkbox"/> EE <input type="checkbox"/> IAP <input type="checkbox"/> SA <input checked="" type="checkbox"/> MEA			
<b>CUSTOMER SYMPTOM:</b>	<b>**The customer may comment on the following:**</b> <ul style="list-style-type: none"> <li>Mismatched front seat covers (one or more seat covers have a "SERIES 1" badge Fig. 1, others have no badges). 2023 (WS) Grand Wagoneer/Wagoneer front seat covers do not have badges.</li> </ul>

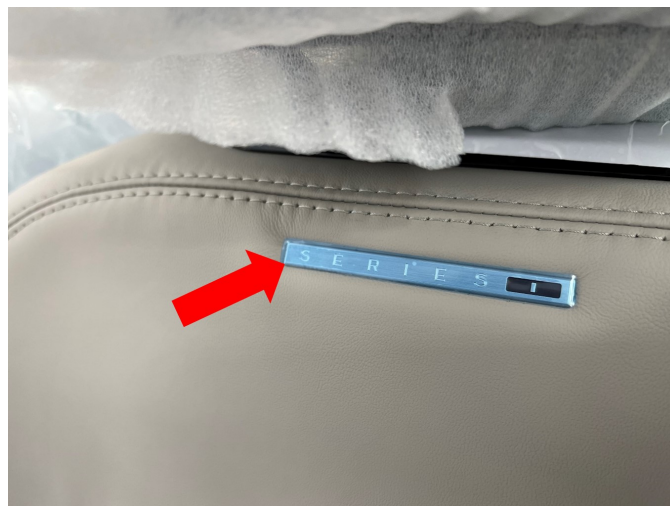
<b>CAUSE:</b>	Model Year 2022 front seat covers installed.

**Fig. 1**  
Incorrect "SERIES 1" Badge Front Seat Cover

1. Replace the front seat covers as required. Refer to the detailed service procedures available in DealerCONNECT/Service Library under: Service Info>23 - Body / Seats, Front / Cover, Seat Back, Front / Removal and Installation.
