**Technical Service Bulletin (TSB)**  
**Air Conditioning Not Blowing Cold or is Inoperative**

<b>REFERENCE:</b>	<b>TSB:</b> 24-002-24 <b>GROUP:</b> 24 - Heating and Air Conditioning	<b>Date:</b>	May 14, 2024	<b>REVISION:</b>	–
<b>VEHICLES AFFECTED:</b>	<p><b>2023 - 2025 (B1) Jeep Renegade</b> <b>2023 - 2025 (M1) Jeep Compass</b> <b>2023 - 2025 (H1) Jeep Commander</b></p> <p><b>This bulletin applies to:</b></p> <ul style="list-style-type: none"> <li>• <b>B1</b> vehicles built on and after September 01, 2023 (MDH 0901XX) and on and before March 13, 2024 (MDH 0313XX).</li> <li>• <b>M1</b> vehicles built on and after September 01, 2023 (MDH 0901XX) and on and before March 05, 2024 (MDH 0305XX).</li> <li>• <b>H1</b> vehicles built on and after September 01, 2023 (MDH 0901XX) and on and before March 07, 2024 (MDH 0307XX).</li> </ul> <p><b>Equipped with either the:</b></p> <ul style="list-style-type: none"> <li>• 1.3L I4 Turbo MAIR DI Engine W/ESS (Sales Code EYF) <b>or</b></li> <li>• 1.3L I4 Turbo MAIR DI Engine (Sales Code EYH) <b>or</b></li> <li>• 1.3L I4 Turbo MAIR DI Engine W/ESS E100 (Sales Code EYJ).</li> </ul>	<b>MARKET APPLICABILITY:</b>

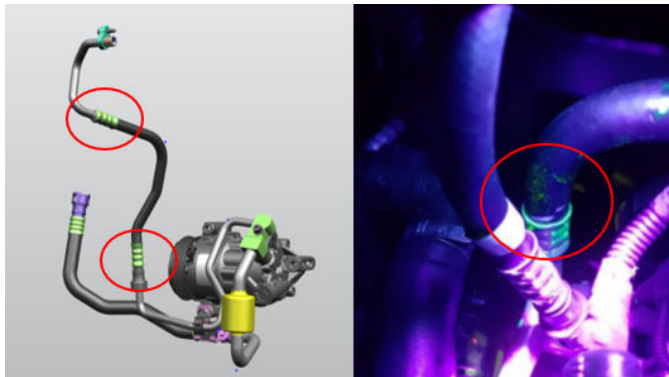
**Fig. 1**

Inspect for leaks all around the circumference of the A/C lines **Fig. 1**.

Areas Of Potential Leaks

7. Replace the A/C suction and liquid double line. Refer to the detailed service procedures available in DealerCONNECT/Service Library under: Service Info> 24 - Heating and Air Conditioning / Plumbing / Assembly, A/C Suction and Liquid Line / Removal and Installation.

8. Tighten the fasteners on the connectors to the proper torque:
  - Refrigerant Lines to A/C Compressor:
    - 9 N·m (80 In. Lbs.) (6mm Bolts).
    - 20 N·m (80 In. Lbs.) (8mm Bolts).

- High Side Line to Condenser: 9 N·m (80 In. Lbs.).
9. Charge the refrigerant system. Refer to the detailed service procedures available in DealerCONNECT/Service Library under: Service Info> 24 - Heating and Air Conditioning/Plumbing - Standard Procedure.
