Technical Service Bulletin (TSB) Incorrect Floor Pan Installed

REFERENCE:	TSB: 23-018-24 REV. A GROUP: 23 - Body	Date:	May 17, 2024	REVISION:	23-018-24
VEHICLES AFFECTED:	2024 (DT) RAM 1500 Pickup This bulletin applies to vehicles built on and after September 20, 2023 (MDH 0920XX) and on and before September 21, 2023 (MDH 0921XX).			MARKET APPLICABILITY:	
				<input checked="" type="checkbox"/> NA	<input type="checkbox"/> CH
				<input type="checkbox"/> EE	<input type="checkbox"/> IAP
				<input checked="" type="checkbox"/> SA	<input checked="" type="checkbox"/> MEA
CUSTOMER SYMPTOM:	Customer's vehicle may have been built with the following: <ul style="list-style-type: none"> Extra holes in floor pan under carpet. 				
CAUSE:	Incorrect floor pan installed

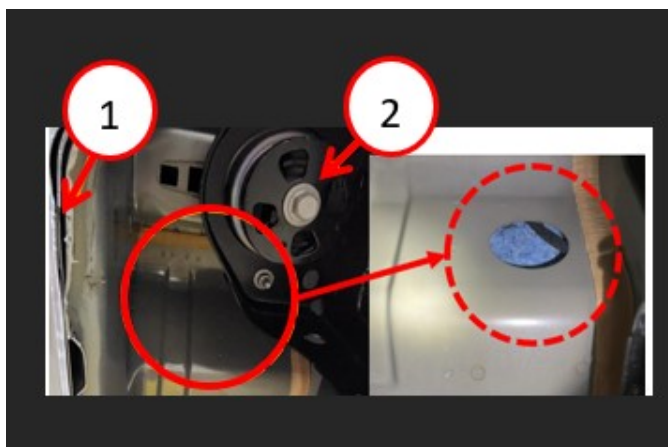
Fig. 1
70 mm Hole Location

- Is the vehicle on the RSU VIN list?
 - YES>>> Proceed to [Step 2](#).
 - NO>>> This bulletin does not apply.
- Raise vehicle on hoist. Refer to the detailed service procedures listed in DealerCONNECT Service Library under: 04 - Vehicle Quick Reference / Hoisting / Standard Procedure.
- Locate the 70 mm (2.75 in.) hole between the left hand rear cab mount and the left hand rocker panel [Fig. 1](#).

- Install a 100mm (3.93 in.) X 100mm (3.93 in.) butyl patch over the hole [Fig. 1](#).
- Lower vehicle.
- Remove left rear carpet retainer.
- Disconnect heated seat connector (if applicable).

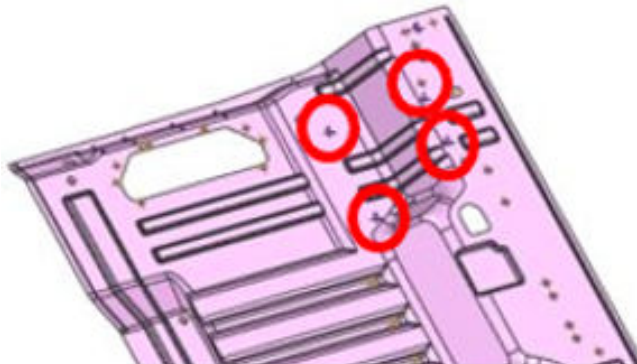
Fig. 4

Floor Pan Hole Locations

10. Reinstall left rear carpet.
11. Install the left rear carpet retainer.
12. Reconnect heated seat connector (if applicable).
13. Remove the right rear carpet retainer.
14. Disconnect heated seat connector (if applicable).
15. Remove subwoofer (if equipped). Refer to the detailed service procedures listed in DealerCONNECT>Service Library>Service info>under: 08 - Electrical / 8A - Audio/Video/Entertainment/Connectivity / Speaker / Removal.
16. Pull back carpet to expose the floor pan area.
17. Install four round black patches over the four 12mm (.047 in.) holes [Fig. 4](#).

NOTE: It is only necessary to cover the holes from the inside.
