Technical Service Bulletin (TSB)
Crank Gear Flange Dislocation

REFERENCE:	TSB: 09-014-24 GROUP: 09 - Engine	Date:	May 18, 2024	REVISION:	-
VEHICLES AFFECTED:	2023 - 2024 (H6) Jeep Meridian 2023 - 2024 (M6) Jeep Compass This bulletin applies to the following vehicles built on or after February 02, 2023 (MDH 0202XX) on or before February 24, 2024 (MDH 0224XX) equipped with a 2.0L I4 Turbo Diesel Engine With/ESS (Sales Code EBS) .	MARKET APPLICABILITY:			
		<input type="checkbox"/> NA <input type="checkbox"/> MEA <input type="checkbox"/> SA <input checked="" type="checkbox"/> IAP <input type="checkbox"/> EE <input type="checkbox"/> CH			
CUSTOMER SYMPTOM:	Customers may experience one or more of the following: <ul style="list-style-type: none"> • Vehicle does not start due to crank gear flanged dislocated. • Abnormal noise from the engine compartment. • Noise from the timing cover area. 				
CAUSE:	Manufacturing issue

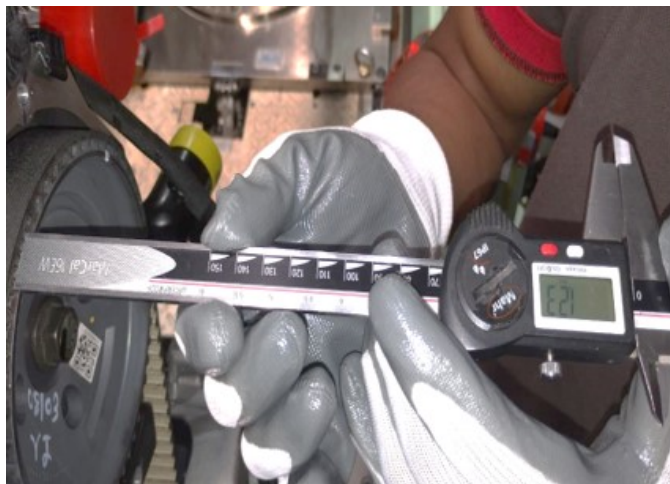
Fig. 5
Vernier Caliper Inspection

7. Rotate the engine 360 degree and check the belt position gap from the cam gear face to the belt face using a Vernier Caliper [Fig. 5](#).

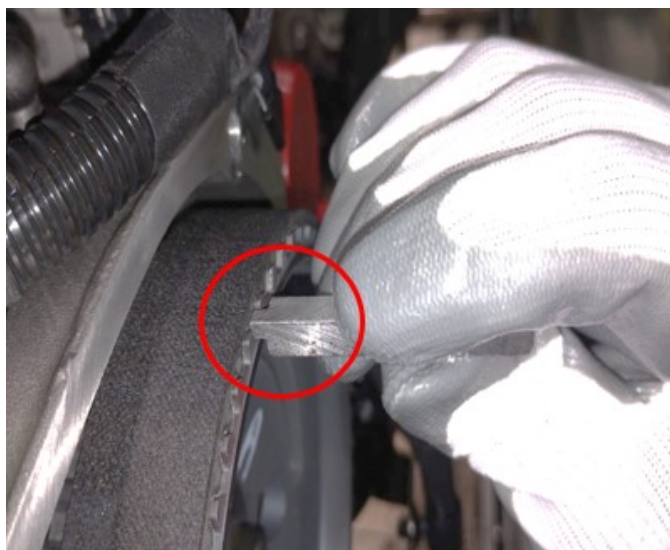
Fig. 6
Gap Inspection

8. Is the gap between the cam gear face and the belt face more than 3 mm (0.1 Inch) [Fig. 6](#)?
 - YES>>> Proceed to [Step 9](#).
 - NO>>> Proceed to [Step 12](#).

9. Remove and reinstall the timing belt. Refer to the detailed service procedures available in DealerCONNECT/Service Library under: Service Info> 09 - Engine / Valve Timing / Belt, Timing / Removal and Installation.
10. Rotate the engine 360 degree and recheck the belt position gap from the cam gear face to the belt face with using a Vernier Caliper [Fig. 5](#).
11. Is the gap between the cam gear face and the belt face still more than 3 mm (0.1 Inch) [Fig. 6](#)?
 - YES>>> Contact the technical support team for further instruction.
 - NO>>> Proceed to [Step 12](#).
12. Install the timing cover and torque the mounting bolts to 9 N·m. (80 In. Lbs.) [Fig. 1](#).
13. Install the fuel filter. Refer to the detailed service procedures available in DealerCONNECT/Service Library under: Service Info> 14 - Fuel System / Fuel Delivery, Diesel / Filter, Fuel / Installation.
