**Technical Service Bulletin (TSB)**  
**Rear Cargo Door Glass Shattered**

| REFERENCE: | TSB: 23-039-24<br>GROUP: 23 - Body | Date: | May 18, 2024 | REVISION: | – |
| VEHICLES AFFECTED: | 2024 (VF) RAM Promaster<br>This bulletin applies to vehicles built on or after November 11, 2023 (MDH 1111XX) and on or before December 21, 2023 (MDH 1221XX) equipped with Rear Window Defroster (Sales Code GFA). | | | MARKET APPLICABILITY:<br><div><input checked="" type="checkbox"/> NA<input type="checkbox"/> MEA<br/><input type="checkbox"/> SA<input type="checkbox"/> IAP<br/><input type="checkbox"/> EE<input type="checkbox"/> CH</div> | |

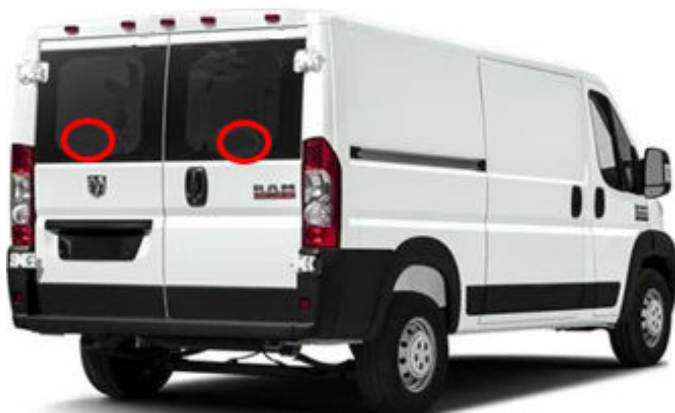
**Fig. 1**  
Mopar Logo

- Inspect the Mopar logo at the bottom center of both rear cargo door glass [Fig. 2](#) for one of the following build dates, [Fig. 1](#).
  - ...3 (April 2023)
  - ..3 (May 2023)
  - .3 (June 2023)
  - 3.... (September 2023)

- Do the glass dates match any of the four dates in [Fig. 1](#)?
  - YES >>> Proceed to [Step 3](#).
  - NO >>> This bulletin does not apply. Use inspect LOP 23-30-16-91 to close the active RSU.

3. Replace rear glass. Refer to the detailed service procedures available in DealerCONNECT/Service Library under: Service Info> 23 - Body / Stationary Glass / Glass, Rear Door / Removal and Installation.
