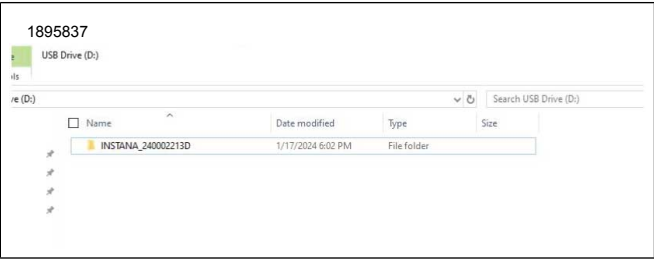
Figure 2. One File on USB 1

d. Download file to thumb drive designated USB 2: INSTANA\_240002237D
3. Unzip the downloaded file titled: INSTANA\_240002213D.
- a. Make sure there is only one Folder on USB 1. See Figure 2.

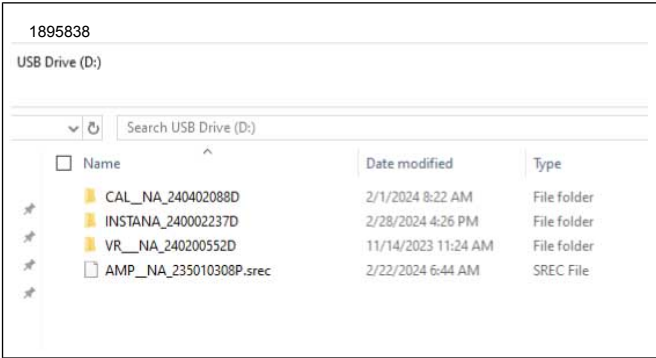
Figure 3. Three Folders and One File on USB 2

4. Unzip the downloaded file titled: INSTANA\_240002237D.
- a. Make sure there are three Folders and one file on USB 2. See Figure 3.

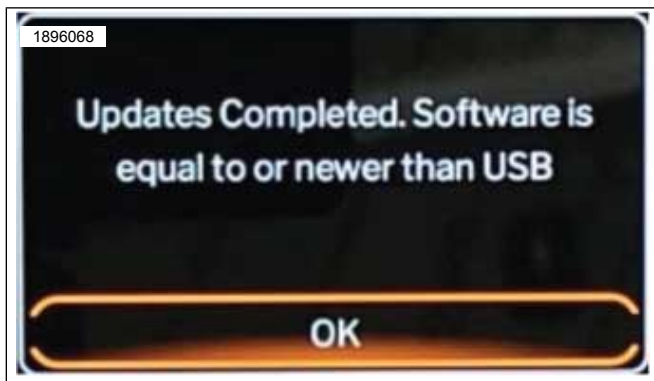
**Figure 4.**

10. Follow prompts on the IFCU screen.
- a. There will be multiple updates performed while USB 2 is connected and the IFCU will reboot multiple times.
11. See Figure 4. After the last update has been completed, a pop-up message will say: **Updates Completed**. Software is equal to or newer than USB.
