<b>REFERENCE:</b>	<b>TSB:</b> 08-130-24 <b>GROUP:</b> 08 - Electrical	<b>Date:</b>	May 25, 2024	<b>REVISION:</b>	-
<b>VEHICLES AFFECTED:</b>	<b>2023 (GU) Alfa Romeo Stelvio</b> This bulletin applies to vehicles built on or before February 07, 2023 (MDH 0207XX) equipped with a Global Telematics Box Module (Sales Code RDG) and SiriusXM Guardian-Included Trial (B) (Sales Code RT1).	<b>MARKET APPLICABILITY:</b>			
		<input checked="" type="checkbox"/> NA <input type="checkbox"/> MEA <input type="checkbox"/> SA <input type="checkbox"/> IAP <input type="checkbox"/> EE <input type="checkbox"/> CH			
<b>CUSTOMER SYMPTOM:</b>	<b>The customer may experience one or more of the following:</b> <ul style="list-style-type: none"> <li>• Outdated vehicle data on customer's mobile app.</li> <li>• Connected Services maintenance popup displayed on the radio screen.</li> <li>• Connected Services battery maintenance popup displayed on the radio screen.</li> </ul>

<b>CAUSE:</b>	<b>TBM Software</b>

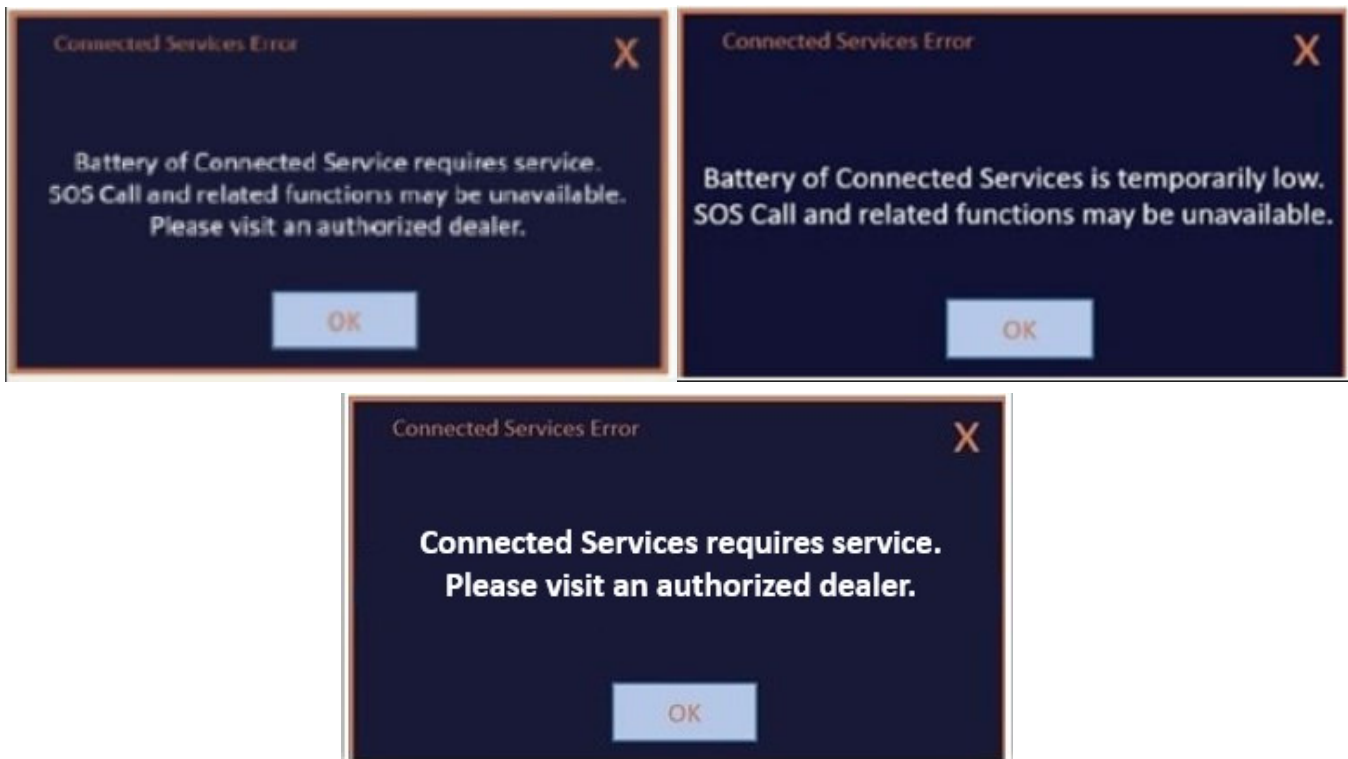
Message display on the radio screen, "Uconnect Box requires service. Please visit an authorized dealer." Fig. 1.

**Fig. 1**  
Battery Of Connected Services Messages

This bulletin involves reprogramming the TBM with the latest available software.

1. Reprogram the TBM with the latest software. If issues arise when flashing a module using the wiTECH Diagnostic Application, please submit a ticket to the Helpdesk. The helpdesk can be found within the Help menu.
