<b>REFERENCE:</b>	<b>TSB:</b> 08-131-24 REV. A <b>GROUP:</b> 08 - Electrical	<b>Date:</b>	May 29, 2024	<b>REVISION:</b>	08-131-24
<b>VEHICLES AFFECTED:</b>	<b>2021 (GU) Alfa Romeo Stelvio</b> This bulletin applies to vehicles equipped with a Global Telematics Box Module (Sales Code RDG) and SiriusXM Guardian-Included Trial (B) (Sales Code RT1).	<b>MARKET APPLICABILITY:</b>			
		<input checked="" type="checkbox"/> NA <input type="checkbox"/> MEA <input type="checkbox"/> SA <input type="checkbox"/> IAP <input type="checkbox"/> EE <input type="checkbox"/> CH			
<b>CUSTOMER SYMPTOM:</b>	<b>The customer may also experience one or more of the following:</b> <ul style="list-style-type: none"> <li>• Outdated vehicle data on customer's mobile app.</li> <li>• Connected Services maintenance popup displayed on the radio screen.</li> <li>• Connected Services battery maintenance popup displayed on the radio screen.</li> </ul>

<b>CAUSE:</b>	TBM Software

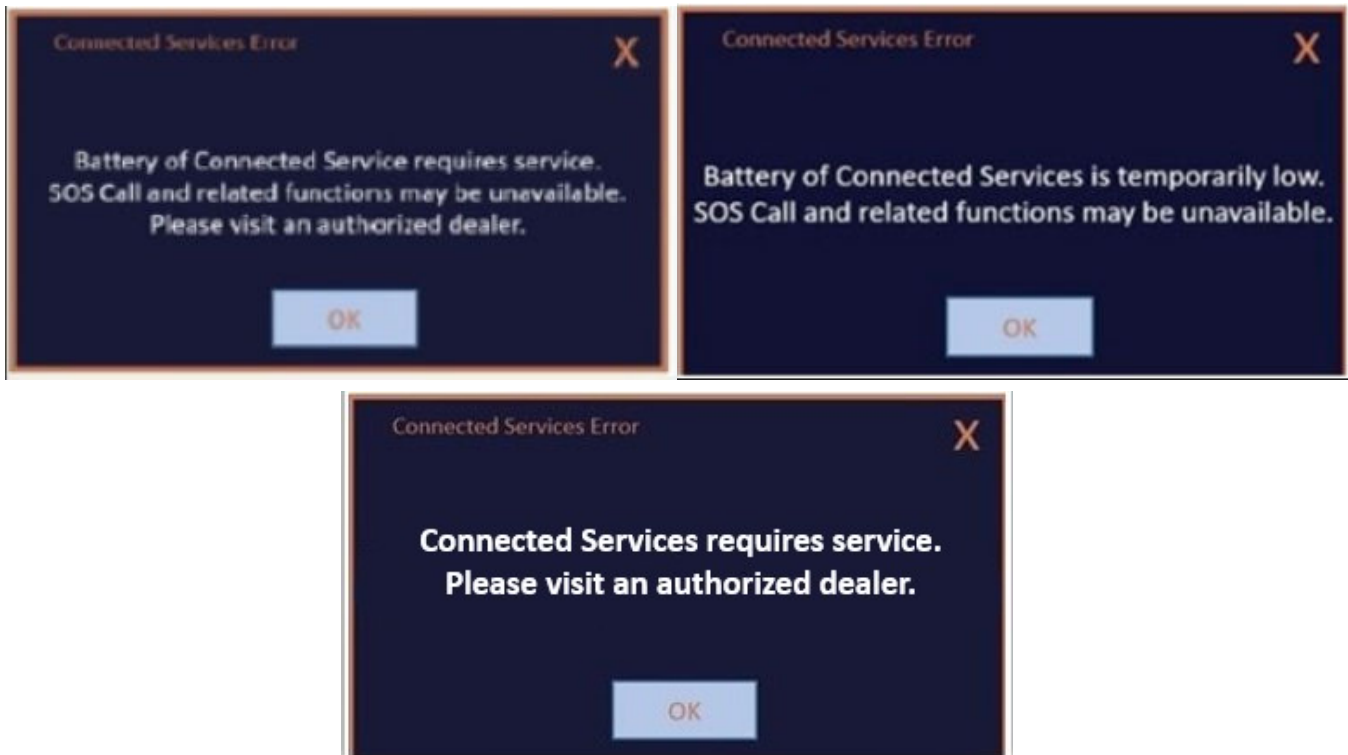
**Fig. 1**  
Battery Of Connected Services Messages

Message display on the radio screen, "Uconnect Box requires service. Please visit an authorized dealer." [Fig. 1.](#)

This bulletin involves reprogramming the TBM with the latest available software.

1. Reprogram the TBM with the latest software. If issues arise when flashing a module using the wiTECH Diagnostic Application, please submit a ticket to the Helpdesk. The helpdesk can be found within the Help menu.
2. Clear all DTCs that may have been set in any module due to reprogramming. The wiTECH application will automatically present all DTCs after the flash and allow them to be cleared.
