Service Bulletin

Bulletin No.: 22-NA-003

Subject: Instrument Panel Cluster (IPC) Warning Lamps, Malfunction Indicator Lamp (MIL) Illuminated, Diesel Exhaust Fluid (DEF) Message Displayed - Various DTCs Set

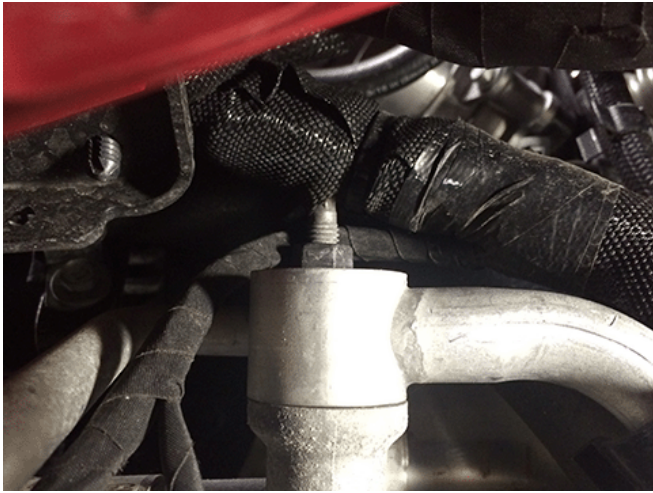
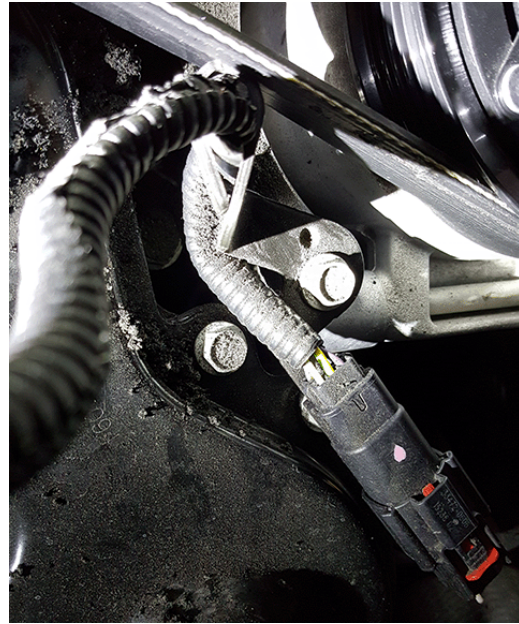
- Air Conditioning (AC) compressor, AC compressor suction and discharge line manifold, AC line and AC compressor clutch.

Concerns in the area of the AC compressor, lines or suction/discharge pipes may cause:

- The MIL to illuminate.
- The Driver Information Center (DIC) may display a reduced power message or service power steering message.
- The engine to run rough.
- The Service Four Wheel Drive (4WD) Light or Stabilitrak light may illuminate.
- A possible extended crank or a crank no start.
- The oil pressure gauge may read erratically or read no oil pressure.
- The Air Conditioning (AC) may not cool or blow hot air.
- An open fuse in the Underhood Bussed Electrical Center (UBEC).

DTCs associated with chaffing in this area include:

- B127E, C0306, C0321, C0398, C0800, P0071, P0072, P0091, P0117, P0119, P0340, P0341, P0406, P0483, P0522, P0628, P0641, P06A3, P0700, P20BB, P20BF, P227E, P24B1, U0073, U0077, U0121, U0131, U0140, U0151, U0415, U2099, U0401, U0415 and U0420.
- Serpentine Belt. The fan clutch wiring harness support bracket may be out of position allowing the harness to rub on the belt.

If you encounter these scenarios, inspect, repair (as necessary) and route the wiring harness away from these possible chafe points.

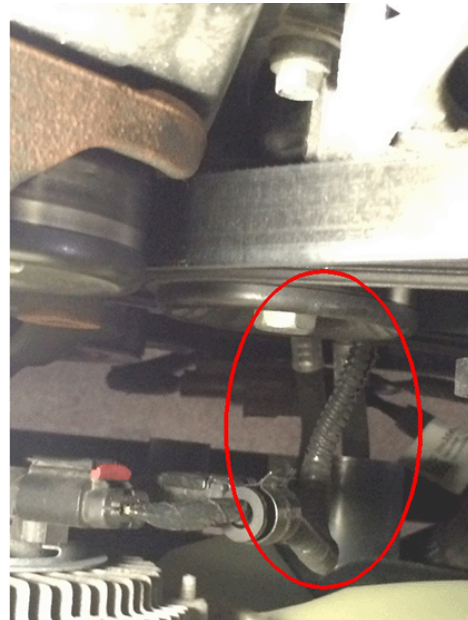
4573222

Concerns in the area of the serpentine belt may cause:

- Various IPC warning lights to illuminate.
- A crank no start concern.
- The MIL to illuminate.
- The engine may run rough or misfire.
- The Service Four Wheel Drive (4WD) light may illuminate.
- The Stabilitrak light may illuminate.
- The Air Conditioning (AC) may not cool or may blow hot air.

DTCs associated with chafing in this area may include:

- C0273, P0526, P0480, P0336, P0526, P0641 and P0651.

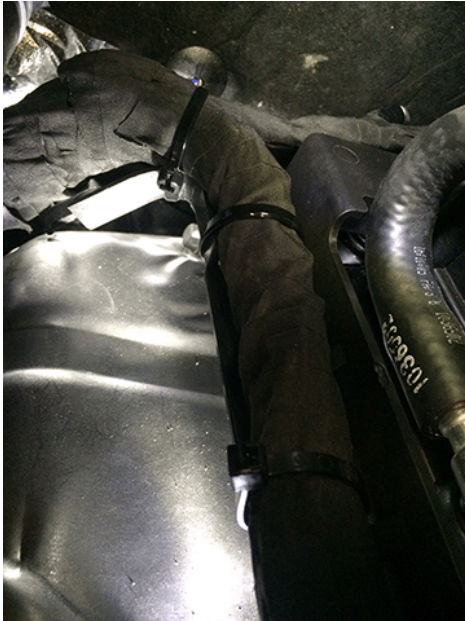
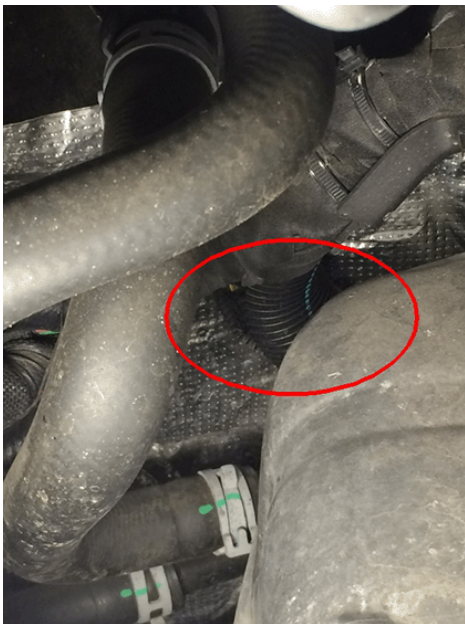
Concerns in the area of the right rear of engine / exhaust heat shield may cause:

- Various IPC warning lights to illuminate.
- The Service Four Wheel Drive (4WD) light may illuminate.
- The Stabilitrak light may illuminate.
- The check engine light to illuminate.

- The Driver Information Center (DIC) may display a reduced power message.
- An open fuse in the Underhood Bussed Electrical Center (UBEC)

DTCs associated with chafing in this area may include:

- B1011, C0306, P0201, P0202, P0203, P0204, P0410, P0575, P062D, P0697, U0073, U0100, U0121, U0140, U0415 and U0420.
- Transmission bell housing bolt/stud.

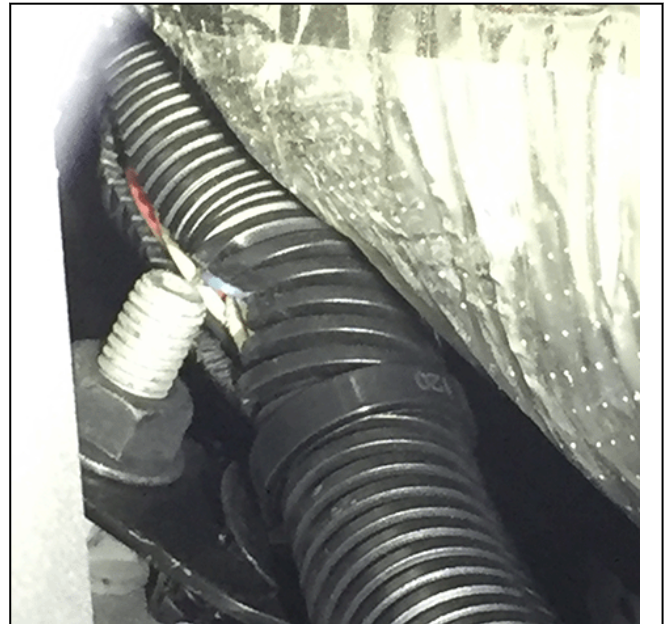
4573244

Concerns in the area of the rear of engine / transmission bell housing bolt/stud may cause:

- Various IPC warning lights to illuminate.
- The Service Four Wheel Drive (4WD) light may illuminate.
- The Stabilitrak light may illuminate.
- The MIL to illuminate.

DTCs associated with chafing in this area may include:

- P0201, P0202, P0203, P0204, P0392, P0401, P0420, P062D and U0073.
- Coolant pipe and clamp tabs between engine and cowl.

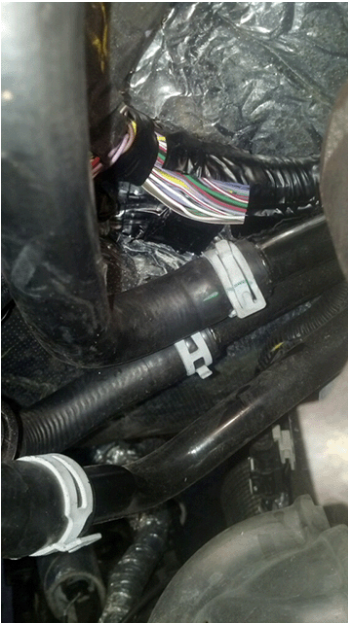
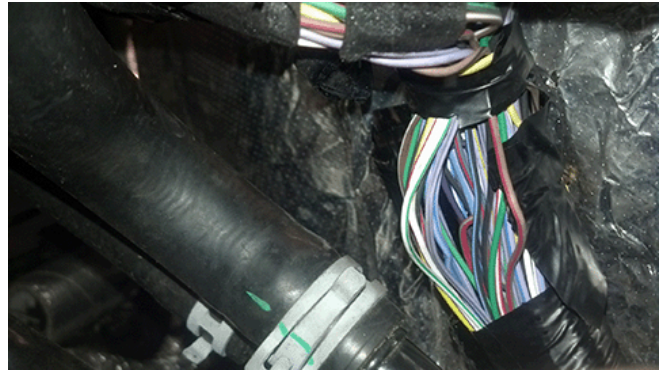
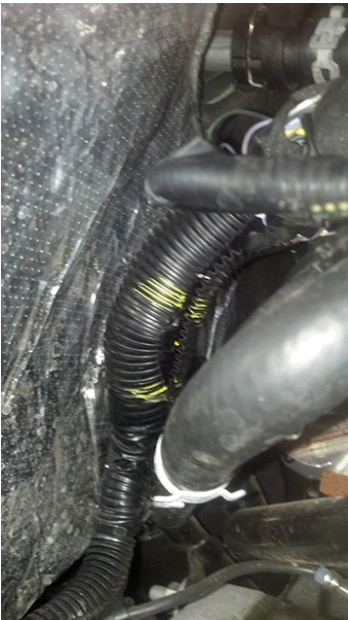
Concerns in the area of the coolant pipe / clamp / clamp tabs between engine and cowl may cause:

- Various IPC warning lights to illuminate.
- The Service Four Wheel Drive (4WD) light may illuminate.
- The Stabilitrak light may illuminate.
- The MIL to illuminate.

DTCs associated with chafing in the area may include:

- B1011, P0575, U0073, U0100, U0121, U0140, U0415 and U0420.
- Near the brake fluid level switch.

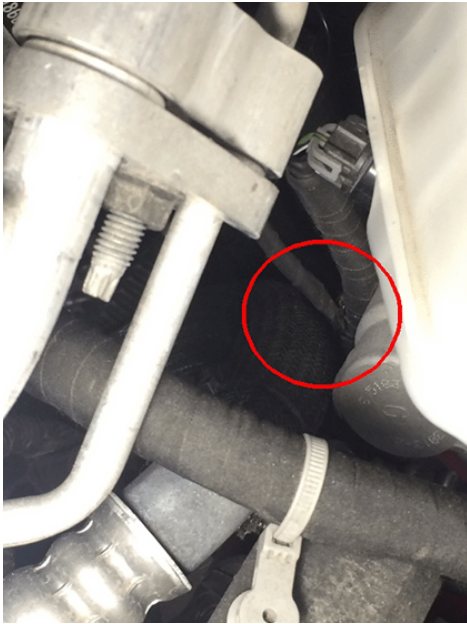
4573216

Concerns in the area near the brake fluid level switch may cause:

- The service brake light to illuminate.
- The DIC may display that the brake fluid is low.
- The check engine light to illuminate.

DTCs associated with chafing in this area may include:

- C0273 and P0641.
- Transfer case encoder motor.

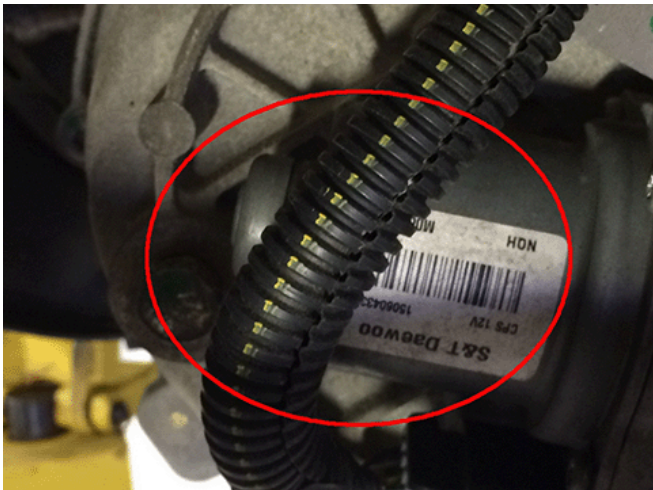
4573221

Concerns in the area near the encoder motor on the transfer case may cause:

- Various IPC warning lights to illuminate.

DTCs associated with chafing in this area may include:

- C0396.
- Turbocharger Vane Position Actuator Connector.

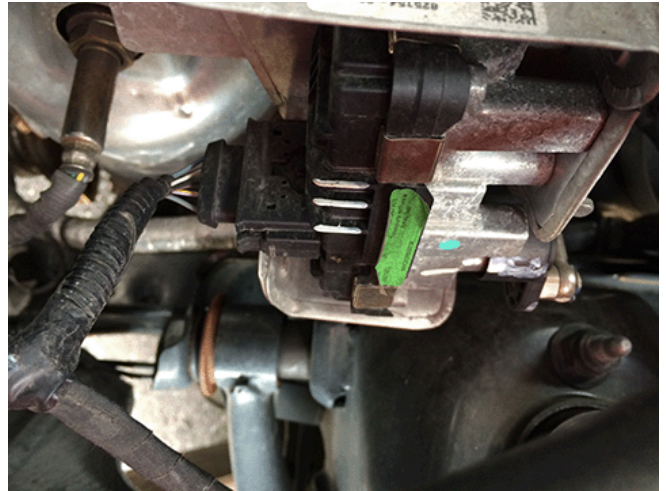
4575279

Concerns with loose terminals or connector not fully seated at the Turbocharger Vane Position Actuator may cause:

- The Check Engine Light to illuminate.
- The Driver Information Center (DIC) may display a reduced power message.
- The vehicle may have a low power concern.

DTCs associated with a loose connector or terminals include:

- P0045 or P2599.
- Additionally, there may be chafing of the wiring harness on the power steering pump pulley.
