## STAR ONLINE PUBLICATION

**Case Number:** S2423000030

**Symptom/Vehicle Issue:** Buzz Squeak Rattle (BSR) From Upper Left Dash Area.

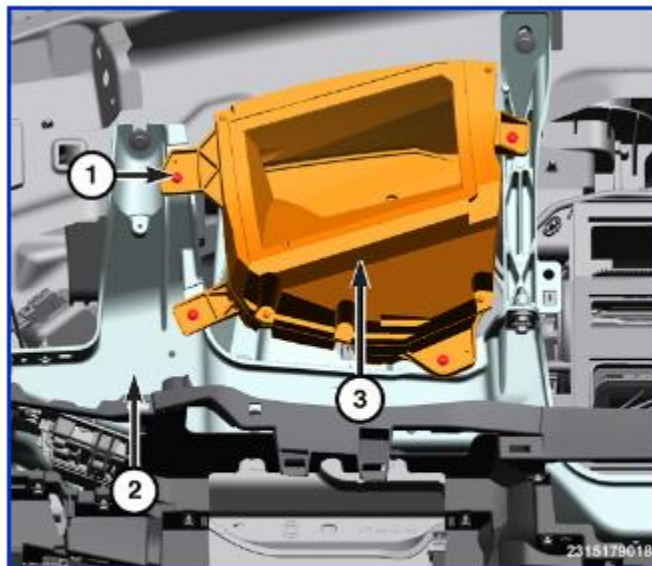
**Discussion:** Attempt to duplicate the noise with the radio off. If the condition is still there with no audio input, examine the heads up display (HUD) fastener clips. The clips may be installed on vehicles without the HUD option. Refer to Service Library 08 - Electrical / 8J - Instrument Cluster / DISPLAY, Heads Up / Removal and Installation.

- 1 - Fasteners
- 2 - Instrument Panel Carrier
- 3 - Heads Up Display (HUD) Module
