Service Bulletin

Bulletin No.: 24-NA-086

Subject: Folding Top Service Tips to Prevent a Broken Rear Glass Assembly

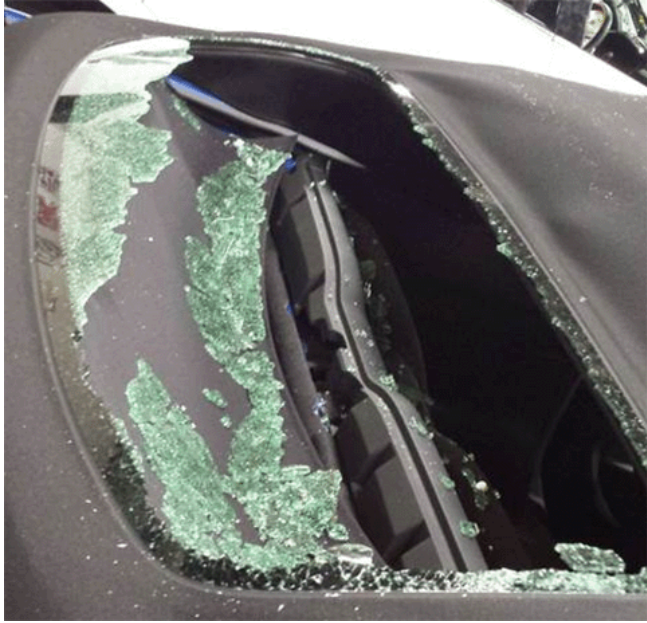
5040809

Cause	The cause of this concern may be due to improper reassembly of the folding top linkage where it connects to the back glass
Correction	If this concern is encountered, dealership technicians are to first inspect the linkage that connects the folding top frame to the back glass that is attached to the folding top canvas.

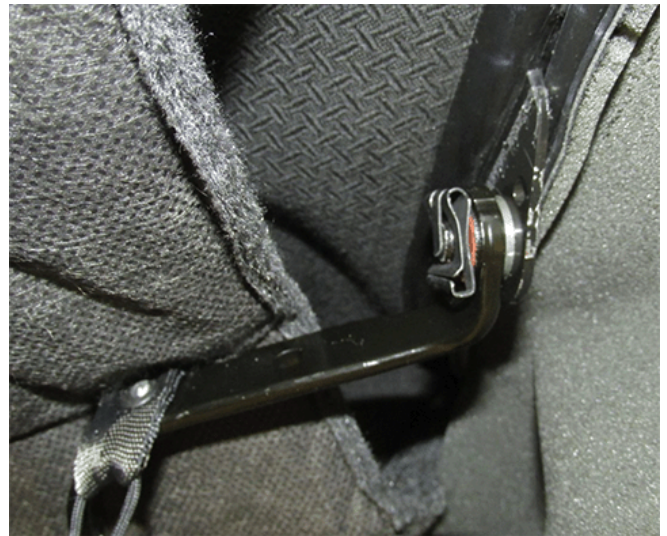
5124926

The most common issue seen is mistakenly putting the top linkage on the inboard side of the back glass attachment point. This creates additional stress on the back glass.

In this condition, when the top is operated several times, the back glass may unexpectedly crack or shatter. This will usually not occur during the first top cycle attempt after service. Usually, this happens after the folding top is cycled several times.

See photo below of a correctly assembled folding top linkage at the rear glass attachment point.

The folding top linkage that attaches to the rear glass MUST be located on the outboard side of the back glass bracket. The pin that holds it together is inserted from the inboard side of the linkage. It first goes through the back glass bracket, after that it goes through the top frame linkage. A gray plastic washer MAY be found in this assembly. Servicing technicians are to note if this is present during disassembly. Finally, the spring clip is installed on the outboard side of the top frame linkage.
