| Title: | PACCAR MX-13 U17F0 Code | | | |
| Number: | SB_686 | Release Date: | 03/12/2024 | |

## SERVICE BULLETIN #686.1

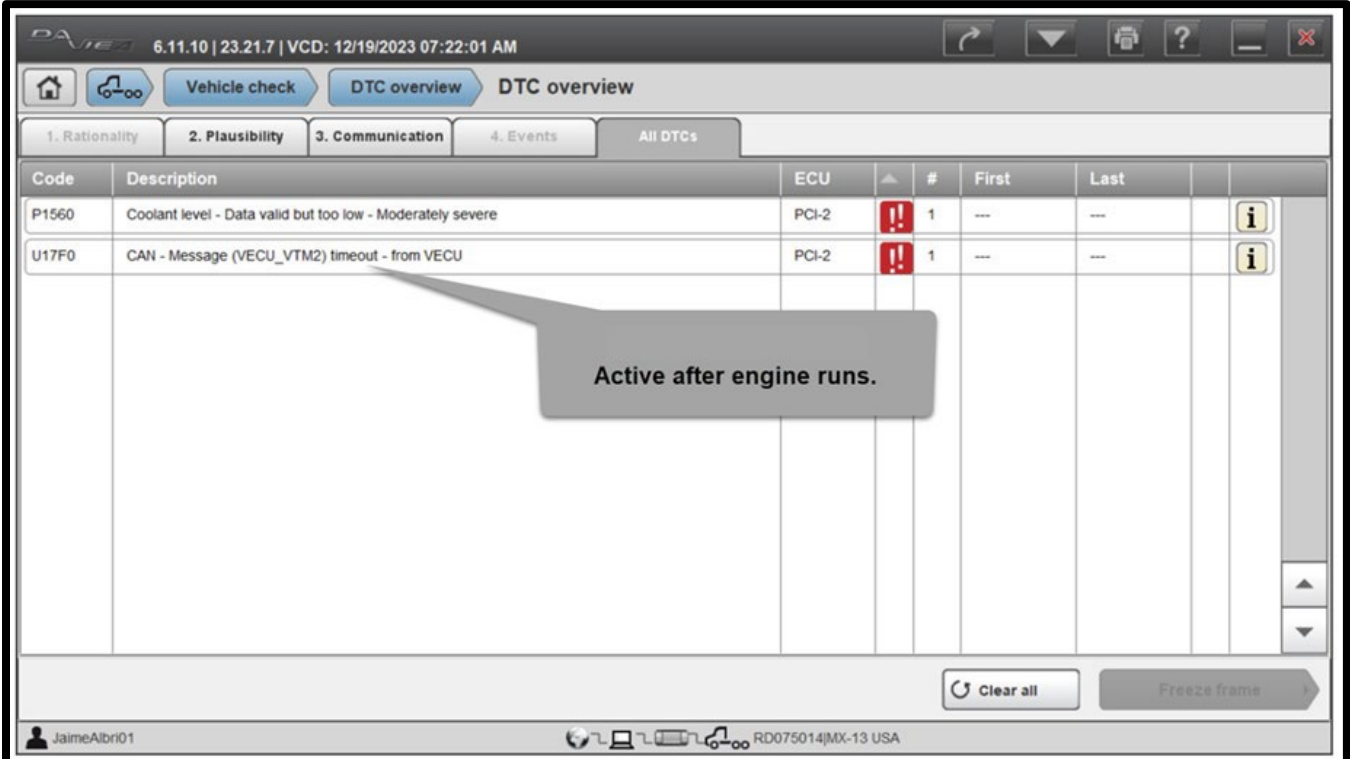
If the engine sees no reply, the engine will remain in its variable state (current normal operation) and returns a U17F0 Code in DAVIE.

| Code | Description | ECU | # | First | Last |
|---|---|---|---|---|---|
| U17F0 | CAN - Message (VECU_VTM2) timeout - from VECU | PCI-2 | 1 | --- | --- |

Active after engine runs.

1. Notify Pierce Customer Support that there is coolant pump control functionality available. There is a Pierce module update available that can be added to utilize the variable speed coolant pump control, which will make the code no longer appear.

2. Ignore it and resume normal operation without Pierce Engine Interface Module additional control.
