Technical Service Bulletin (TSB)
Back Glass Water Leak Warranty Extension XL1

REFERENCE:	TSB: 23-042-24 GROUP: 23 - Body	Date:	June 5, 2024	REVISION:	23-098-23 REV. A
VEHICLES AFFECTED:	2019 - 2021 (DT) RAM 1500 Pickup This bulletin applies to vehicles built on and before September 30, 2020 (MDH 0930XX) equipped with a Rear Power Sliding Window (Sales Code GFE) or Rear Sliding Window (Sales Code GFD).	MARKET APPLICABILITY:			
		<input checked="" type="checkbox"/> NA <input type="checkbox"/> MEA <input type="checkbox"/> SA <input type="checkbox"/> IAP <input type="checkbox"/> EE <input type="checkbox"/> CH			
CUSTOMER SYMPTOM:	The customer may experience one or more of the following: <ul style="list-style-type: none"> • A cracked backlite frame Fig. 1 resulting in an interior water leak (crack is visible to the customer). • Water leak from at top of the backlite. 				
CAUSE:	Manufacturing issue

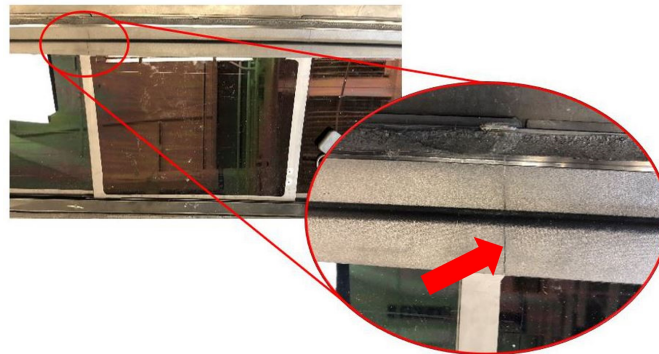
Fig. 1
Cracked Backlite Frame (Left Side Shown, Crack Can Also Be On The Right Side)

This bulletin involves applying urethane to the sliding backlite.

NOTE: **Do not replace the backlite if the frame is cracked. Do not remove the backlite for this Repair Procedure.

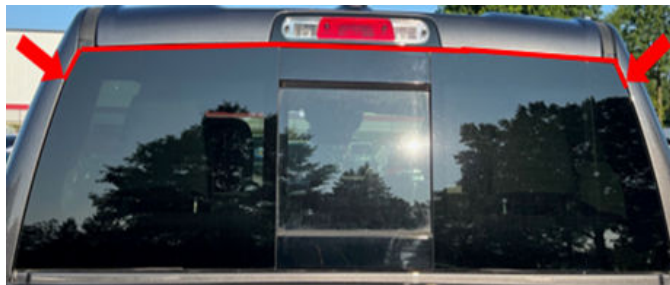
Fig. 2

Area To Fill With Urethane

1. Ensure the top window track area [Fig. 2](#) is clean, free of any debris and dry.

2. Vent one of the windows on the vehicle to relieve cabin pressure and ensure closing a door will not cause movement with the urethane.
3. Using the sealant dispenser, start at one end about 50 mm (2 in.) from either the left or right side below ditch molding and apply the urethane [Fig. 2](#). Dispense the urethane with the tip angled parallel to the gap and up against the backside of the glass. Apply for 2 - 3 mm (0.078 - 0.118 in.) per second until a small puddle (bead) is formed filling the cavity while moving across to the opposite side below the ditch molding.
4. Inspect the urethane to ensure there are no gaps and the entire area is evenly filled with urethane [Fig. 2](#). If any gaps are found, repeat [Step 3](#).

Inform the customer the urethane needs 24 hours time to cure before water is applied.**
