## Technical Service Bulletin (TSB)

### Noise From Front End While Driving Over Bumps

<b>REFERENCE:</b>	<b>TSB:</b> 02-007-24 REV. A <b>GROUP:</b> 02 - Front Suspension	<b>Date:</b>	June 7, 2024	<b>REVISION:</b>	02-007-24
<b>VEHICLES AFFECTED:</b>	<b>**2023** - 2024 (RU) Chrysler Pacifica</b> This bulletin applies to vehicles built on after May 01, 2023 (MDH 0501XX) and on or before January 08, 2024 (MDH 0108XX).			<b>MARKET APPLICABILITY:</b>	
				<input checked="" type="checkbox"/> NA	<input type="checkbox"/> MEA
				<input type="checkbox"/> SA	<input type="checkbox"/> IAP
				<input type="checkbox"/> EE	<input type="checkbox"/> CH
<b>CUSTOMER SYMPTOM:</b>	<b>Customers may experience the following:</b>				
	<ul style="list-style-type: none"> <li>Noise (rattle/thump/clunk noise) coming from the front end of the vehicle when driving over bumps.</li> </ul>				
<b>CAUSE:</b>	Distorted isolator spring.

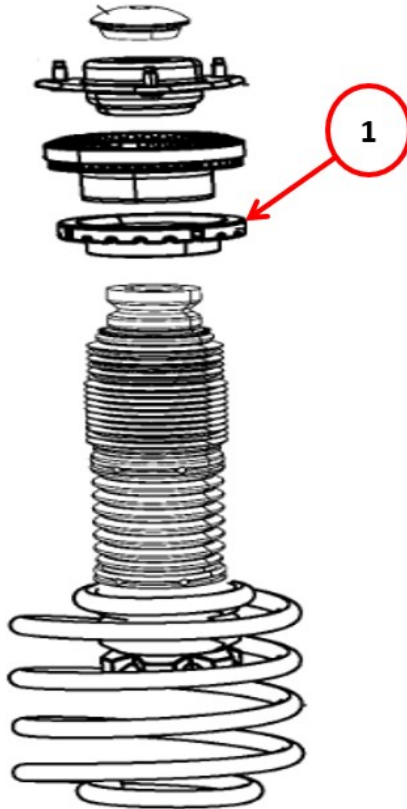
1. Raise and support the vehicle. Refer to the detailed service procedures available in DealerCONNECT/ Service Library under: Service Info> 04 - Vehicle Quick Reference / Hoisting / Standard Procedure.
2. Inspect the both front strut upper isolator springs for deformation [Fig. 1](#).

**Fig. 1**  
Front Upper Isolator Spring Location On Strut

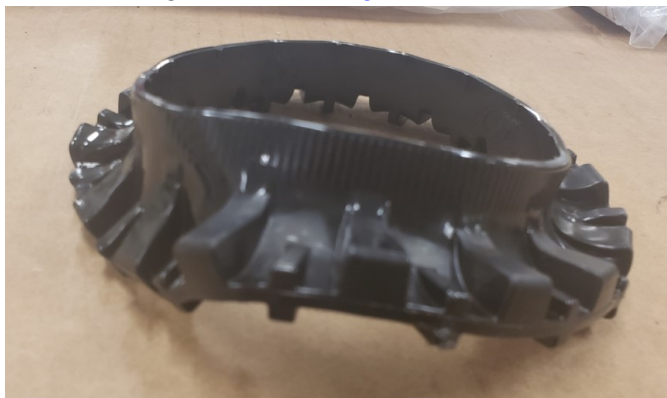
3. Are either front strut upper isolator springs deformed [Fig. 2](#)?

**Fig. 2**  
Distorted Upper Isolator Spring

This bulletin involves inspecting and possibly replacing one or both front upper isolator springs.

- YES>>> Proceed to [Step 4](#).
  - NO>>> This bulletin does not apply. Normal diagnosis should be performed.
4. Disassemble the front strut(s) assembly. Refer to the detailed service procedures available in DealerCONNECT/Service Library under: Service Info>02 - Front Suspension / Front / Strut, Suspension, Assembly / Disassembly.
  5. Replace the deformed upper isolator spring.  
**NOTE: The vehicle comes equipped with a one piece upper spring isolator. The new replacement upper spring isolator is a two piece design.**
  6. Assemble the front strut(s) assembly. Refer to the detailed service procedures available in DealerCONNECT/Service Library under: Service Info>02 - Front Suspension / Front / Strut, Suspension, Assembly / Assembly.
