TECHNICAL SERVICE BULLETIN

Soft Top Roof - Headliner Detaching From Soft Top Material

24-2186

Ford 2021-2024 Bronco	Factory soft top roof
---------------------------------	-----------------------

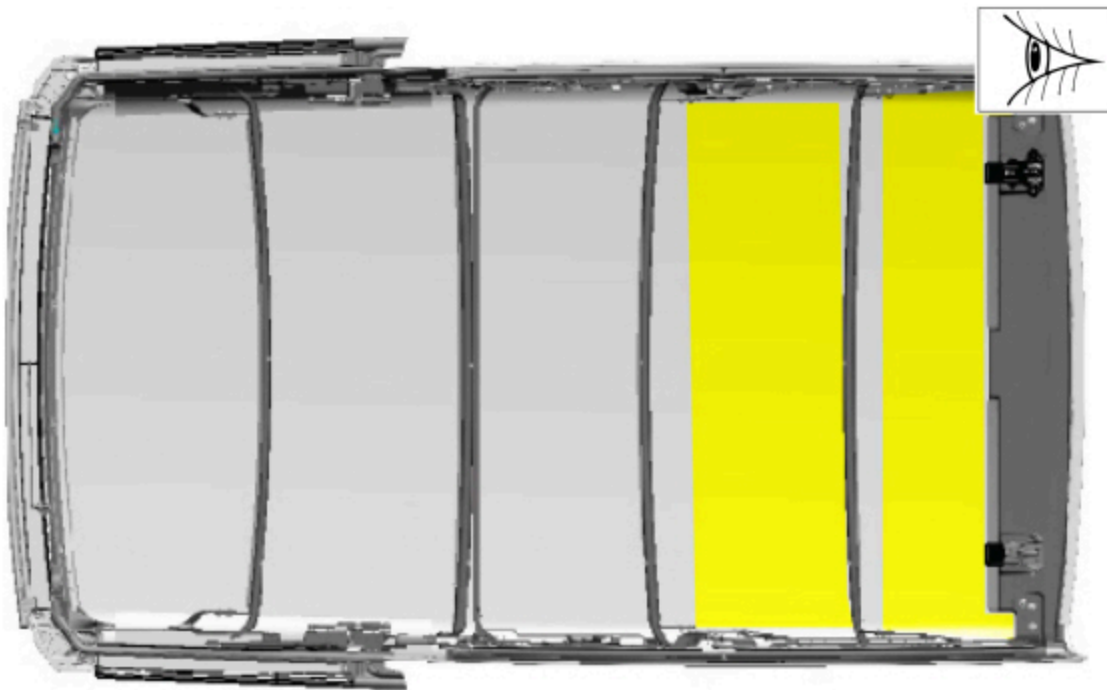
1. The soft top material has 2 separate sections of headliners, refer to Figure 1 for locations. Are either of the 2 headliners completely detached from the soft top material and/or damaged, such as stretched, cut and/or warped? (Figures 1-3)

Figure 1 - View from underside of the soft top assembly. Both headliner locations shown.

- (1). Yes - replace the soft top material. Refer to WSM, Section 501-18A. Repair is complete.
- (2). No - proceed to Step 2.

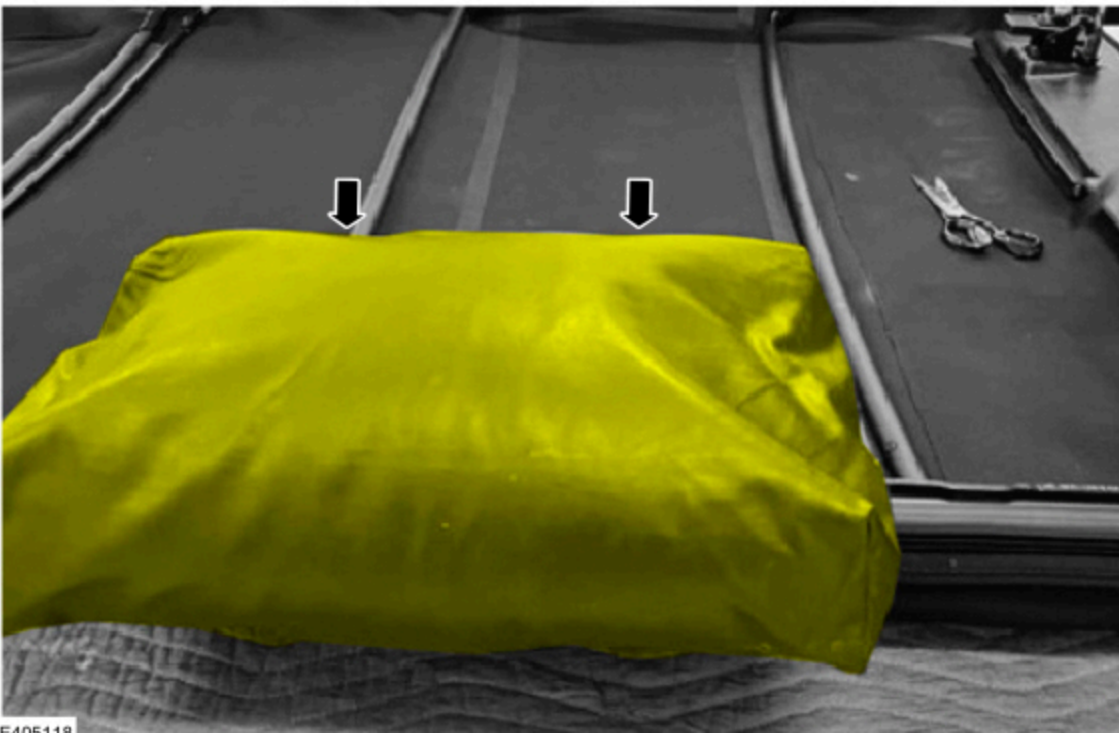
Figure 7 - Sandbag shown on top of frame hinge location. Left side shown, right side similar.

(2). Place a 50 lb. (22.6 kg) sandbag (or similar item) on each the side of the frame to weigh down the raised hinged sections of the frame. This flattens the soft top assembly for easier application. If needed, place a clean cloth underneath the sandbags to prevent the soft top assembly from getting dirty. Refer to Figure 7.

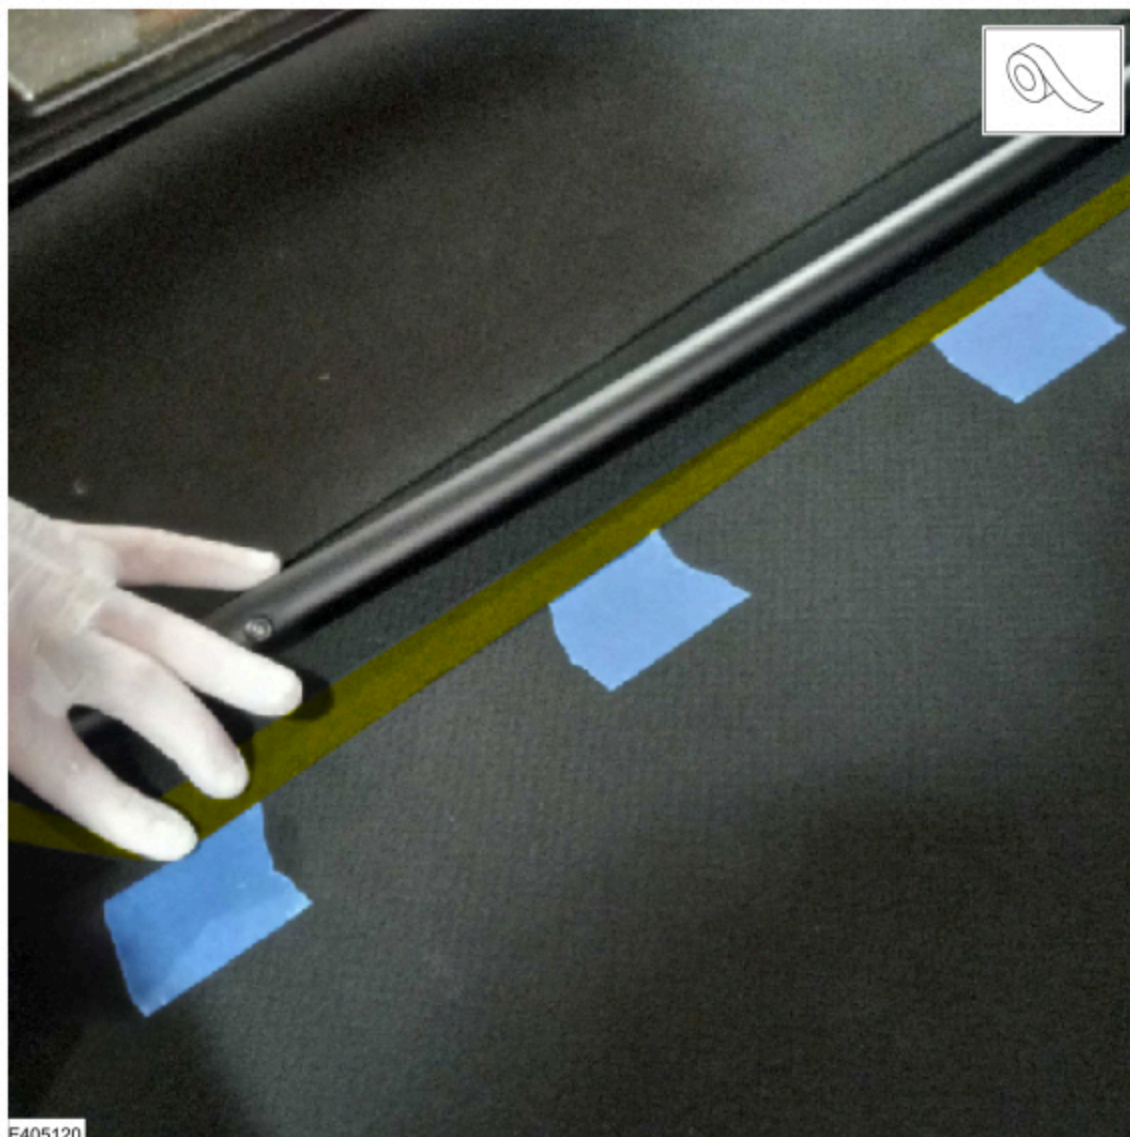
Figure 9 - Showing proper tape Installation following the taped guidelines.

(6). Set the center point of the cut section of film tape on the middle of the soft top assembly. This leaves extra tape on each end of the soft top assembly. Beginning on one side, approximately 12 in. (30 cm) away from one edge of the seam, peel the tape backing in small increments as needed (do not remove the entire length of the tape backing all at once) and lightly install the tape following the 0.5 in. (13 mm) tape guidelines. Be sure that half of the tape width is on the headliner and the other half on the soft top material, creating a straight/uniform line, refer to Figures 9-10. Do not stretch the tape at any point before or during the application. Film tape is extremely pliable which allows it to have excellent adhesion to the fabric. If it is installed while being stretched, it retracts over time which causes it to lose adhesion, refer to Figure 10.

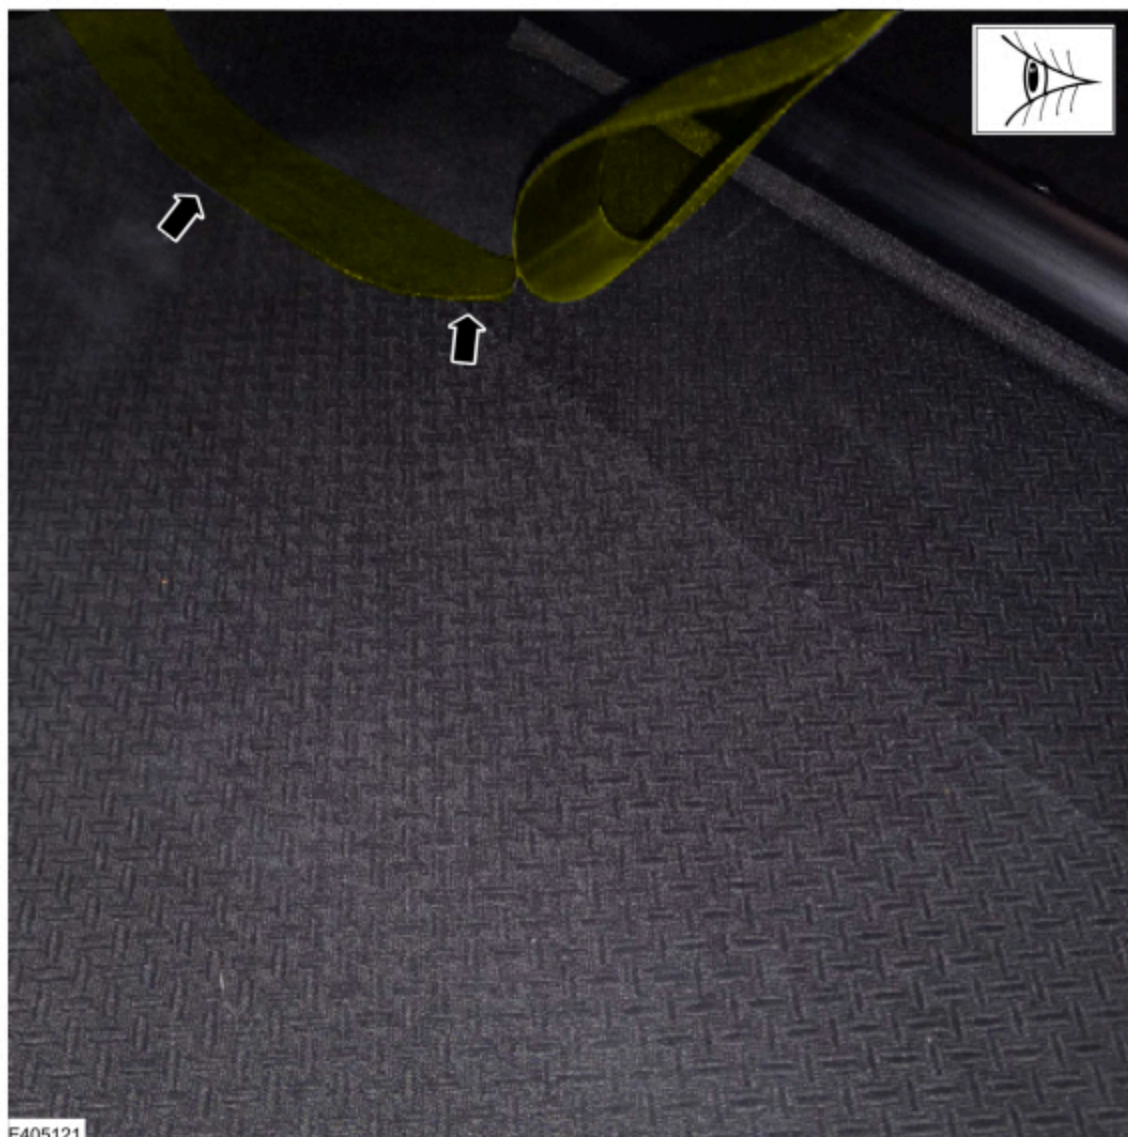
Figure 10 - Showing proper tape installation. Do not stretch tape and only remove backing as needed.

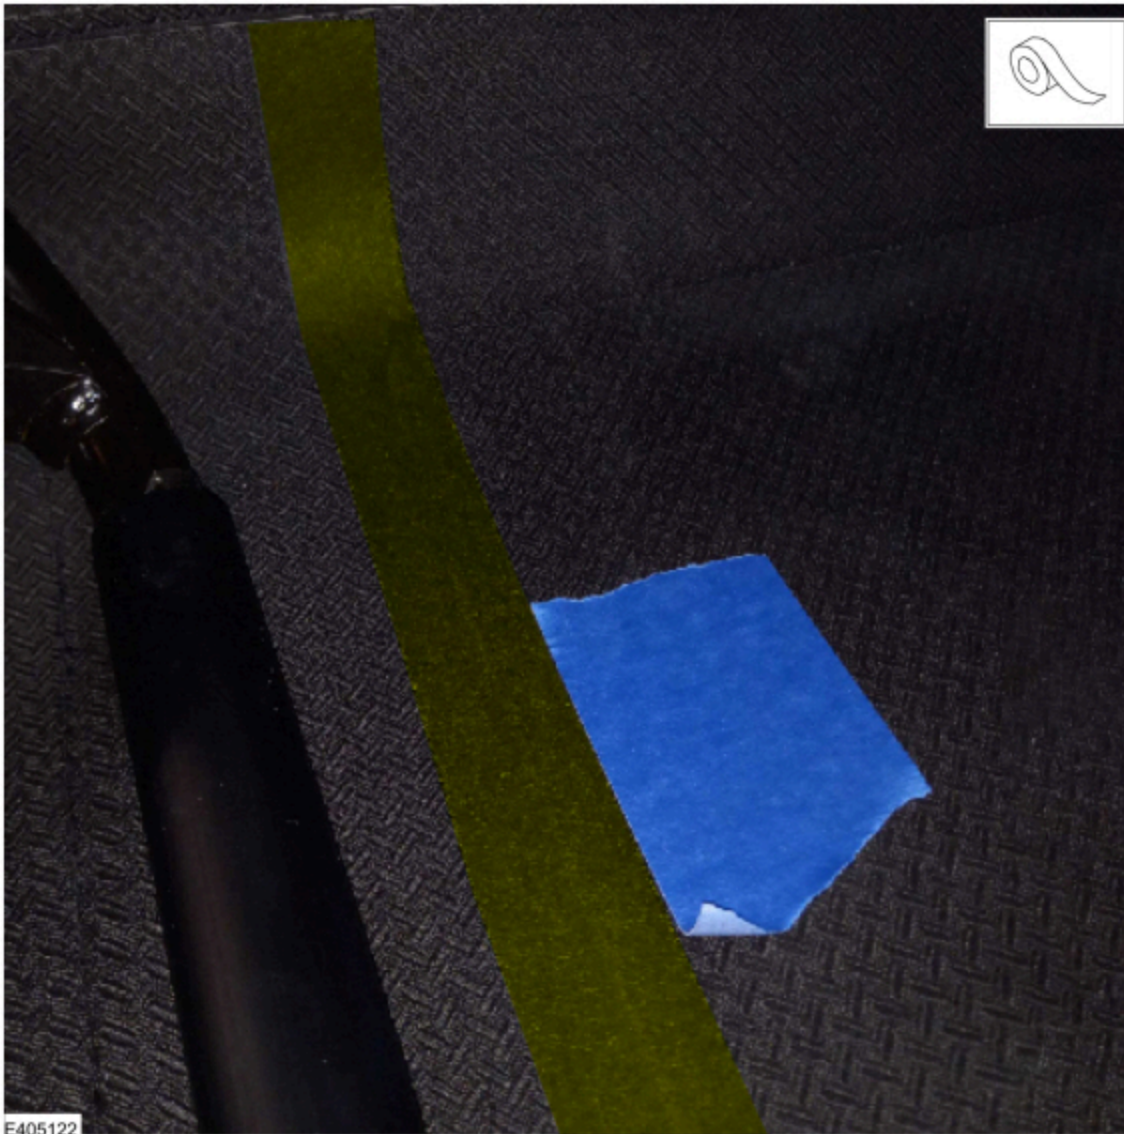
Figure 11 - Showing proper tape installation on the edge of the soft top material.

(7). When the section of film tape reaches the end of the headliner seam, continue to tape in a straight line all the way to the edge of the soft top seam. Allow the tape to stay loose during application. Cut the end of the film tape so that it ends just before the soft top material edge but do not tape past the edge, which runs perpendicular to the tape routing. Be sure that 100% of the film tape is secured and flat to the surface. Do not leave any sections of tape loose/unattached, as this causes tape to peel over time. Perform this step on the opposite edge of the section of film tape, then proceed to the next step. (Figure 11)
