Technical Service Bulletin (TSB)

Leaking Power Steering Fluid from the Power Brake Hydro-Booster Assembly

REFERENCE:	TSB: 05-003-24 GROUP: 23 - Body	Date:	June 13, 2024	REVISION:	-
VEHICLES AFFECTED:	2024 (D2) RAM 3500 Pickup 2024 (DJ) RAM 2500 Pickup 2024 (DD) RAM 3500 Cab Chassis 2024 (DP) RAM 4500/5500 Cab Chassis This bulletin applies to vehicles built on or after July 07, 2023 (MDH 0707XX) and on or before November 24, 2023 (MDH 1124XX).	MARKET APPLICABILITY:			
CUSTOMER SYMPTOM:	Customers may experience the following: <ul style="list-style-type: none"> Leaking power steering fluid from the hydroboost assembly. 				
CAUSE:	Contamination.

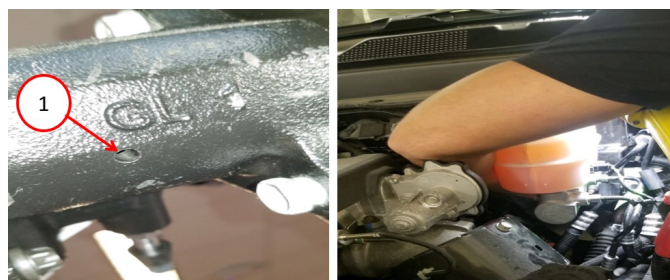
Fig. 2
Power Brake Hydro-Booster Weep Hole Location

2. Using the clean cloth or paper towels with cleaner applied, wipe the bottom of the black power brake hydro-booster body around the weep hole to remove all oils, moisture, and debris. The weep hole is located at the six o'clock position of the power brake hydro-booster assembly as installed, near the master cylinder/power brake hydro-booster assembly connection and can be reached from the inboard side [Fig. 2](#).

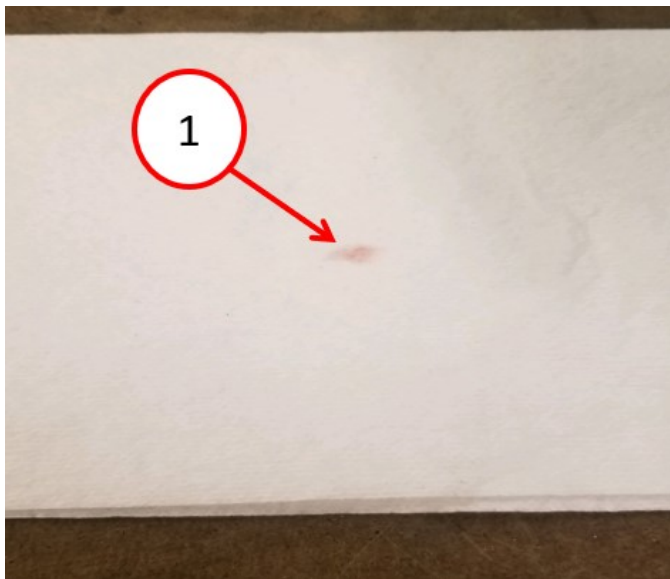
Fig. 3
Cloth/Paper Towel Inspection

8. Is red fluid found on the cloth or sheets of paper towel after wiping the weep hole [Fig. 3](#)?
 - YES>>> Proceed to [Step 9](#).
 - NO>>> This bulletin has been completed. Use Inspection LOP (05-60-01-9A) to close the active RSU.

1 - Indication Of Fluid Leaking Post Weep Hole Wipe Inspection.

9. Replace the power brake hydro-booster assembly. Refer to the detailed service procedures available in DealerCONNECT/Service Library under: Service Info> 05 - Brakes / 05 - Brakes, Base / Hydraulic/Mechanical / Booster, Power Brake, Hydro-Boost / Removal and Installation.
