Technical Service Bulletin (TSB)
Right Side Door Trim Panels Not Secure

REFERENCE:	TSB: 23-045-24 GROUP: 23 - Body	Date:	June 14, 2024	REVISION:	-
VEHICLES AFFECTED:	2024 (WL) Grand Cherokee / Grand Cherokee L This bulletin applies to vehicles built on or after February 22, 2024 (MDH 0222XX) and on or before May 06, 2024 (MDH 0506XX).			MARKET APPLICABILITY:	
				<input checked="" type="checkbox"/> NA	<input type="checkbox"/> MEA
				<input type="checkbox"/> SA	<input type="checkbox"/> IAP
				<input type="checkbox"/> EE	<input type="checkbox"/> CH
CUSTOMER SYMPTOM:	Customers may experience one or more of the following: <ul style="list-style-type: none"> Both right door trim panels loose. Both right door panels rattles during music. 				
CAUSE:	Incorrect torque applied

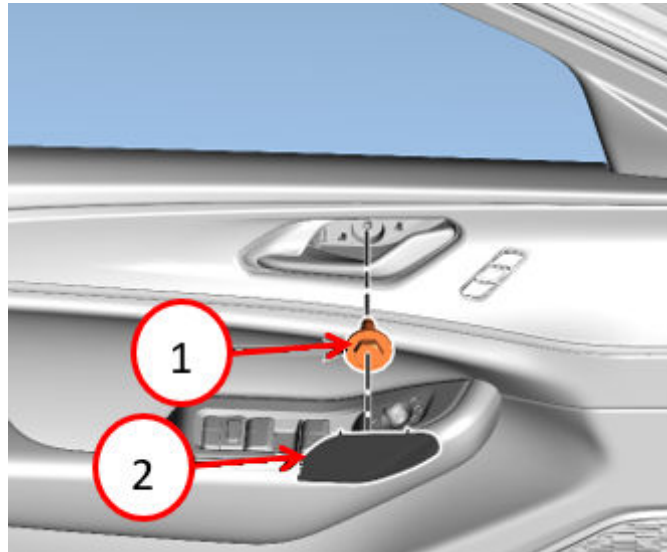
Fig. 1
Door Trim Interior Handle

1 - Door Trim Interior Handle Bolt
2 - Trim Cover

Using a small flat bladed tool or equivalent, pull out on the interior right door handle and remove the trim cover located in the door handle cavity [Fig. 1](#).

3. Verify trim bolts [Fig. 1](#) and [Fig. 2](#) are tightened to 8 N·m (71 In. Lbs.).
4. After trim bolts are tightened, place door trim panel screw covers back on.

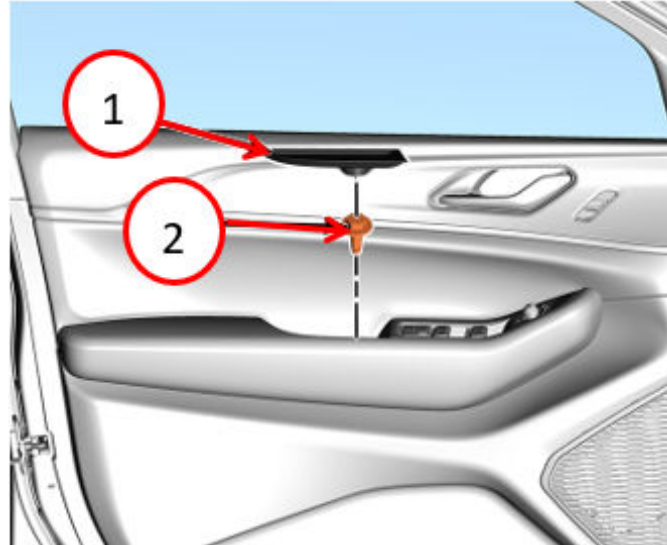
Fig. 2
Pull Cup Trim

1 - Pull Cup Trim Mat
2 - Door Trim Pull Cup Bolt

2. Using a small flat bladed tool or equivalent, remove the right pull cup trim mat [Fig. 2](#).
