Service Bulletin

Bulletin No.: 23-NA-142

Subject: No Forward Gear When Shifting from Park to Drive and/or Reverse to Drive

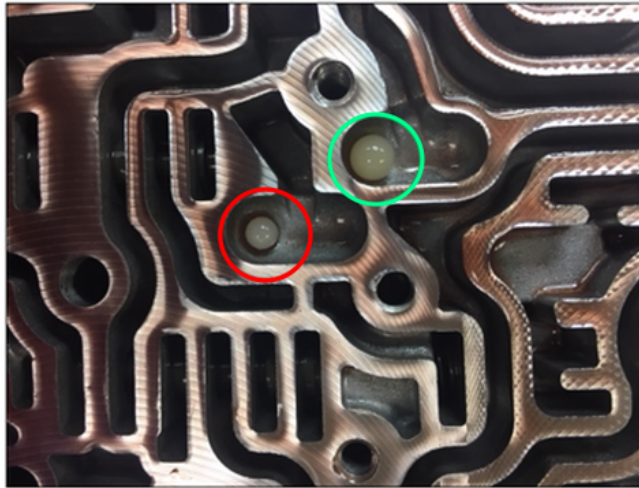
6404322

- As indicated in the graphic above, the check ball circled in RED has prematurely worn down. It should be the same diameter as the check ball circled in GREEN.

Correction	Replace the spacer plate and check ball.
-------------------	--
