Service Bulletin

Bulletin No.: 23-NA-151

Subject: Hybrid/EV Battery, High Priority DTCs, Potential Loss of Isolation, Vehicle Handling and RESS Shipping Requirements

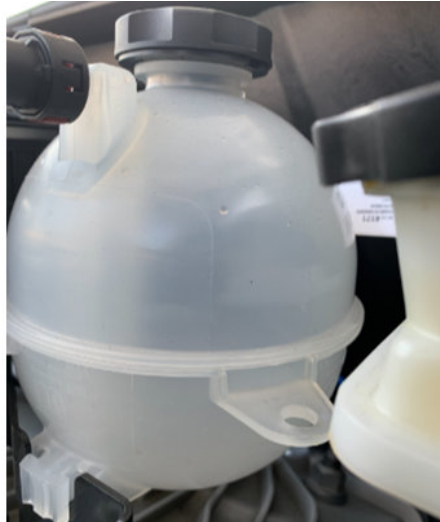
Figure 1

4. Visually inspect and document the coolant level in the high-voltage battery surge tank (Fig 1) and document via photo. Inform TAC if coolant has previously been added.

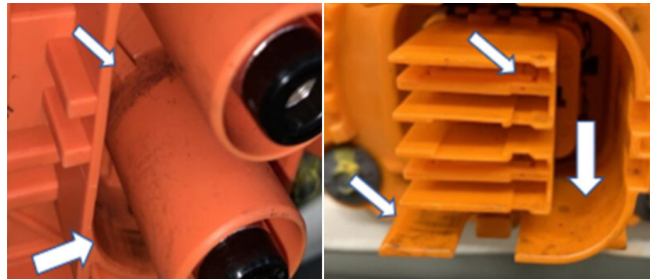
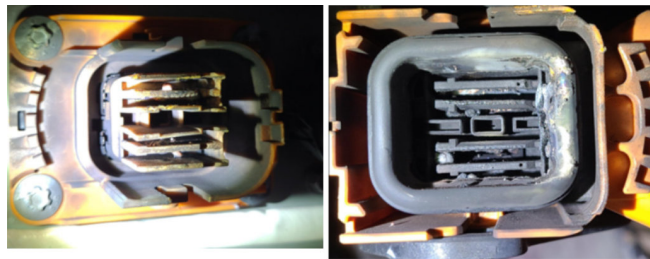
Figure 2 Soot Examples

10. Follow SI Procedure for RESS removal, Hybrid/Electric Vehicle Battery Pack Removal and Installation.
11. After High Voltage Battery removal, inspect the High Voltage Connectors at the High Voltage Battery for corrosion, moisture, and/or soot. (Fig 2) Take photos of the vehicle side HV connectors and High Voltage Battery connection headers. Attach photos to TAC Case. Refer to the SI Procedure for High Voltage System Inspection.

Note: If corrosion or moisture is observed, stop all work and call TAC.

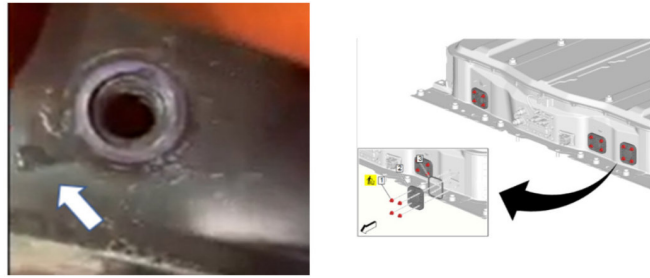
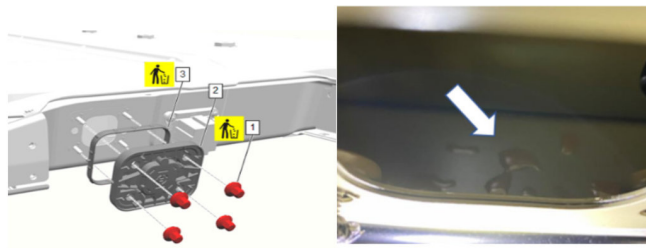
Figure 3 Liquid and Moisture Examples

13. After High Voltage Battery removal, remove the High Voltage Battery Pressure Equalizer Vent Deflector(s) and/or Battery Inspection plug (if equipped) (Fig 3). Using a cotton swab or paper towel to swab inside the enclosure for moisture or coolant. Take photos and attach to TAC case.

Note: If fluid is observed, stop all work and call TAC.
