Service Bulletin

Bulletin No.: 24-NA-089

Subject: Water Leak into Interior and/or Various Electrical Concerns

Brand:	Model:	Model Year:		Vehicle Build Date:		Engine:	Transmission:
		from	to	from	to		
Chevrolet	Malibu	2024	2024	February 15, 2024	February 21, 2024	All	All

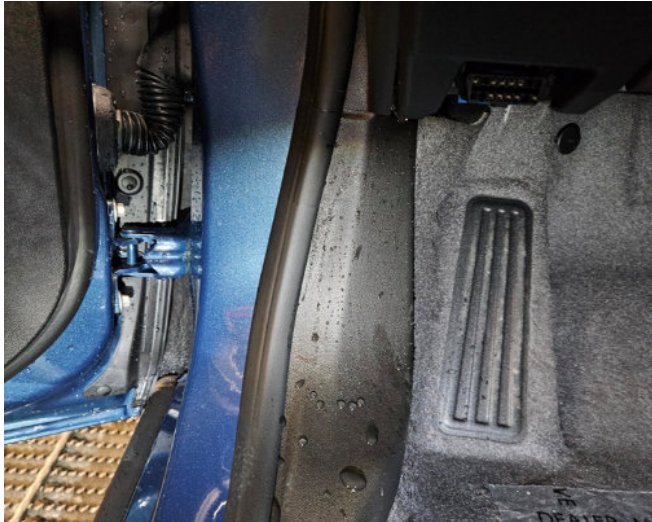
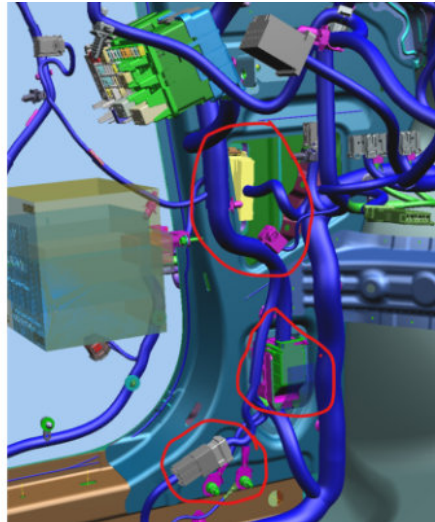
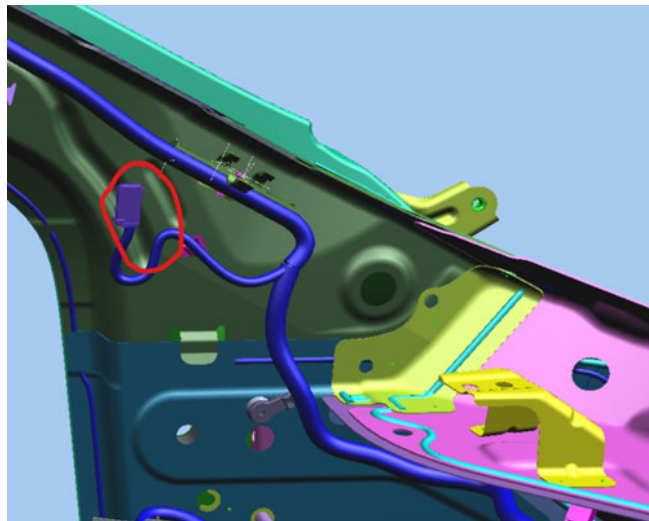
Involved Region or Country	North America
Condition	<p>Some customers may comment that the front row carpet on the left side is wet near the IP and front carpet retainer.</p>

Technicians might also find water intrusion in the following electrical connectors or component:

1. X210 Instrument Panel Wiring Harness to Body Wiring Harness
2. X211 Instrument Panel Wiring Harness to Body Wiring Harness
3. X500 Front Side Door Wiring Harness - Driver to Body Wiring Harness
4. P19H Speaker - Left Front Tweeter

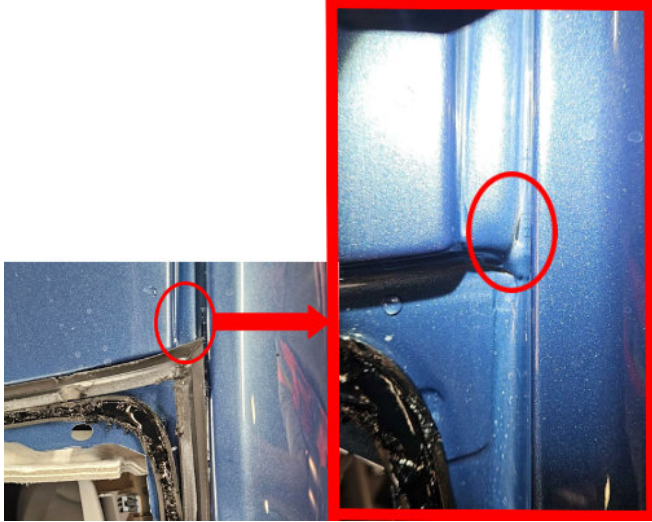
<p style="text-align: right;">6640646</p> <p>The cause of this condition may be a possible "pinhole" void in the roof ditch sealer on the left side front near the top of the windshield.</p>
<p>Correction</p>	<p>Visually inspect for a gap or hole in the sealer on the left side front near the top of windshield.</p> <p>If a gap or hole is found, complete the Service Procedure below.</p> <p>If no holes or gaps are found, continue with water leak diagnostics. Refer to <i>Water Leak Test Preparation</i> in SI.</p>

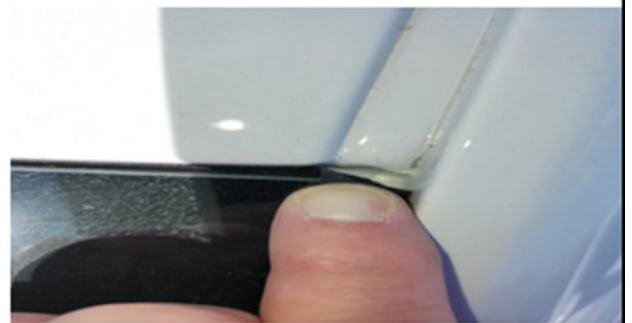
Note: The pin holes/cracks may be more difficult to see on darker color finishes. An example of a visible pin hole is shown in the graphics above.

1. Gently lift windshield lace to inspect for a gap or hole in the sealer on the left side front near the top of windshield.
2. Seal the holes/crack in any roof ditch sealer area by mixing a small amount of Kent® High-Tech Seam Sealer Clear P10200, or Wurth Euroseal Gel Clear 18920104, or equivalent WITH the proper touch-up paint color.

3. Avoiding excess sealer build-up within the ditch, work a small amount of the sealer into the hole with a gloved finger, making sure the windshield lace is lifted as shown in the photo to allow the seam sealer to completely cover the hole.
4. Wipe away any excess sealer with a light amount of solvent on a rag or paper towel. The solvent will help the sealer flow into the hole/crack.
