Service Bulletin

Bulletin No.: 18-NA-020

Subject: Poor Engine Performance in Extremely Cold Weather Conditions, Malfunction Indicator Lamp (MIL) Illuminated with DTCs P0300, P0299, P0234 and/or P2227 Set

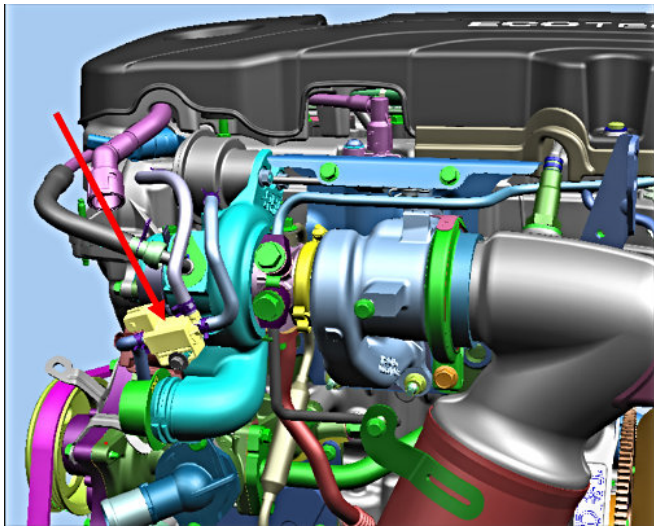
6055063

Inspect the Turbocharger Control Valve (TCV) to ensure it is not frozen.

1. Remove Turbocharger Wastegate Regulator Solenoid Valve.
2. Drain Turbocharger Wastegate Regulator Solenoid Valve (TCV) by turning valve upside down.

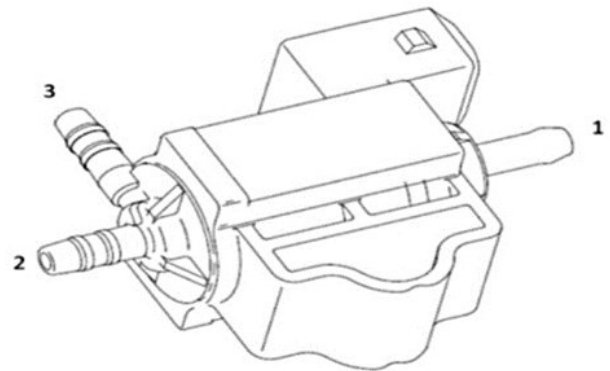
6055068

Note: Check port #2 to assure the spring gets lifted off the seat. This will be determined by the compressed air not dead heading when applied to port #2. When applying air to this port a small amount of air should be observed at port #3 and even less air will be noticed at port #1. If this does not happen, the TCV plunger may have hardened deposits from hot operating conditions which will impede TCV plunger movement, and the Turbocharger Wastegate Regulator Solenoid Valve should be replaced.

3. Using clean shop air regulated to 80-100 PSI (551-689 kPa), blow through all three ports (1, 2 & 3) for 5 seconds each. Repeat this step twice.

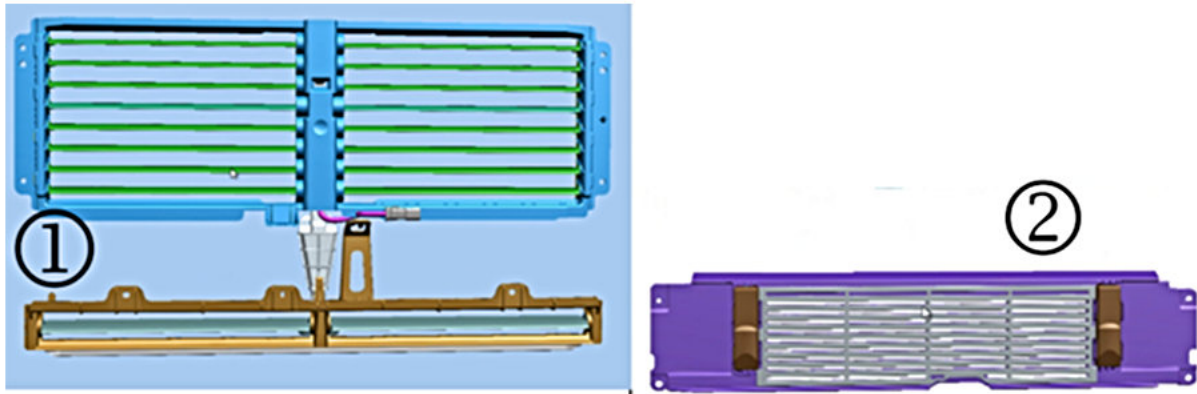
- Front Bumper Upper Shutter with the Front Bumper Secondary (lower) Shutter attached (1), as shown in the picture above.
- Front Bumper Lower Shutter that mounts in the front of Charge Air Cooler (2), as shown in the picture above.

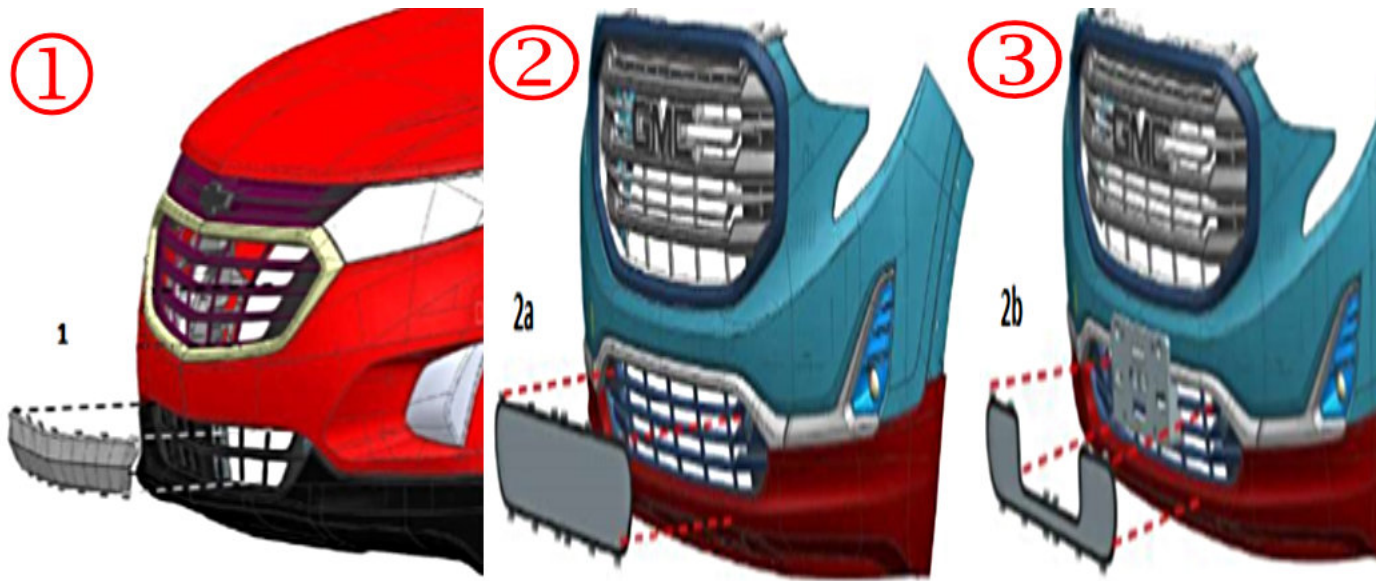
5776421

Shown in the picture above are examples of the grill opening covers for the Equinox (1), Terrain without (RPO VK3) (2) and Terrain with (RPO VK3) (3).
