Service Bulletin

Bulletin No.: 22-NA-128

Subject: Malfunction Indicator Lamp (MIL) Illuminated - DTC P0172, P026D, P2459, and/or P2A00 Set

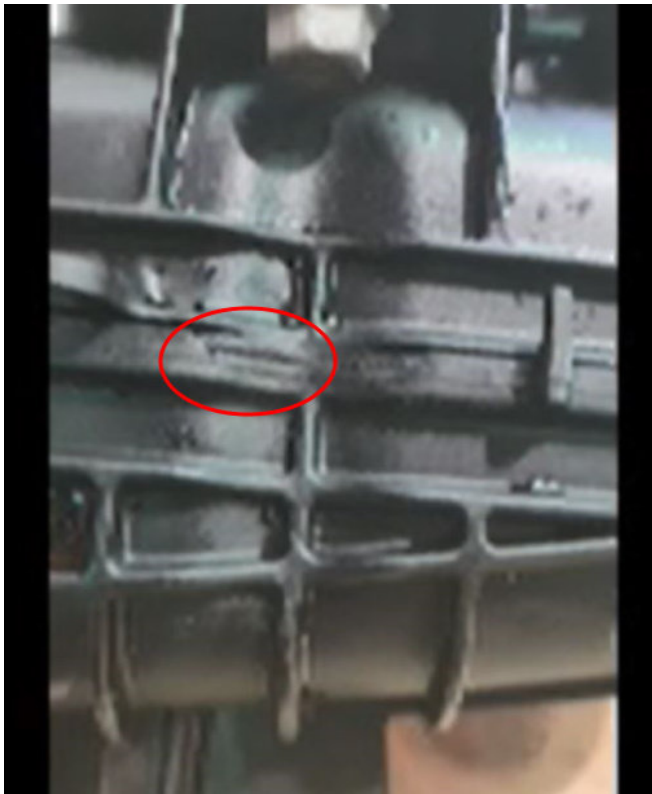
<p style="text-align: right;">6102369</p> <p>This condition may be caused by a leak at the intake manifold.</p>
<p>Correction</p>	<p>The technician can find this leak by testing using the <i>Component/System Leak Test in SI</i> or bulletin PIP5684. If a leak is found in the intake manifold, replace the intake manifold.</p>

Refer to *Intake Manifold Replacement in SI*.
