Service Bulletin

Bulletin No.: 24-NA-009

Subject: Loss of Forward Gear, Slipping, Malfunction Indicator Lamp (MIL) Illuminated - DTC P2714 Set

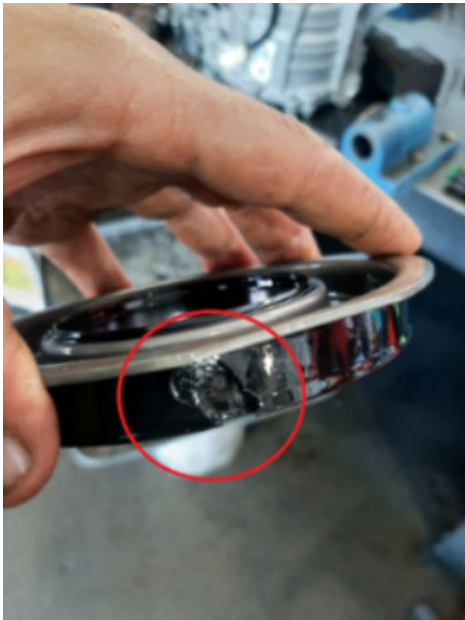
5896314

Inspect the Forward Clutch Piston for damage along the side.

If the forward clutches are worn and there is damage seen to the Forward Clutch Piston, then replace the Forward Clutch Piston and Housing and the applicable apply components as needed.

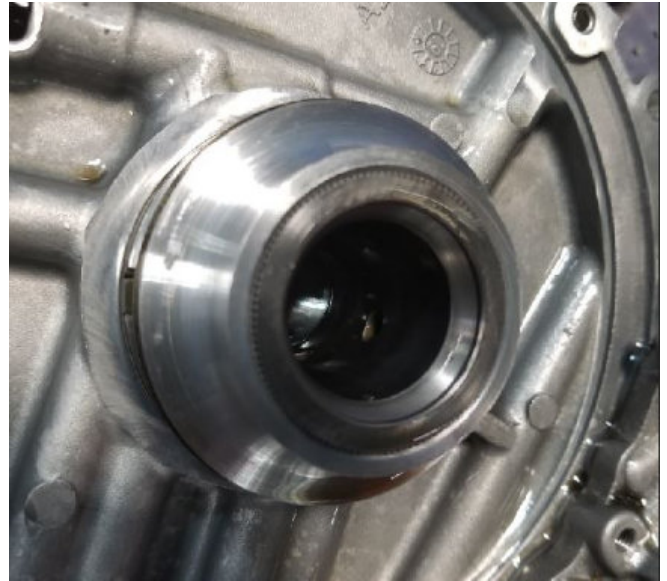
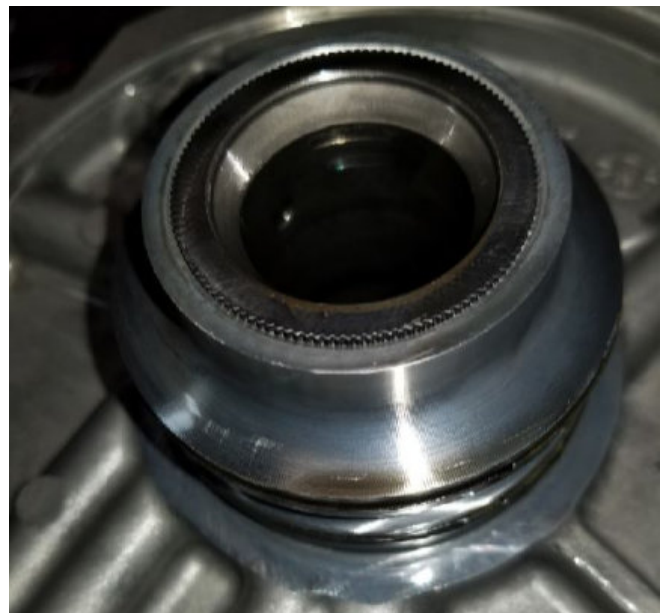
Note: The first 2 graphics show the outside of the pump, and the second 2 graphics show the wear that is found internal to the pump when wear to the Primary Pulley Bearing Bore is found.

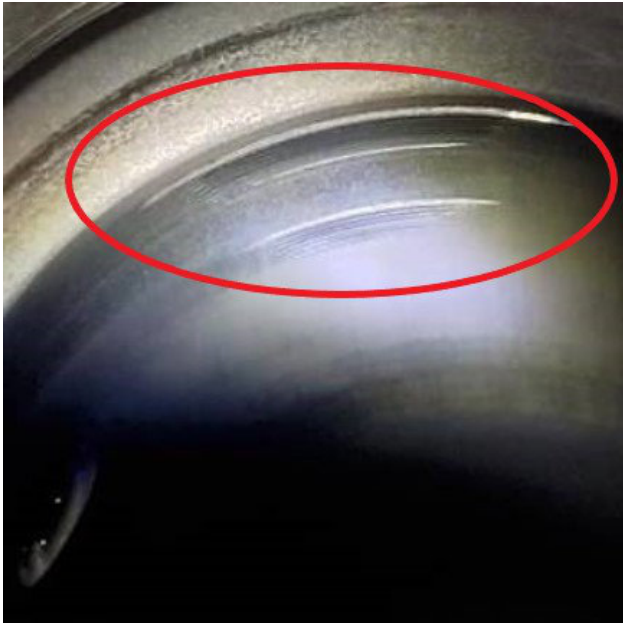
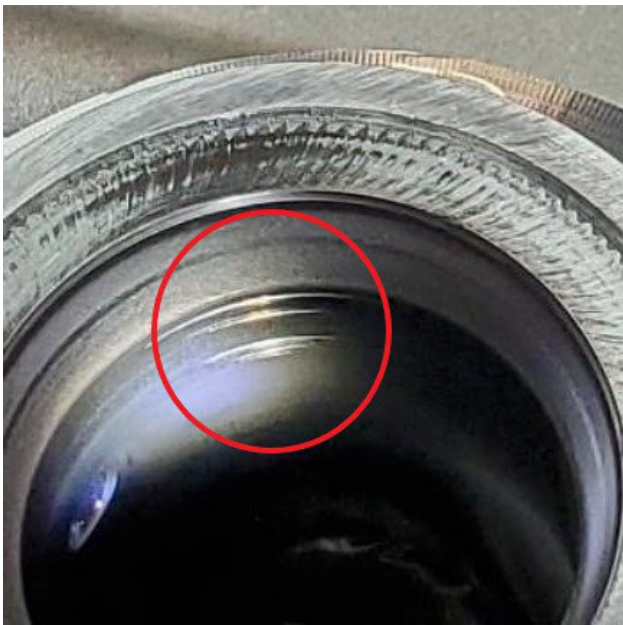
If signs of wear are seen as shown, this indicates the Primary Pulley Bearing has spun in the bore and is allowing the Turbine Shaft to become off center. When this happens, it causes a pressure leak.

If this concern is found, the transmission will need to be replaced.
