2020-2021MY  
Soul (SK3)  
2021MY  
Seltos (SP2)

SC209Y (Rev 2, 06/17/2024)

ENGINE REPLACEMENT INSTRUCTIONS  
FOR PISTON RING NOISE DTC P1327 (SC209Y)

P1327 / P132700 - Piston Noise Detection

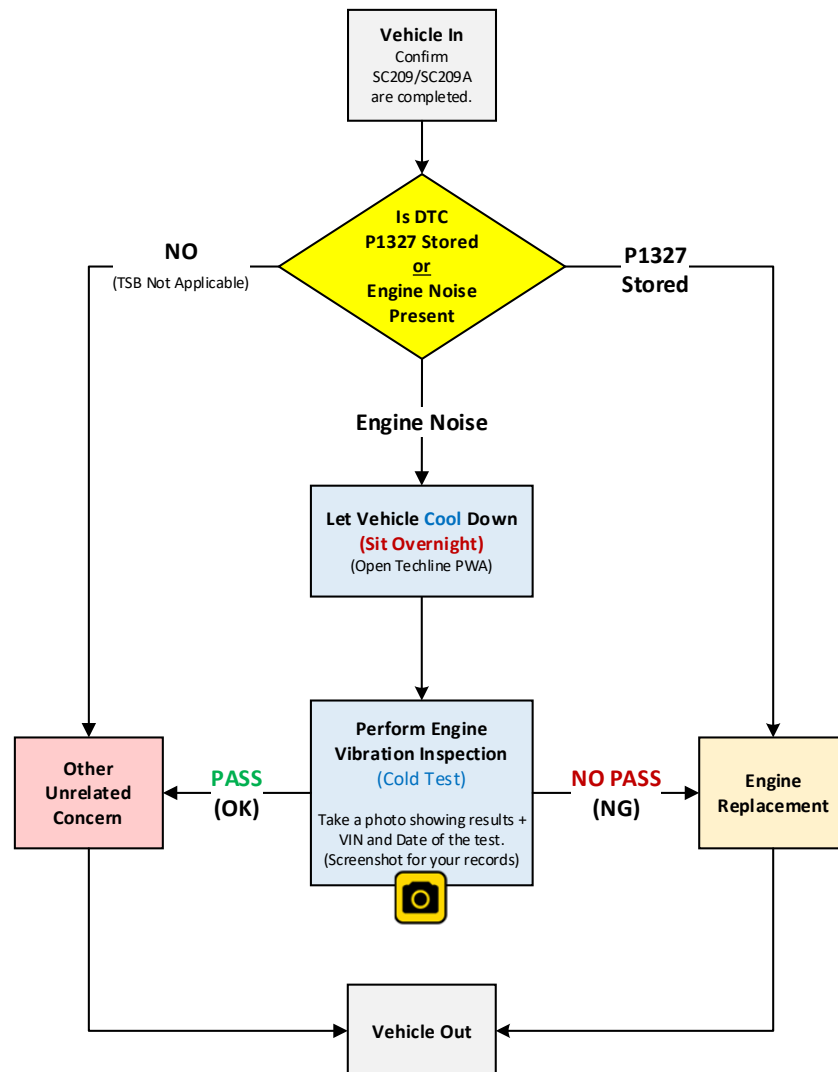
Flowchart:

**Path 1:** Vehicle In w/DTC P1327 → Engine Replacement

**Path 2:** Vehicle In w/Engine Noise → Perform Engine Vibration Inspection → No Pass (NG) → Engine Replacement

**Path 3:** Vehicle In w/Engine Noise → Perform Engine Vibration Inspection → Pass (OK) → Other Unrelated Concern

**Path 4:** Vehicle In without DTC P1327 or Engine Noise (TSB is not applicable) → Other Unrelated Concern

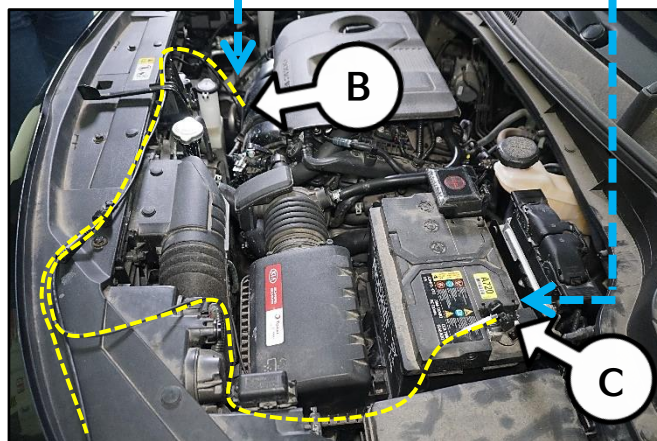
If the vibration inspection harness is placed over the engine components, external vibration may negatively affect to the inspection result. Route the wiring around the engine (yellow outline) shown in the photo.
