GROUP	MODEL
Voluntary Service Campaign	2024MY Telluride (ON)
NUMBER	DATE
SC313	June 2024

STARTER SOLENOID POSITIVE (+) TERMINAL NUT RE-TIGHTENING (SC313)

This bulletin provides the procedure to re-tightening the starter solenoid positive (+) terminal nut on certain 2024MY Telluride (ON) vehicles produced from January 8, 2024 through February 19, 2024. The starter solenoid positive (+) terminal nut in the subject vehicles may not have been properly tightened to specifications during assembly. If this nut is not properly tightening, it may loosen over time, which can result in a no-start condition during start-up and/or Idle Stop and Go (SIG) use. Dealers are to re-tighten the starter solenoid positive (+) terminal nut to the factory specifications on the applicable vehicle. Before conducting the procedure, verify that the vehicle is included in the list of affected VINs listed below.

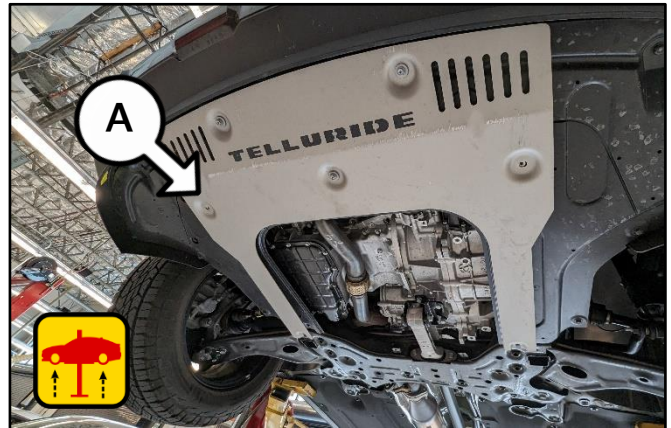
1. Open the hood.
2. Disconnect both 12V battery negative (-) and positive (+) terminals.
3. Lift the vehicle on the hoist.
4. Remove the engine room under cover (A).

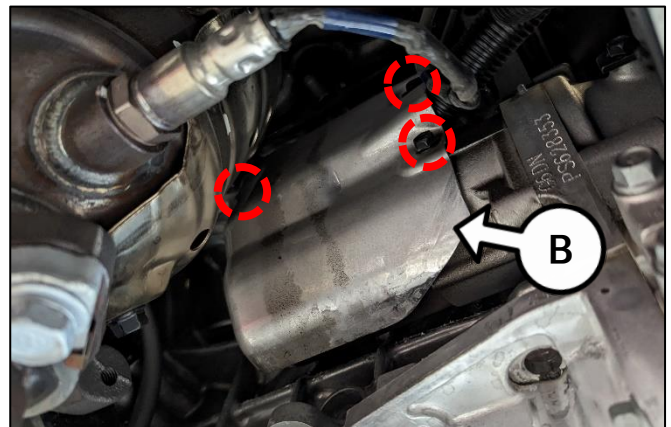
5. Loosen the three (3) engine starter heat shield (B) retaining bolts and remove the heat shield.

Tightening torque for bolts:
6.5 - 10.1 lb.ft (8.8 - 13.7 N.m)

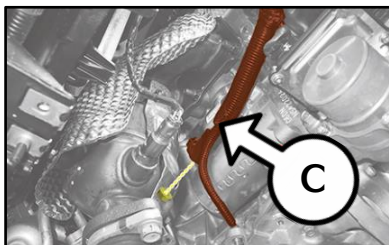
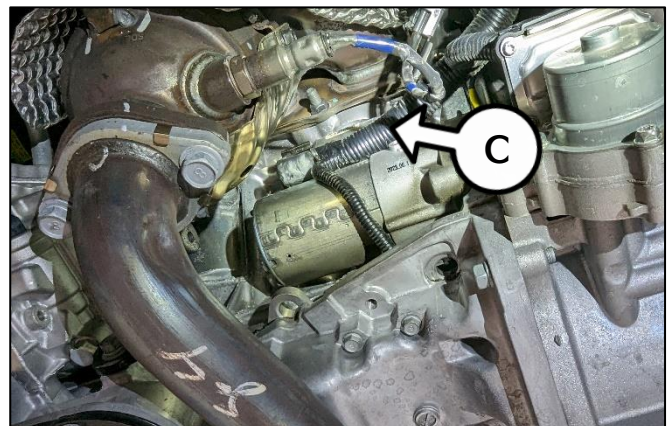
6. Locate the engine starter wire harness (C).

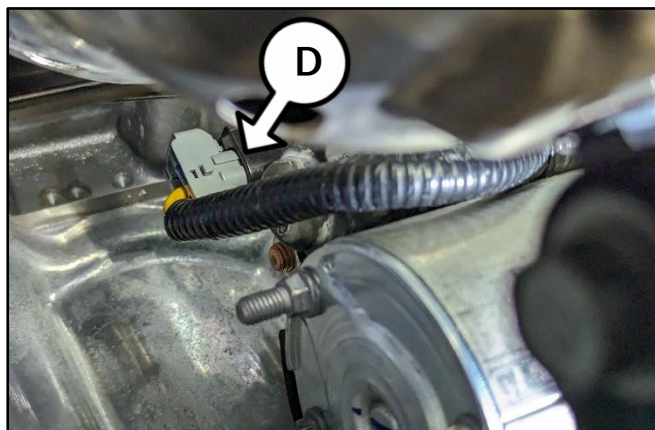
4. Disconnect the starter solenoid connector (D).

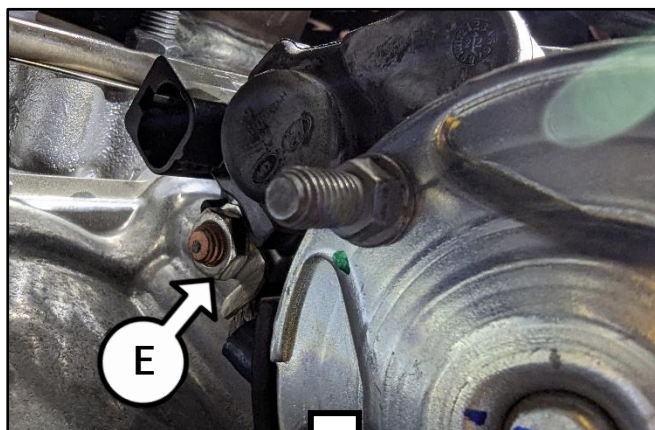
5. Locate the starter solenoid 12V cable retaining nut (E).

Due to limited space, the use of a 1/4" torque wrench is recommended.
