Title: BL1070 update

Applicability: Revero GT and GTS, GS-6 vehicles

Type: Technical Service Bulletin

System: Electric Drive (16)

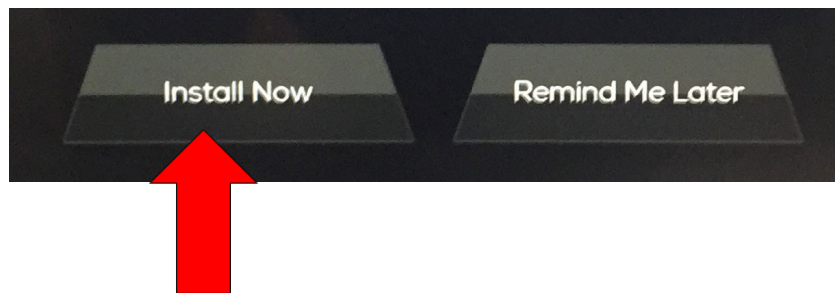
On complaint of MIL on with DTC P0A80, "Replace Battery", or a bucking behavior on moderate to high demand throttle application, there is a software baseline update to remedy this concern. This will be provided over the air.

Create a TSS case and await the coming over-the-air download. Place the vehicle in an area of good cellular reception. When the download is complete, when the vehicle is ready, power down. This will issue a prompt, accept the "install". The vehicle will update. When complete, test drive the vehicle, and complete the TSS case, follow any instructions provided by the representative.

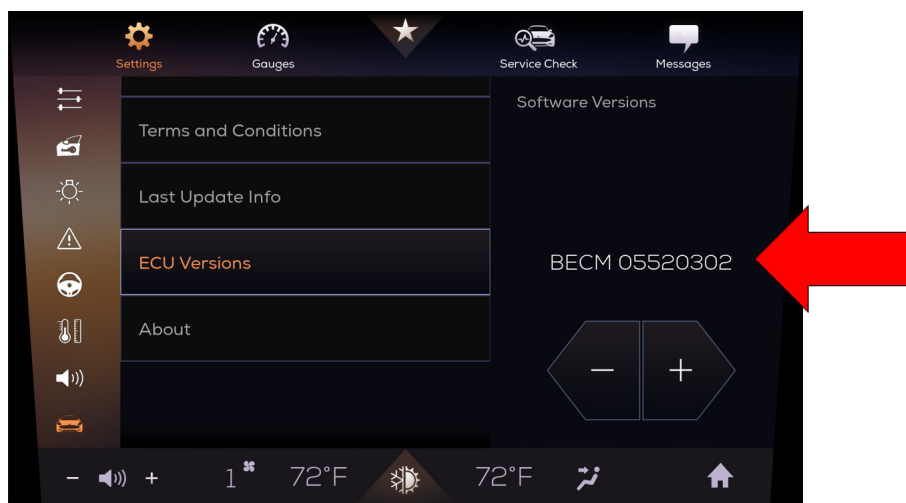
The BECM software level will reflect Baseline 1070 is installed.

Look in software version in the TPI under settings> BECM will display level 05520302.

If it is already at this no work is to be done, discuss with TSS on how to proceed.
