# Service Bulletin

Bulletin No.: 22-NA-193

**Subject:** Information on Malfunction Indicator Lamp (MIL) Illuminated - DTC P219A and/or P219B Set

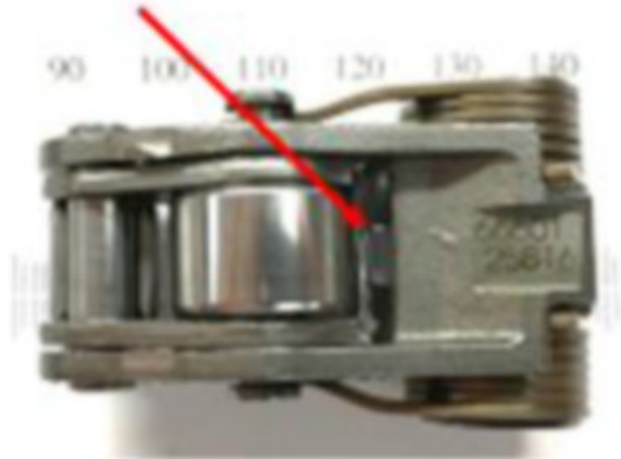
5924237

⇒ Below are pictures of possible SRFF failures. If any one of the SRFFs are damaged, it will be necessary to replace all four on the affected cylinder.

3. Replace the stationary hydraulic lash adjuster's (SHLA's) and the damaged Switching Roller Finger Followers (SRFF) on the bank found to have the concern.

4. If any of the conditions listed above have been verified, refer to the Service Procedure listed in SI for replacement of the Switching Roller Finger Followers (SRFF) and dual function stationary hydraulic lash adjusters for cylinder 5 or cylinder 2.
