# Service Bulletin

Bulletin No.: 24-NA-086

**Subject: Folding Top Service Tips to Prevent a Broken Rear Glass Assembly**

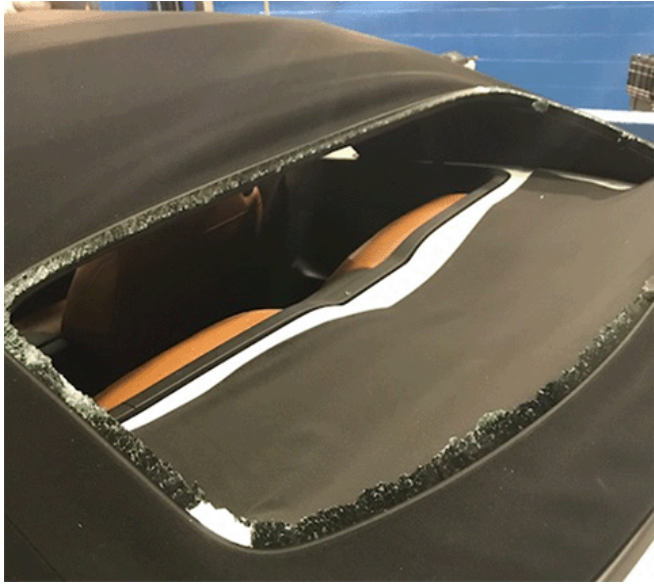
5040810

<b>Involved Region or Country</b>	North America, Argentina, Brazil, Chile, Paraguay, Europe, Middle East, Israel, Palestine, Japan
<b>Additional Options (RPOs)</b>	Power Folding Top (RPO CM8)
<b>Condition</b>	<p>Some technicians may comment that the back glass, which is an integral part of the folding top canvas, had broken after cycling the folding top assembly. This will be noticed very soon after a folding top canvas or a side rail has been replaced for service.</p>

<b>Cause</b>	The cause of this concern may be due to improper reassembly of the folding top linkage where it connects to the back glass.
<b>Correction</b>	If this concern is encountered, dealership technicians are to first inspect the linkage that connects the folding top frame to the back glass that is attached to the folding top canvas.

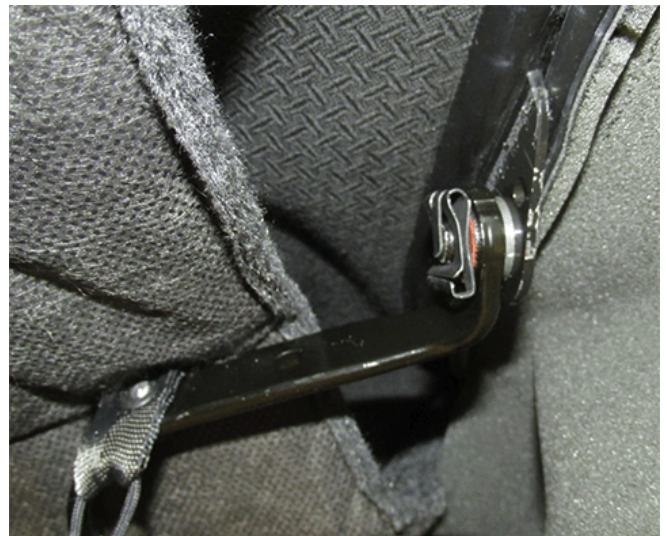
5124926

See photo below of a correctly assembled folding top linkage at the rear glass attachment point.

The folding top linkage that attaches to the rear glass **MUST** be located on the outboard side of the back glass bracket. The pin that holds it together is inserted from the inboard side of the linkage. It first goes through the back glass bracket, after that it goes through the top frame linkage. A gray plastic washer **MAY** be found in this assembly. Servicing technicians are to note if this is present during disassembly. Finally, the spring clip is installed on the outboard side of the top frame linkage.
