Technical Service Bulletin (TSB)
Right Front Door Glass Snowflaking

| REFERENCE: | TSB: 23-040-24 REV. A GROUP: 23 - Body | Date: | June 18, 2024 | REVISION: | 23-040-24 |
| VEHICLES AFFECTED: | 2023 (WL) Grand Cherokee **/ Grand Cherokee L** This bulletin applies to vehicles built on or after June 01, 2023 (MDH 0601XX) and on or before September 30, 2023 (MDH 0930XX). | MARKET APPLICABILITY: | | | |

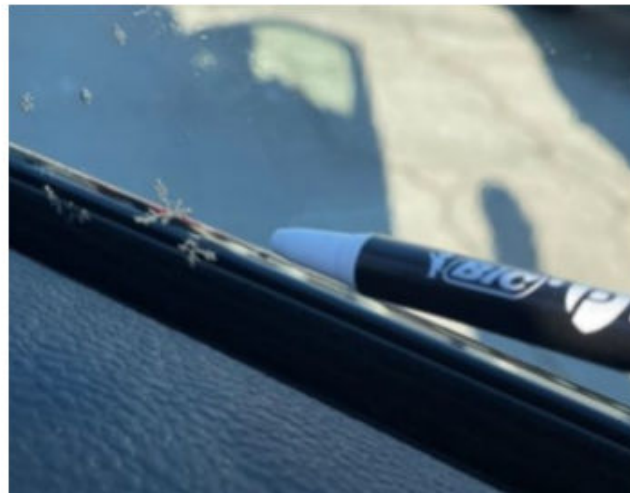
Fig. 1
Door Glass Bubbling

| CAUSE: | Manufacturing defect of the right front door glass leading to contamination in the laminated layers | | | | |

1. Inspect right front door glass for snowflaking/bubbling [Fig. 1](#). Effect is viewable from both inside and outside.

NOTE: Temperatures above 80° F (27° C) will accelerate the defects' appearance.

1. Replace the right front door glass. Refer to the detailed service procedures available in DealerCONNECT> Service Library under: Service Info>23 - Body / Doors - Front / Glass, Door / Removal and Installation.
