REFERENCE:	TSB: 23-013-24 REV. A GROUP: 23 - Body	Date:	June 19, 2024	REVISION:	23-013-24
VEHICLES AFFECTED:	2023 - 2024 (WD) Dodge Durango This bulletin applies to vehicles built on or after October 09, 2023 (MDH 1009XX) and on or before **January 12, 2024 (MDH 0112XX)** equipped with Floor Carpet (Sales Code CKD).	MARKET APPLICABILITY:			
		<input checked="" type="checkbox"/> NA		<input checked="" type="checkbox"/> MEA	
		<input checked="" type="checkbox"/> SA		<input type="checkbox"/> IAP	
		<input checked="" type="checkbox"/> EE		<input type="checkbox"/> CH	
CUSTOMER SYMPTOM:	Customers may experience the following: <ul style="list-style-type: none"> Right hand front carpet exhibits bare spots, carpet pulling apart and/or carpet fibers are coming out Fig. 1. 				
CAUSE:	Manufacturing issue

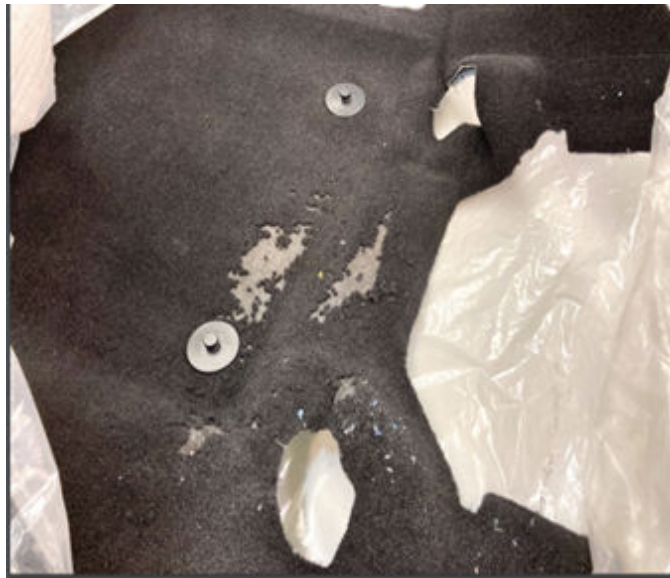
1. Remove the passenger front floor mat.
2. Inspect the right front floor carpet for deterioration or bare spots [Step 2](#).

Fig. 2
Front Right Floor Carpet Deterioration

5. Do the carpet fibers pull up?
 - YES>>> Proceed to [Step 6](#).
 - NO>>> This bulletin has been completed. Use Inspection LOP (23-21-15-98) to close the active RSU.
6. Replace the right front floor carpet. Refer to the detailed service procedures listed in DealerCONNECT> Service Library under: 23 - Body / Interior / Carpet, Floor / Removal and Installation.
7. Install the passenger front floor mat.

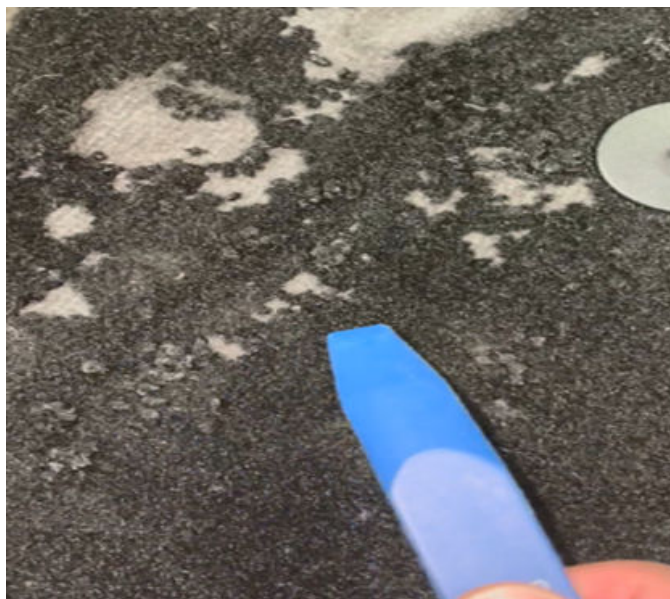
3. Does the right front floor carpet exhibit deterioration or bare spots?
 - YES>>> [Step 6](#).
 - NO>>> [Step 4](#).
4. Using a trim stick or equivalent tool, agitate the carpet with moderate pressure while inspecting for carpet fibers pulling up [Fig. 3](#).

Fig. 3
Agitating Right Front Floor Carpet
