GENERAL MOTORS
DCS6922
URGENT - DISTRIBUTE IMMEDIATELY

Subject: N242450210 - Service Update
Incorrect Outside Rearview Mirror Torque

Models: 2024 Chevrolet Blazer
2024 Chevrolet Blazer EV

N242450210 Incorrect Outside Rearview Mirror Torque

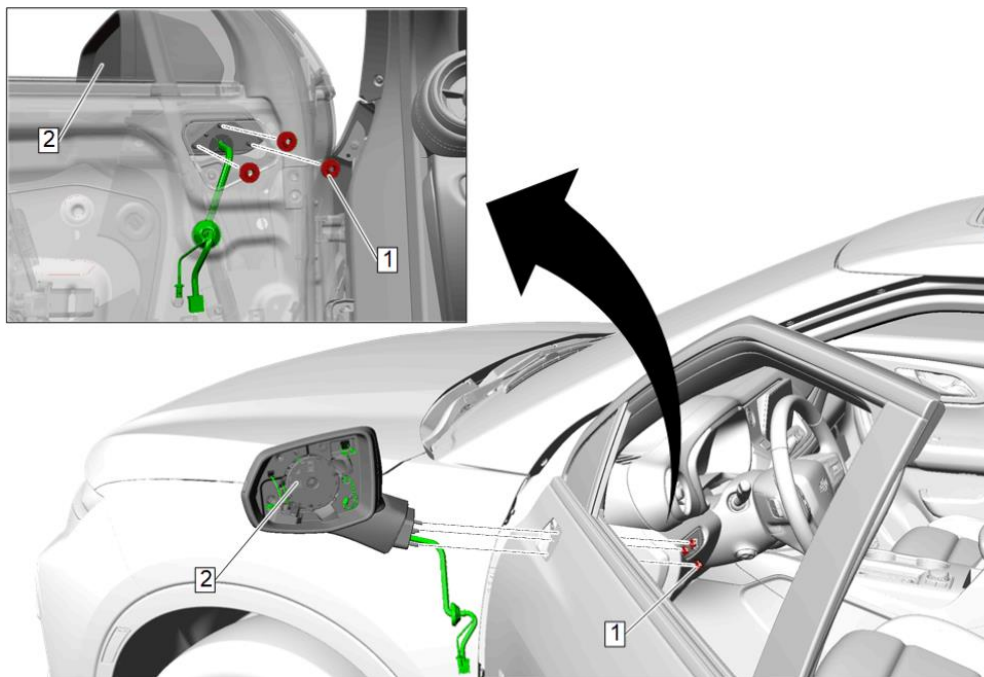
5132480

Condition	Certain 2024 model year Chevrolet Blazer and Blazer EV vehicles may have a condition in which the fasteners on the driver's side Outside Rearview mirror are incorrectly torqued.
Correction	Dealers will fasten the driver's OSRV mirror to the design torque specification.

3. Tighten the Outside Rearview Mirror Fasteners to 9 N•m (80 lb in)
