Technical Service Bulletin

19 Loss of coolant from coolant pump - 2.5ltr. TFSI

19 24 58 2073060/2 May 21, 2024. Supersedes Technical Service Bulletin Group 19 number 24-53 dated February 23, 2024 for reasons listed below.

Model(s)	Year	VIN Range	Vehicle-Specific Equipment
RS 3	2017 - 2022	All	Not Applicable
TT RS	2018 - 2022

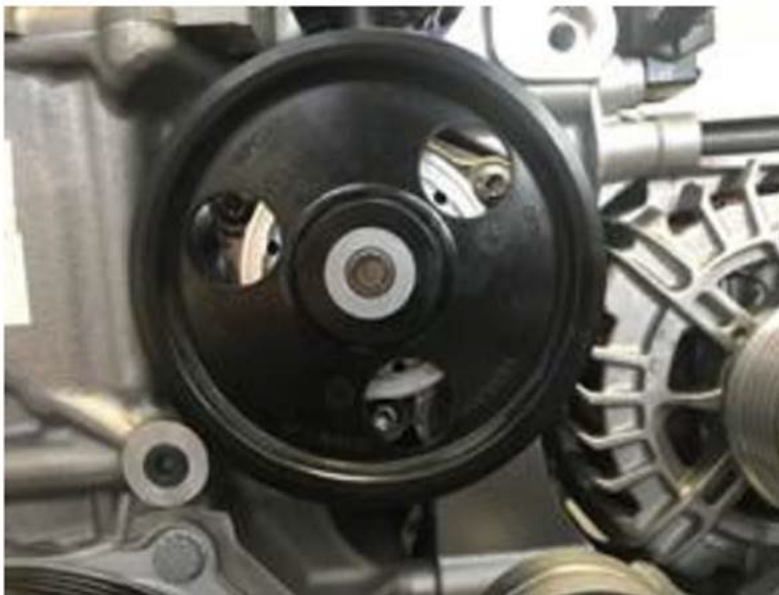
Figure 1. Coolant pump.

- The coolant pump is found to be the source of the leak.

3. Perform visual check; assess whether there may be a leak at idling speed and at higher engine speeds of up to approx. 2500 rpm.
 4. Check the cooling system for leaks according to the Workshop Manual.
 5. Reassess the suspected leak.
- No further coolant leak can be detected: continue to observe without replacing any parts.
- Coolant leak can be detected again, replace the component(s) causing the leaks and any components connected to the vacuum system that show signs of coolant ingress.
