Technical Service Bulletin

51 Cracking noises in right rear roof area during steering thrust

51 24 29 2060145/6 May 31, 2024. Supersedes Technical Service Bulletin Group 51 number 23-27 dated April 27, 2023 for reasons listed below.

Model(s)	Year	VIN Range	Vehicle-Specific Equipment
Q8	2019 - 2023	All	Not Applicable
SQ8, and RS Q8	2020 - 2023

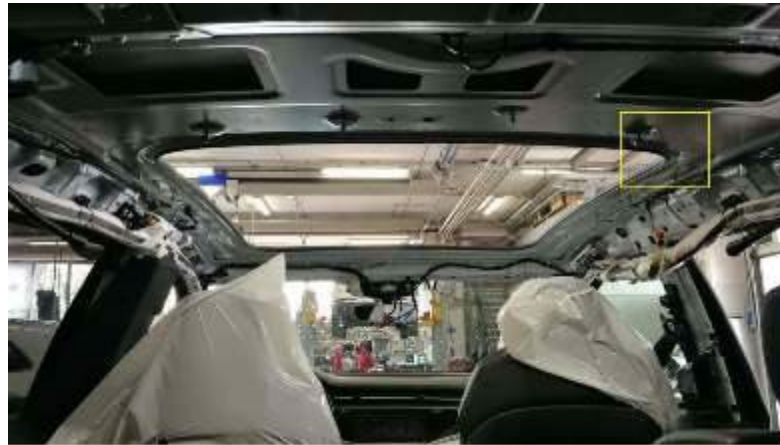
Figure 1. Right rear area of the sunroof opening to be reworked.

1. Remove the headliner and sliding sunroof assembly. Figure 1 shows the area to be reworked in the rear of the sunroof opening, beginning with the right rear.

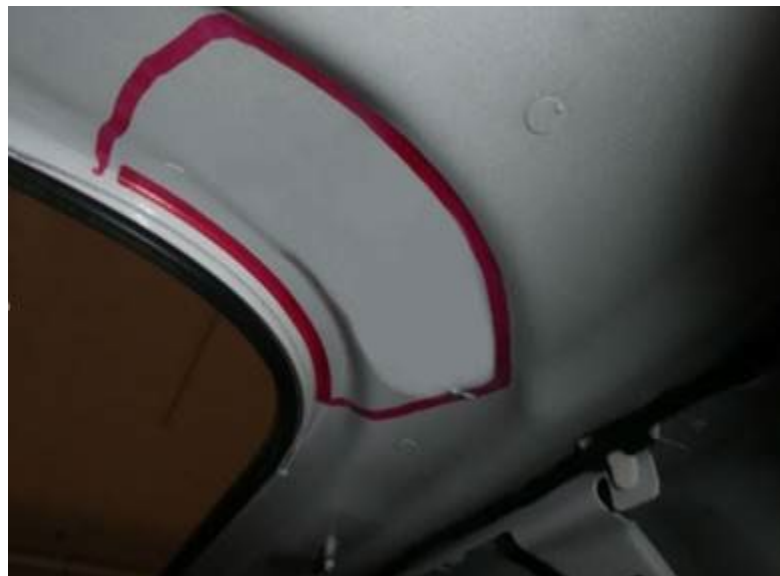
Figure 2. Area to be reworked.

2. Figure 2 shows a close-up view of the area to be reworked.

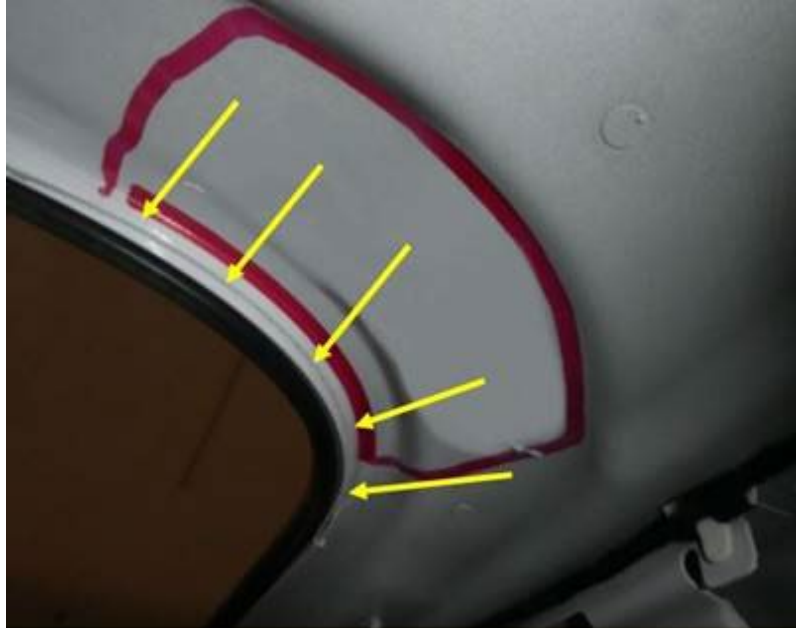
Figure 3. The yellow arrows show the joining seam of the outer roof sheet metal to be separated from the inner roof support.

3. The outer roof sheet metal is to be separated from the inner roof support (Figure 3).

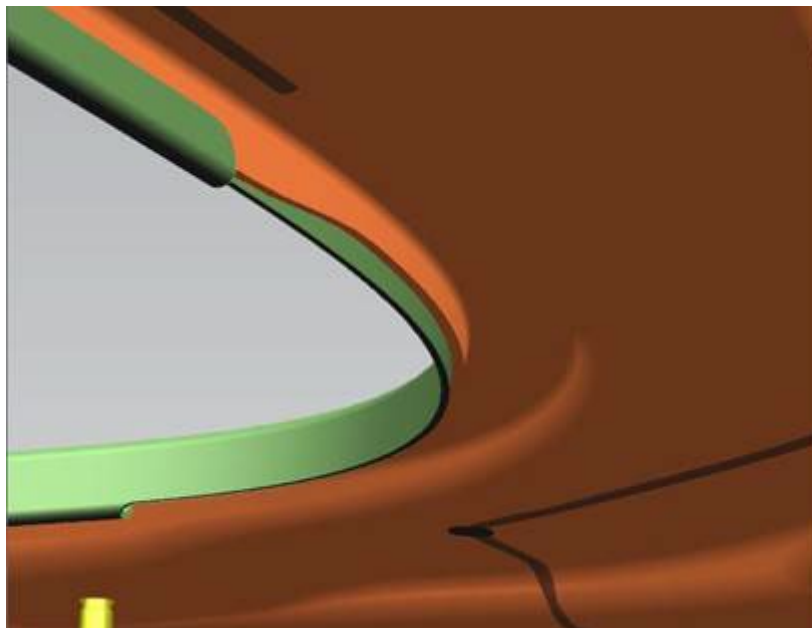
Figure 4. The green-colored section is to be separated from the orange-colored section in this illustration.

4. The drawing in Figure 4 shows the adjoining sheet metal that will be separated.

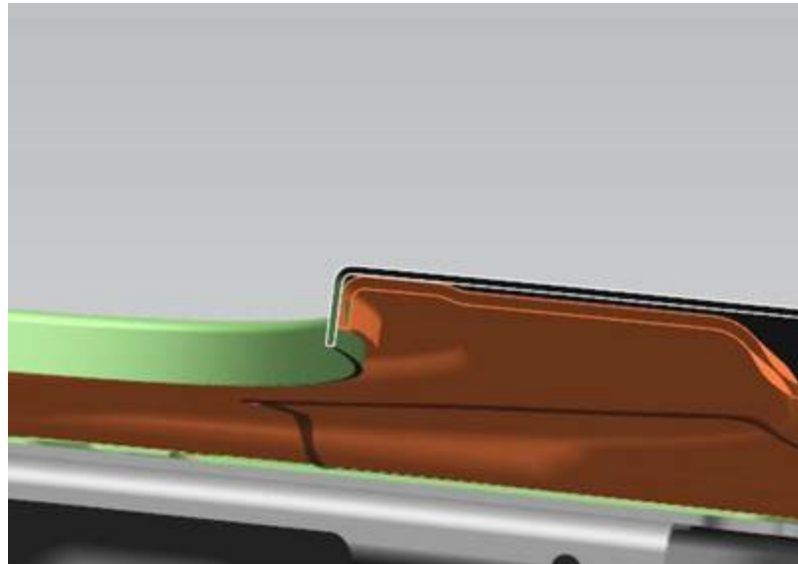
Figure 5. Cut-away view of the adjoining sheet metal that will be separated.

5. Figure 5 shows a cut-away view of the adjoining sheet metal that will be separated.

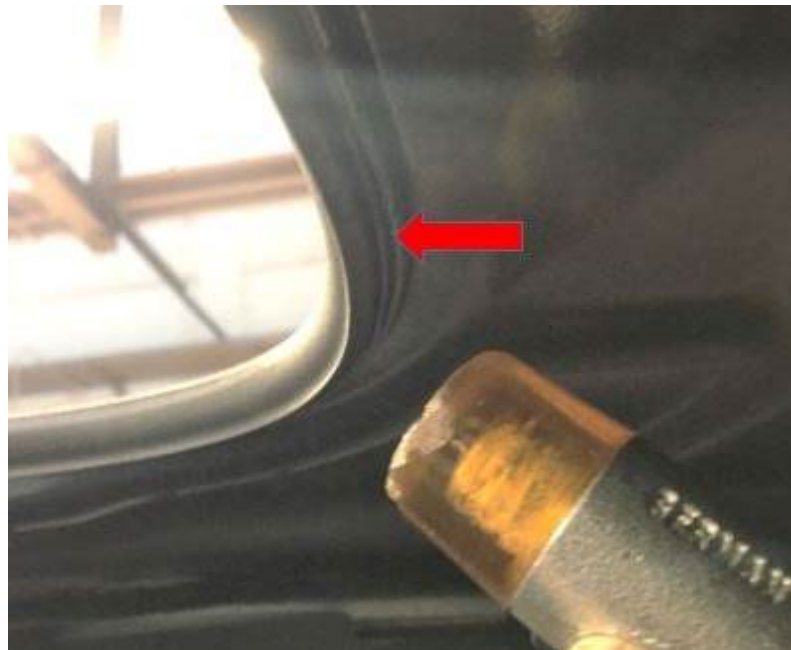
Figure 6. Area of sheet metal to strike with a plastic mallet.

7. Figure 6 shows the area of the roof sheet metal to strike with a plastic mallet. A light strike should suffice.

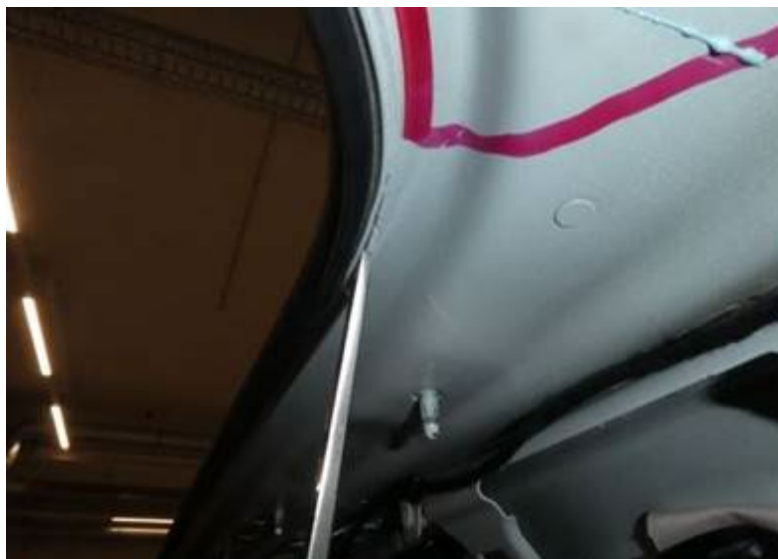
Figure 7. Adhesive joint separated.

8. If separation of the sheet metal proves to be more difficult than a light strike of a plastic mallet will produce use a small screwdriver or small chisel to break away the adhesive (Figure 7).

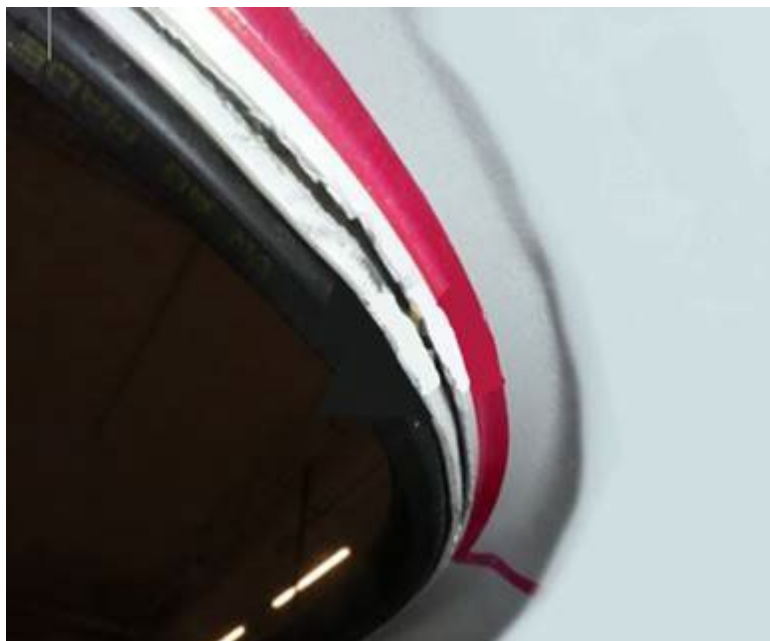
Figure 8. Create a gap of approximately 1mm.

9. Separate the adjoining sheet metal by approximately 1mm (Figure 8).

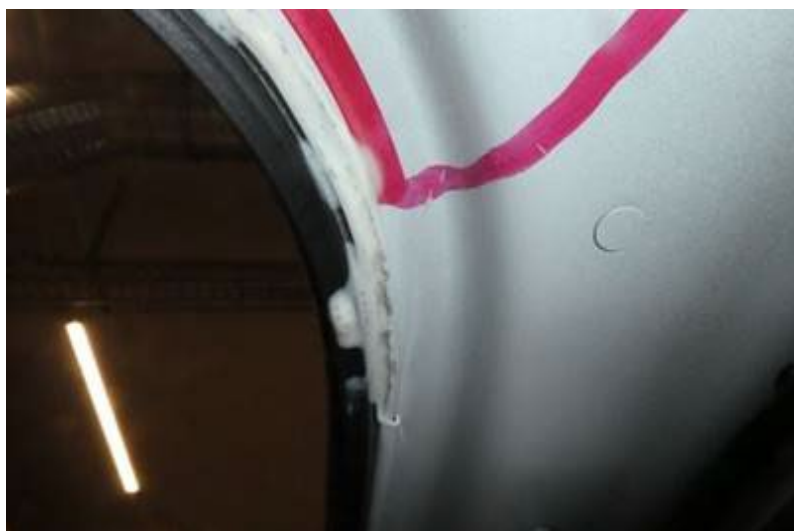
Figure 9. Gap created filled with Cavity Wax.

10. Through this gap fill the cavity with 08852 Cavity Wax Plus (Figure 9).
