Technical Service Bulletin

66 Exterior aluminum optic trim spotted / pitting

66 24 08 2074102/1 May 30, 2024.

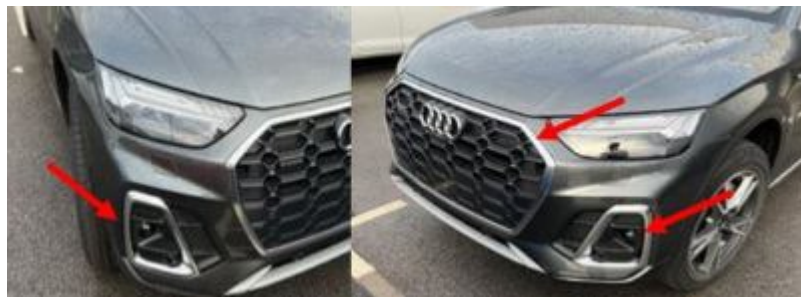
The finish on the aluminum optic trim on the front fascia, specifically the trim that surrounds the radiator grille, the underrun bar and the side cooling air grilles is pitting and / or shows small marks.

Figure 1. Areas of the front fascia showing damage.

Various degrees of damage to the trim surfaces of the aluminum optic trim is confirmed.

The affected trim will need to be replaced in these cases however, due to the nature of the root cause of the failure of the trim finish having been determined as exposure to environmental fallout, road salt and residues of aggressive cleaning agents, trim replacement under warranty is prohibited.

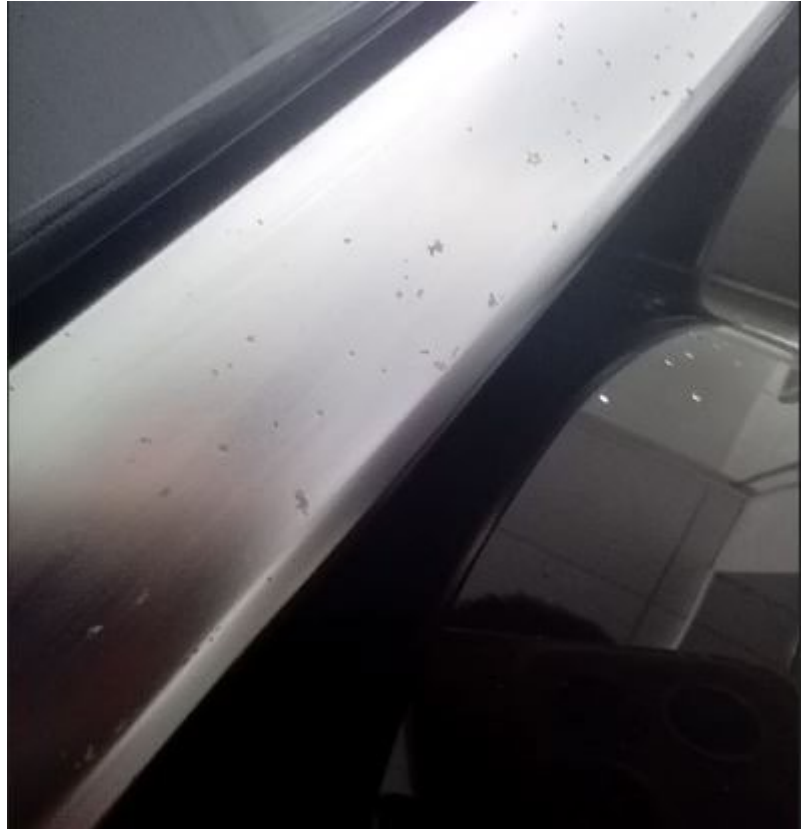
1. Figure 2 shows an example of the damage confirmed.

Figure 2. Pitting in the radiator grille trim.

5. The examples of the damage to the aluminum optic trim shown in this TSB are due to exposure to environmental fallout, road salt and residues of aggressive cleaning agents after laboratory analysis. The damage to the trim is irreversible and cannot be repaired.

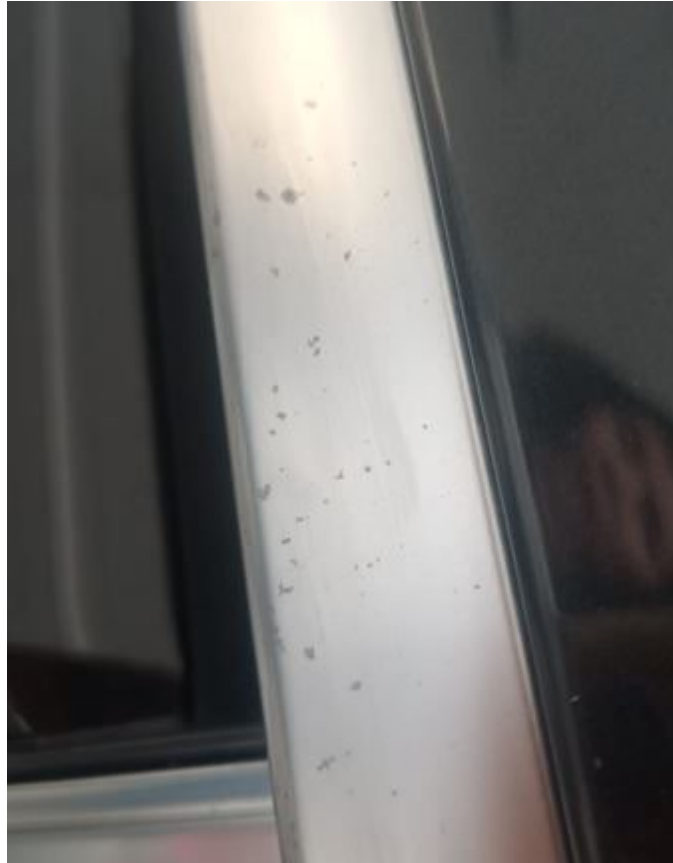
2. Figure 3 shows an additional example of pitting / spotting on the grille trim.

Figure 3. Pitting / spotting in the radiator grille trim.

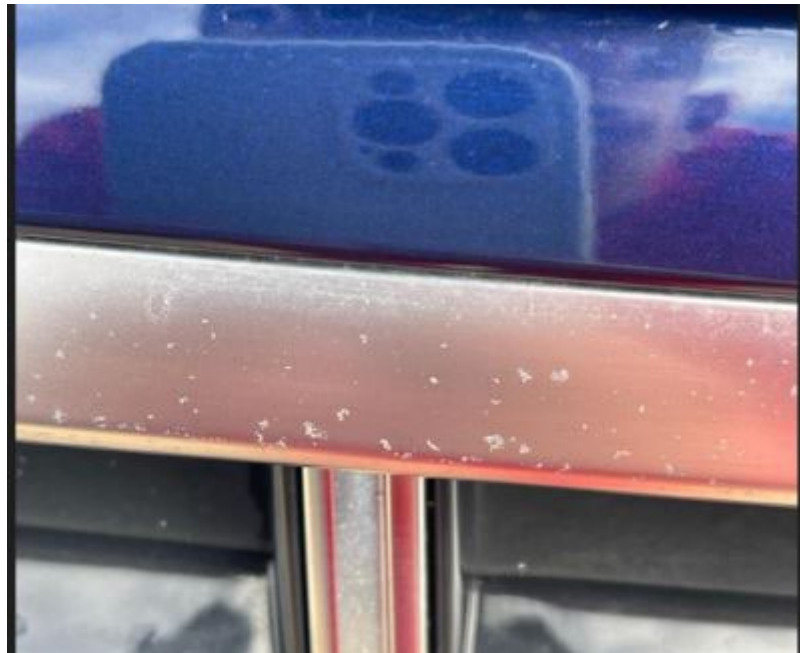
3. Figure 4 shows a close-up view of the damage typically discovered on the trim.

Figure 4. Close-up view of the pitting / spotting on the trim.

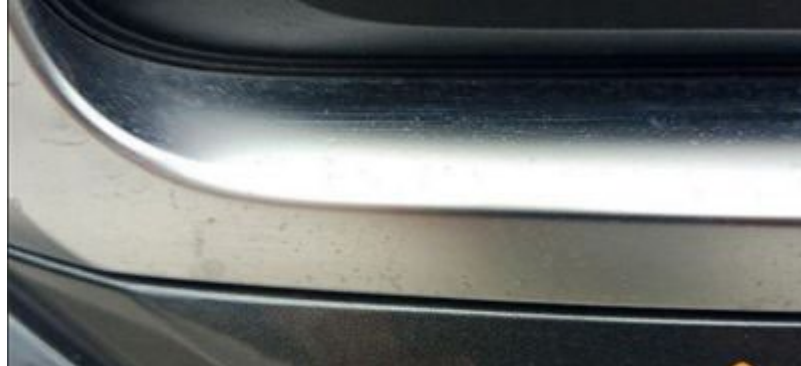
4. Figure 5 shows spotting / discoloration on the side cooling air trim due to exposure to environmental fallout, road salt and / or residues of aggressive cleaning agents.

Figure 5. Spotting discoloration on the side cooling air grille trim.
