# Technical Service Bulletin

## 91 MIB2+: lower display flickering after a software update

91 24 06 2061029/5 May 7, 2024. Supersedes Technical Service Bulletin Group 91 number 21-01 dated May 14, 2021 for reasons listed below.

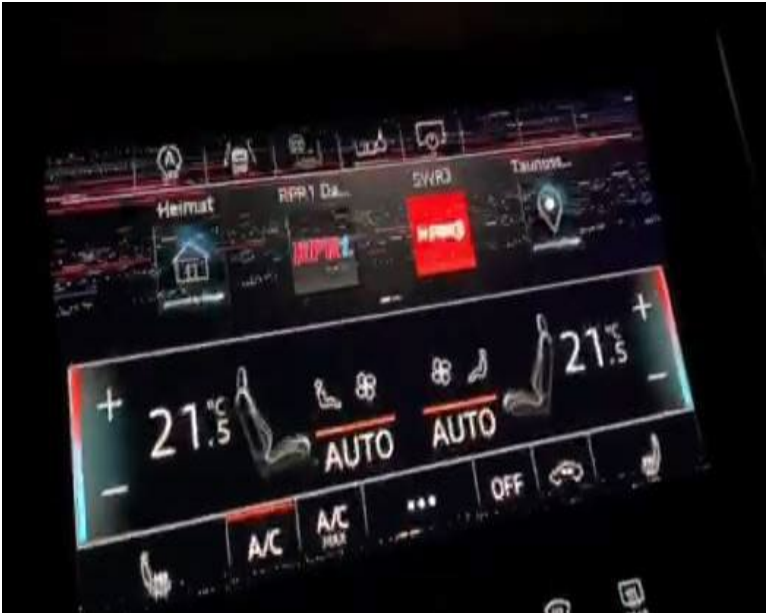
- After a MMI Software update has been completed, the lower display sporadically flickers (Figure 1).

Figure 1. The display sporadically flickers.

There are compatibility issues between the display and the MMI software.

Update the MIB2+ display using Method 2 according to TSB 2056558: *91 MIB2+ Software Update Instructions and use SVM code 636 S002*.
