Technical Service Bulletin

93 PSS Q8 e-tron: Charging flap module without search illumination

93 24 58 2073481/2 May 31, 2024. Supersedes Technical Service Bulletin Group 93 number 24-44 dated March 21, 2024 for reasons listed below.

Model(s)	Year	VIN Range	Vehicle-Specific Equipment
Q8 e-tron, Q8 e-tron Sportback, SQ8 e-tron, and SQ8 e-tron Sportback	2024 - 2025	All	Not Applicable

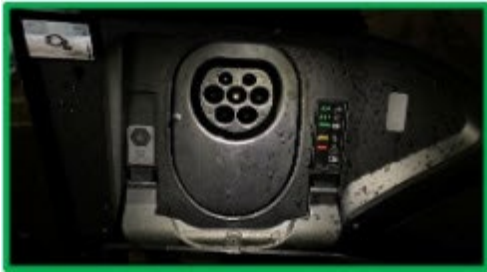
Figure 1: Vehicle with functioning orientation light in the charging flap module.

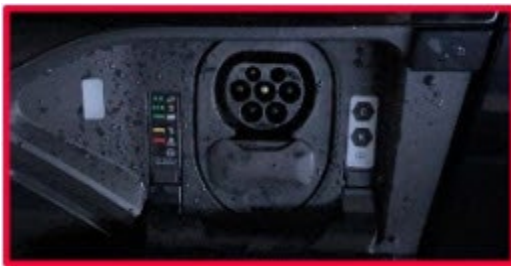
If the vehicle is only equipped with single charging flap module the orientation light does not work. An error in the OBC (00C6) software means that the orientation light LED is not activated when the vehicle is equipped with only one charging flap module.

Figure 2: Vehicle with a non-functioning orientation light in the charging flap module.

- Explain to the customer that a solution is expected to be available by the end of the 3rd quarter of 2024 (subject to change) and that no repairs are necessary at this point. Do not replace any components for this condition since this will not resolve the customer's concern.
- Create a PSS record in the PSS application through the Pending Service Solutions (PSS) link in AccessAudi (under *Related Links* >> *Service*).
