GENERAL MOTORS
DCS6921
URGENT - DISTRIBUTE IMMEDIATELY

Subject: N242449880 - Service Update
Paint Not Applied to Left Interior Rear Door

Models: 2024 Cadillac XT5
2024 Cadillac XT6

N242449880 Paint Not Applied to Left Interior Rear Door

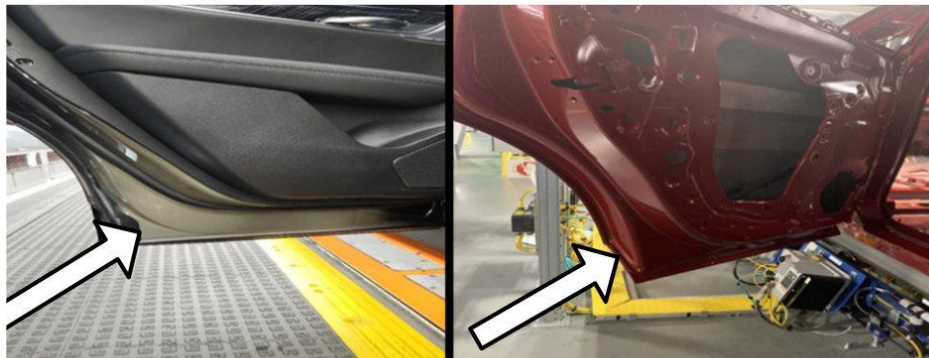
Condition	Certain 2024 model year Cadillac LYRIQ, XT5, and XT6 vehicles may have a condition where the left interior rear door may not have paint applied.
Correction	Dealers are to inspect, and if necessary, recoat the inner rear door.

1. Inspect the interior portion of the driver's side rear door for a condition in which no paint coating has been applied. Clear coat may be applied, but the exterior paint color coat may be missing. Use a bright light to aid in inspection.
 - A. If the interior portion of the left rear door has been painted, no further action is required.
 - B. If the vehicle is missing paint, proceed to step 2.

2. Remove the left rear door trim panel. Refer to *Rear Side Door Trim Removal and Installation* in SI.
3. Remove the Rear Side Door Water Deflector.
4. Remove the left rear door. Refer to *Rear Side Door Replacement* in SI.
5. Prepare the area for painting as necessary.
6. Paint the affected area by blending the base coat.

7. Clear coat the entire interior side of the rear side door.
8. Reinstall the left rear door. Refer to *Rear Side Door Replacement* in SI.
9. Reinstall the left rear door trim panel. Refer to *Rear Side Door Trim Removal and Installation* in SI.
